# FINAL FISCAL YEAR 2021 ANNUAL LAND USE CONTROL AND OPERATION AND MAINTENANCE REPORT

# IOWA ARMY AMMUNITION PLANT MIDDLETOWN, DES MOINES COUNTY, IOWA

**AUGUST 2022**

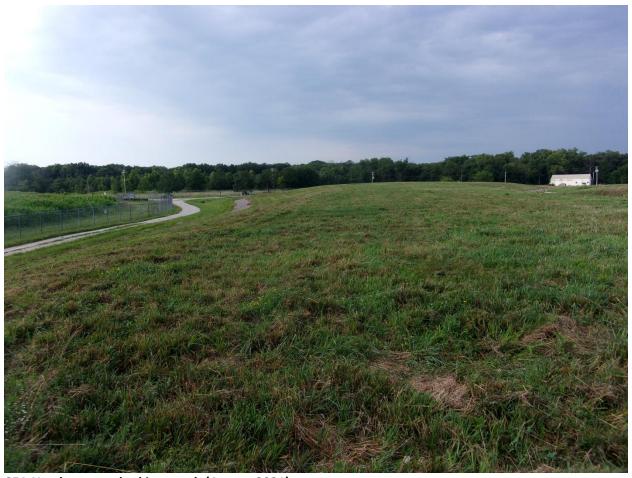
CEA North enc top looking south (August 2021).

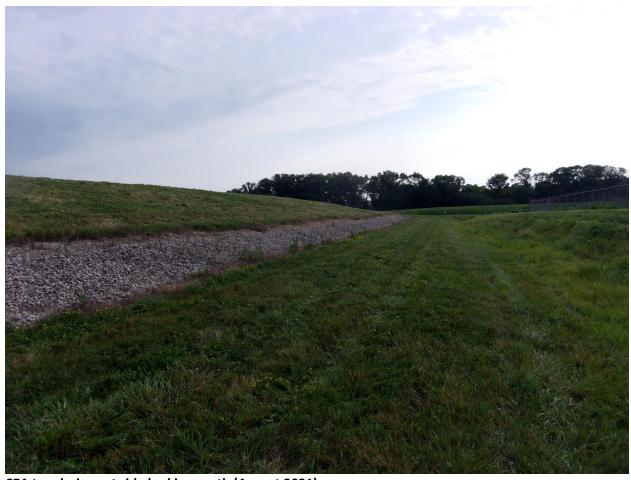
CEA toe drain east side looking north (August 2021).

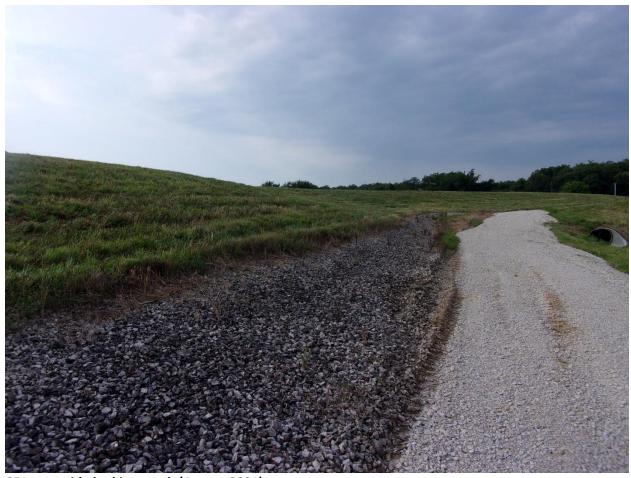
CEA west side looking south (August 2021).

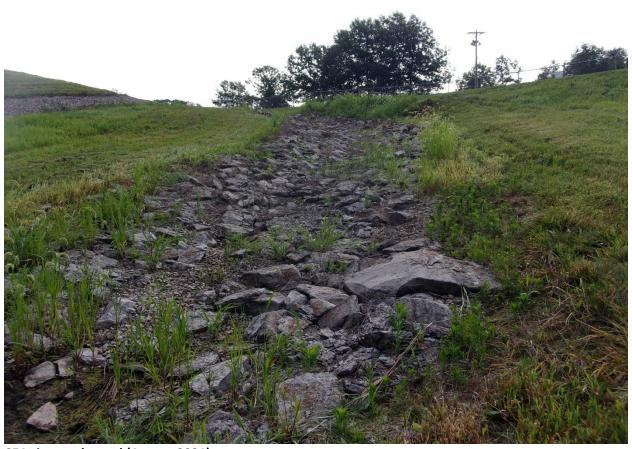
CEA rip rap channel (August 2021).

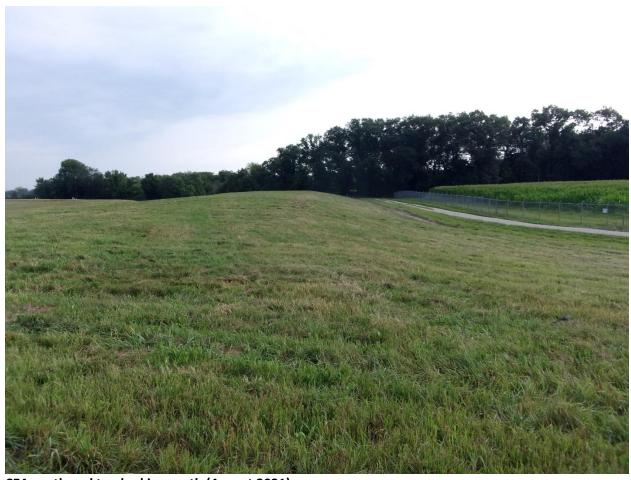
CEA south end top looking north (August 2021).

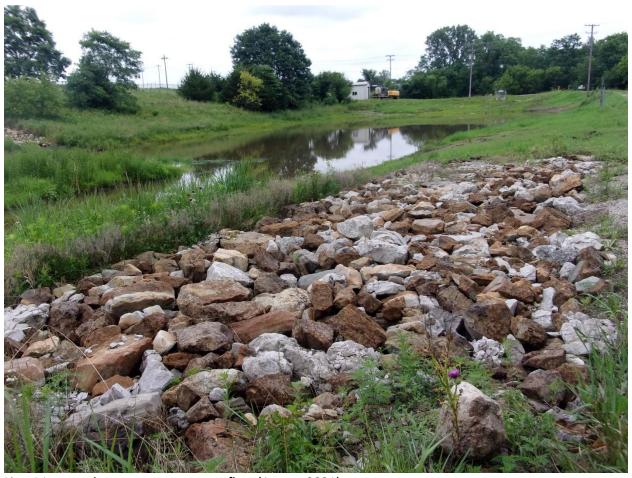
Line 1 Impoundment emergency overflow (August 2021).

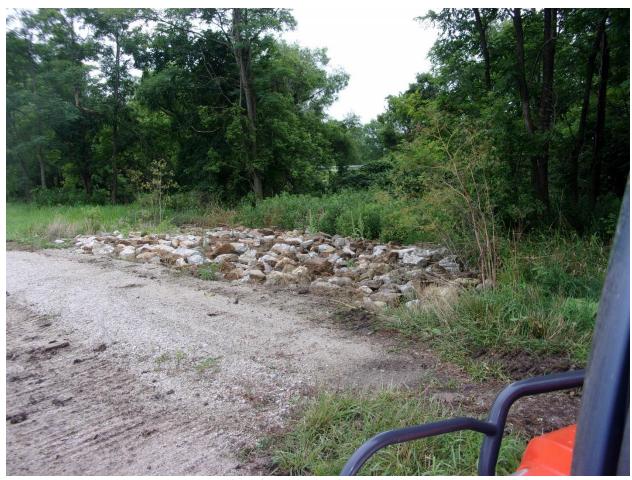
Line 1 Impoundment emergency overflow (August 2021).

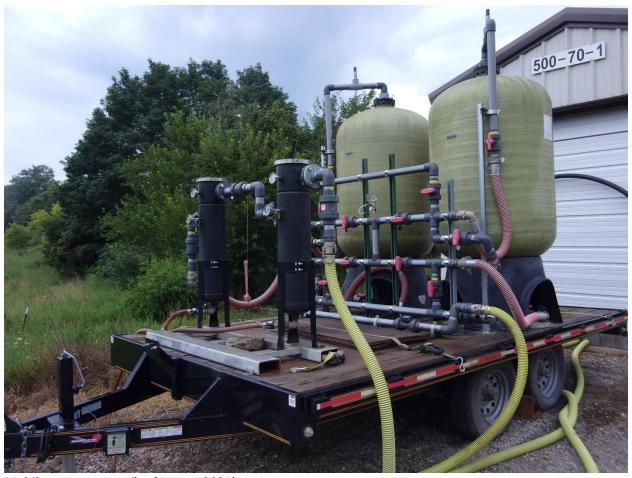
Mobile treatment trailer (August 2021).

No issues were noted throughout FY21. The Line 800 mobile treatment trailer requires storage over the winter, it is recommended that a storage structure be constructed at Line 1 Impoundment or IDA to store the mobile treatment trailer while it is not in use.

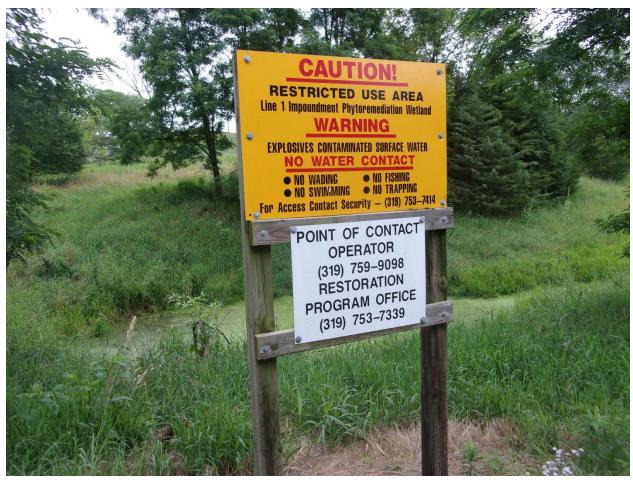
Line 1 Impoundment signage (August 2021).

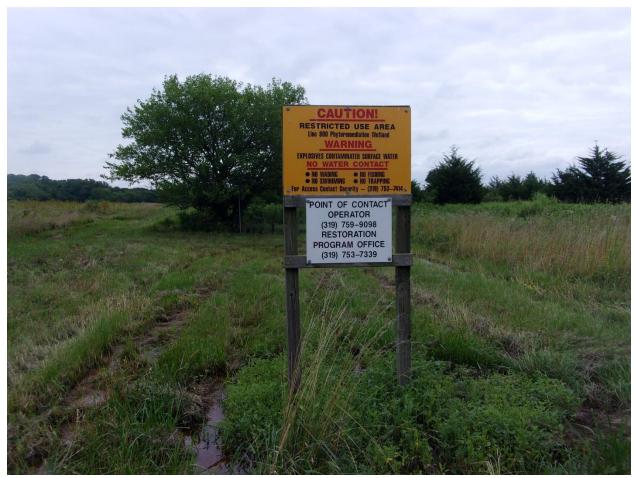
Line 800 signage (August 2021).

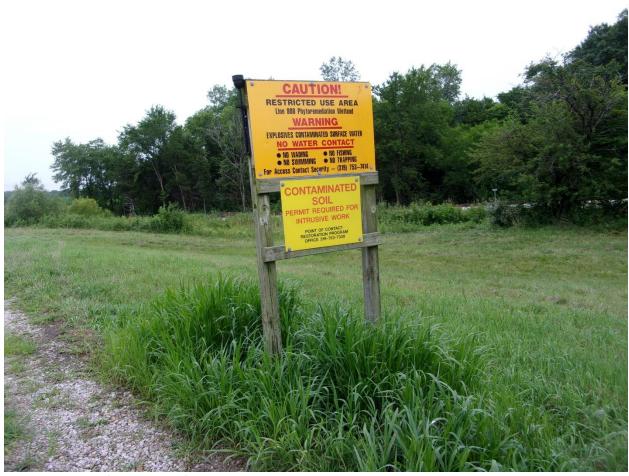
Line 800 signage (August 2021).

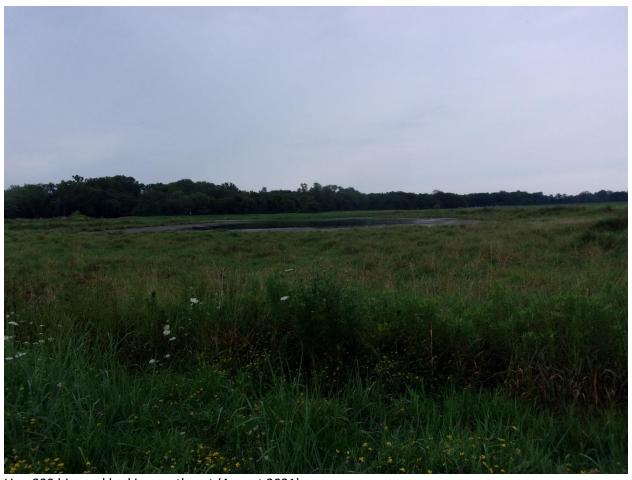
Line 800 big pool looking northeast (August 2021).

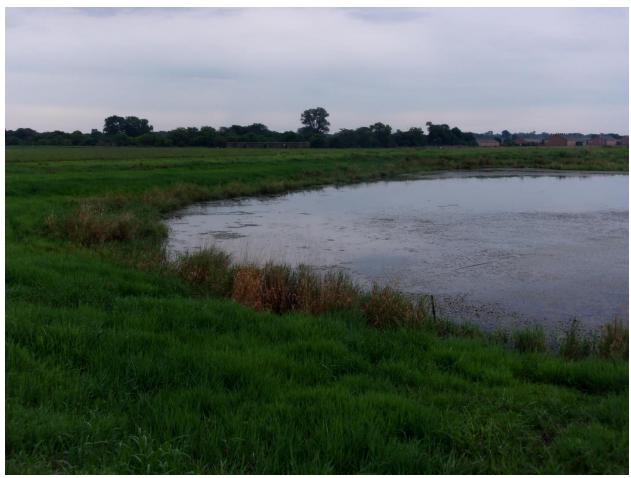
Line 800 big pool looking south (August 2021).

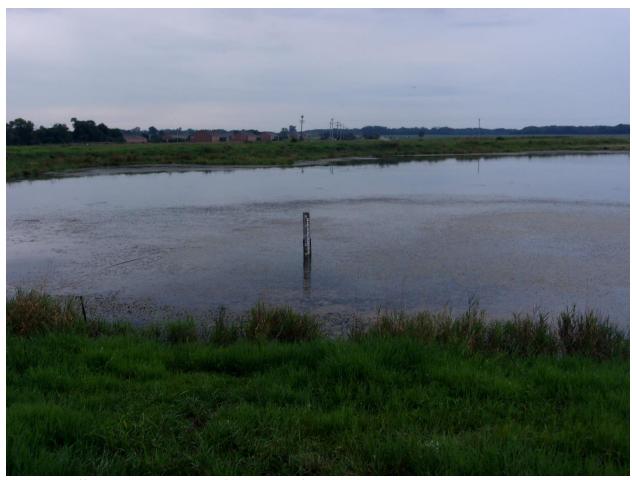
Line 800 staff gauging looking south (August 2021).

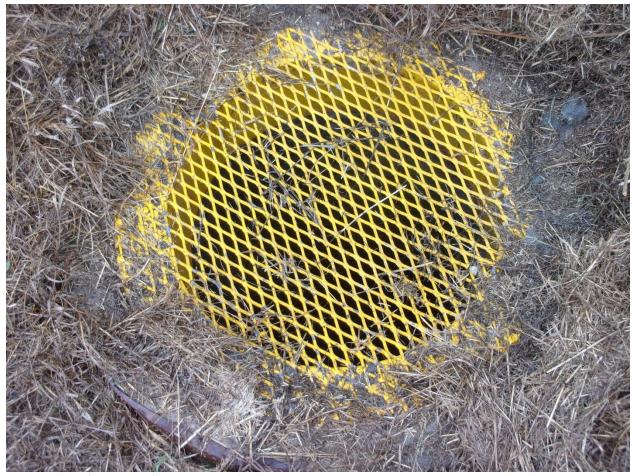
Line 800 overflow point (August 20210).

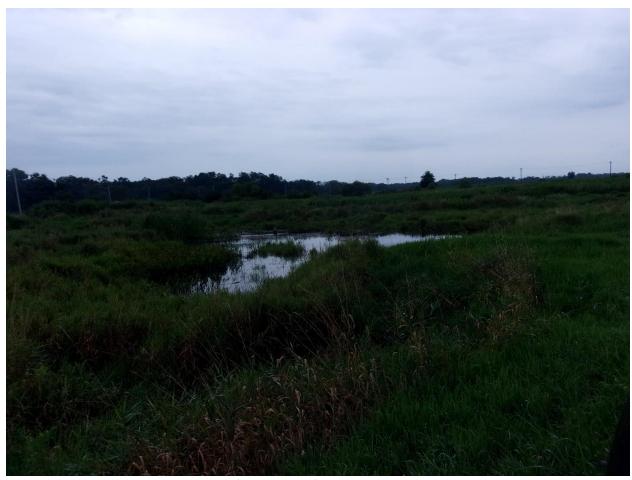
Line 800 small pool looking northwest (August 2021).

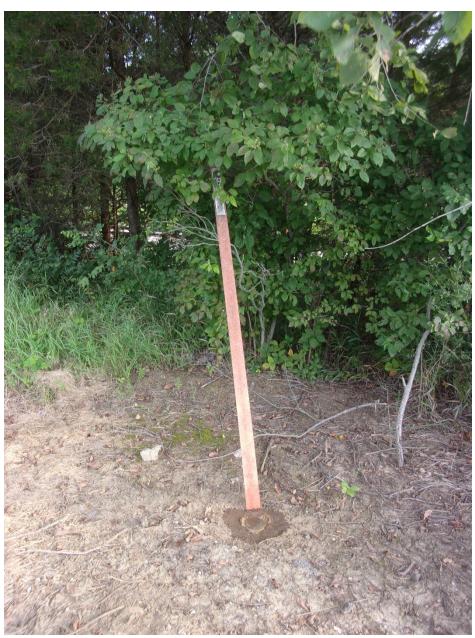
Typical Survey Monument.

The settlement monuments and guard posts are inspected annually for damage. During the FY21 settlement monument survey it was noted that the concrete monuments are deteriorating and may require repair. A photograph of a monument is included in Appendix D.

The professional surveyor that performed the FY20 settlement monument survey indicated that due to weathering of the concrete monuments since their installation in 1998, some repairs may be required for continued use. During the FY21 inspection in August 2021, the JV noted the poor condition of a number of survey monuments and recommends replacement of damaged monuments.

While not identified during the annual inspection, the professional surveyor that performed the ILF settlement monument survey in September 2020 indicated the monuments are becoming weathered and may require repair for continued use. The settlement monuments were evaluated by the JV in FY21 and recommends replacement.
