**Annual Land Use Control Implementation Report
for Operable Unit 5 Munitions Response Sites
Military Munitions Response Program**

**Iowa Army Ammunition Plant
Middletown, Iowa**

September 2022

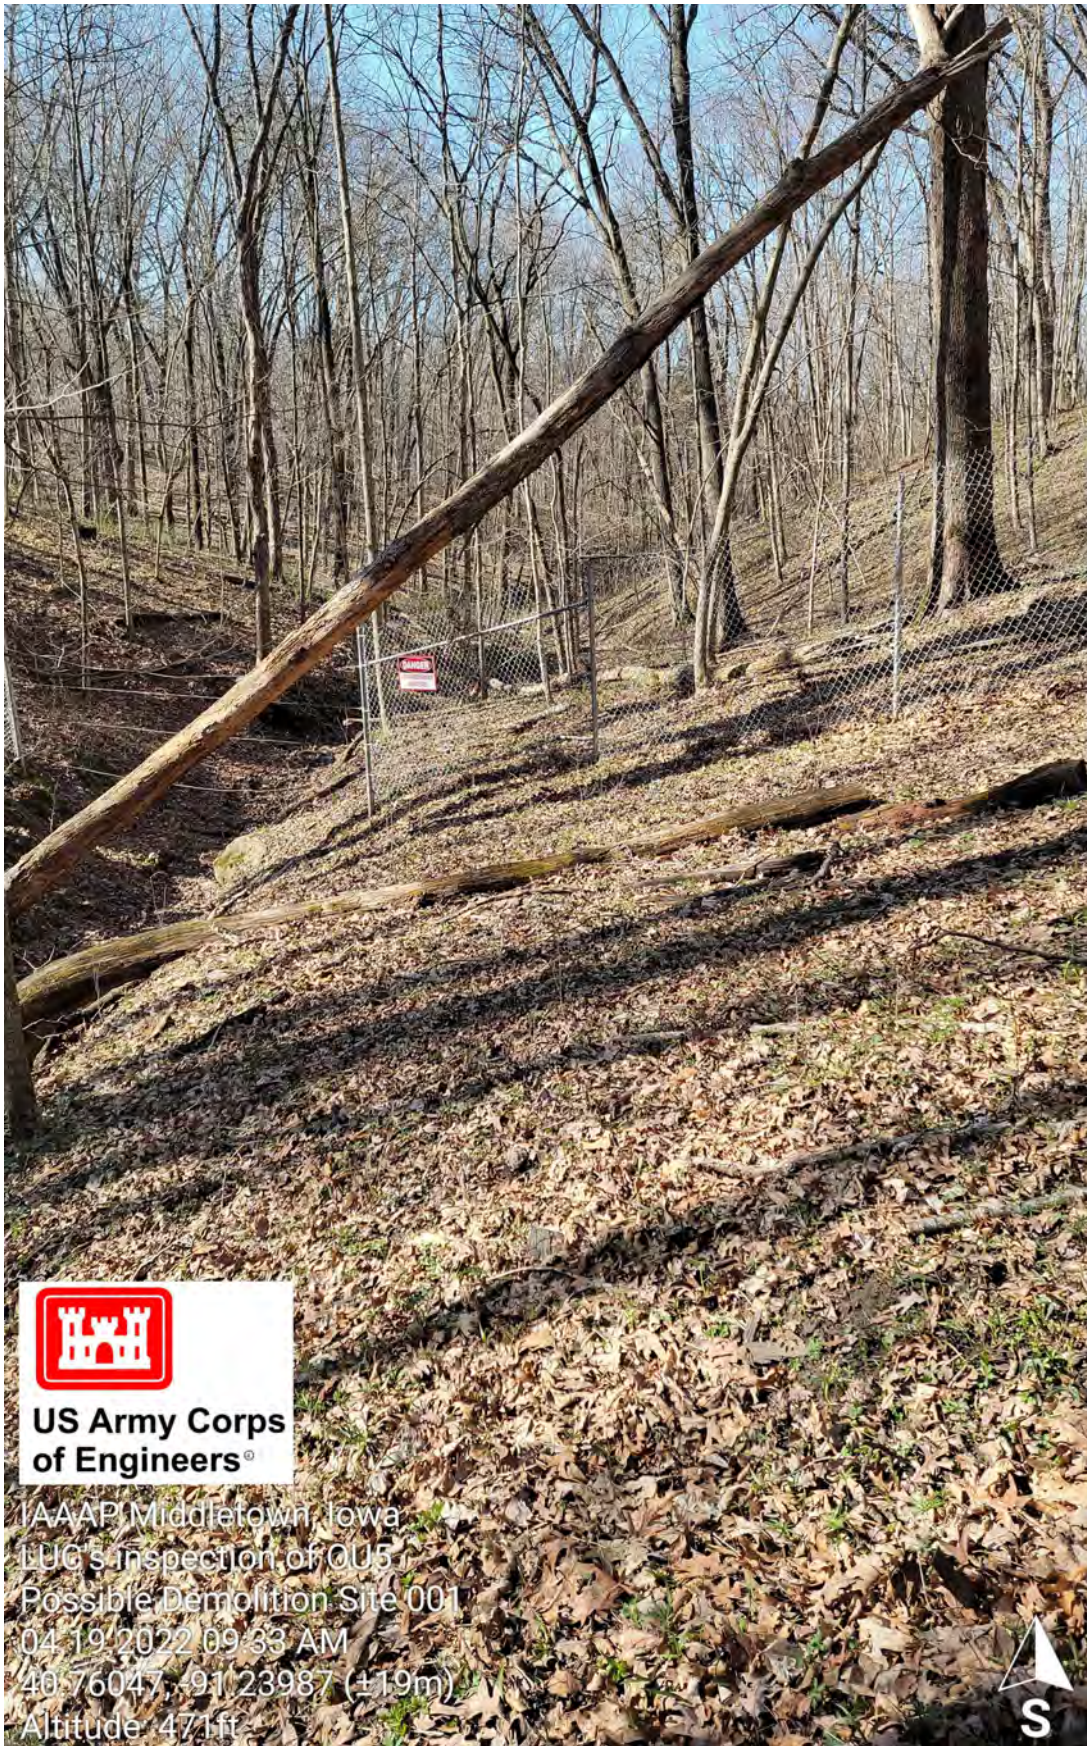
Photo 1 - PDS, Future/potential fence damage (fallen tree).

Location:	Description of deficiency and repair needed::	Photo ID:
40.76047, -91.23987	Future/potential fence damage (fallen tree). Remove tree.	1
40.75926, -91.23955	Tree has been cut away from fence after damage. Damage approximate 10 feet. Reattach/replace section of fence.	2

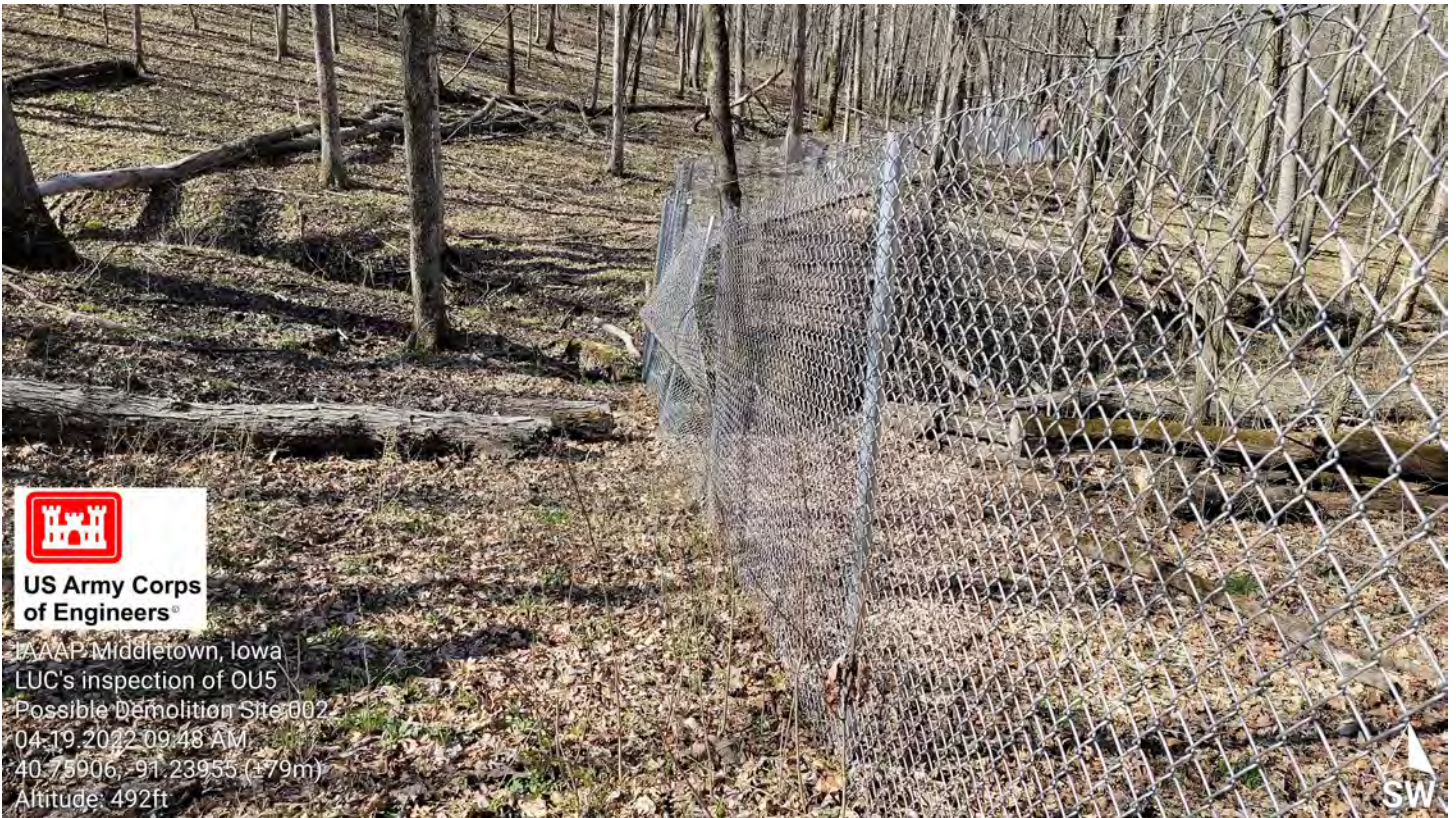
Photo 2 – PDS, Tree has been cut away from fence after damage. Approximately 10 feet damaged fence.

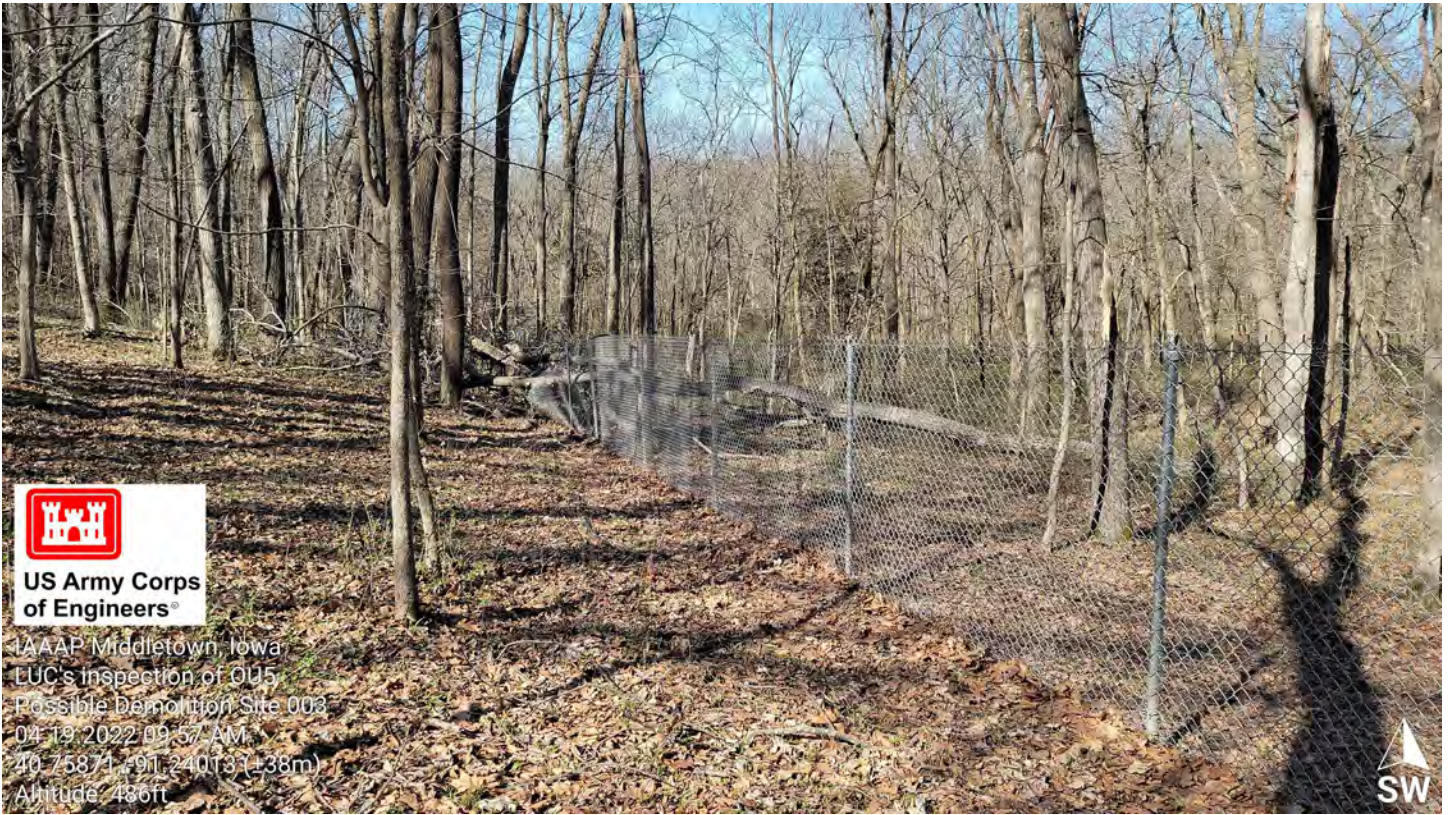
40.75871, -91.24013	Each section of fence is approximately 10 feet. Damage to fence is approximately 20 feet. Reattach/replace section of fence.	3
40.75832, -91.24077	Damage to fence is approximately 20 feet. In two locations ~ 30ft. apart. Reattach/replace section of fence.	4

Photo 3 – PDS, Approximately 20 feet damaged fence.

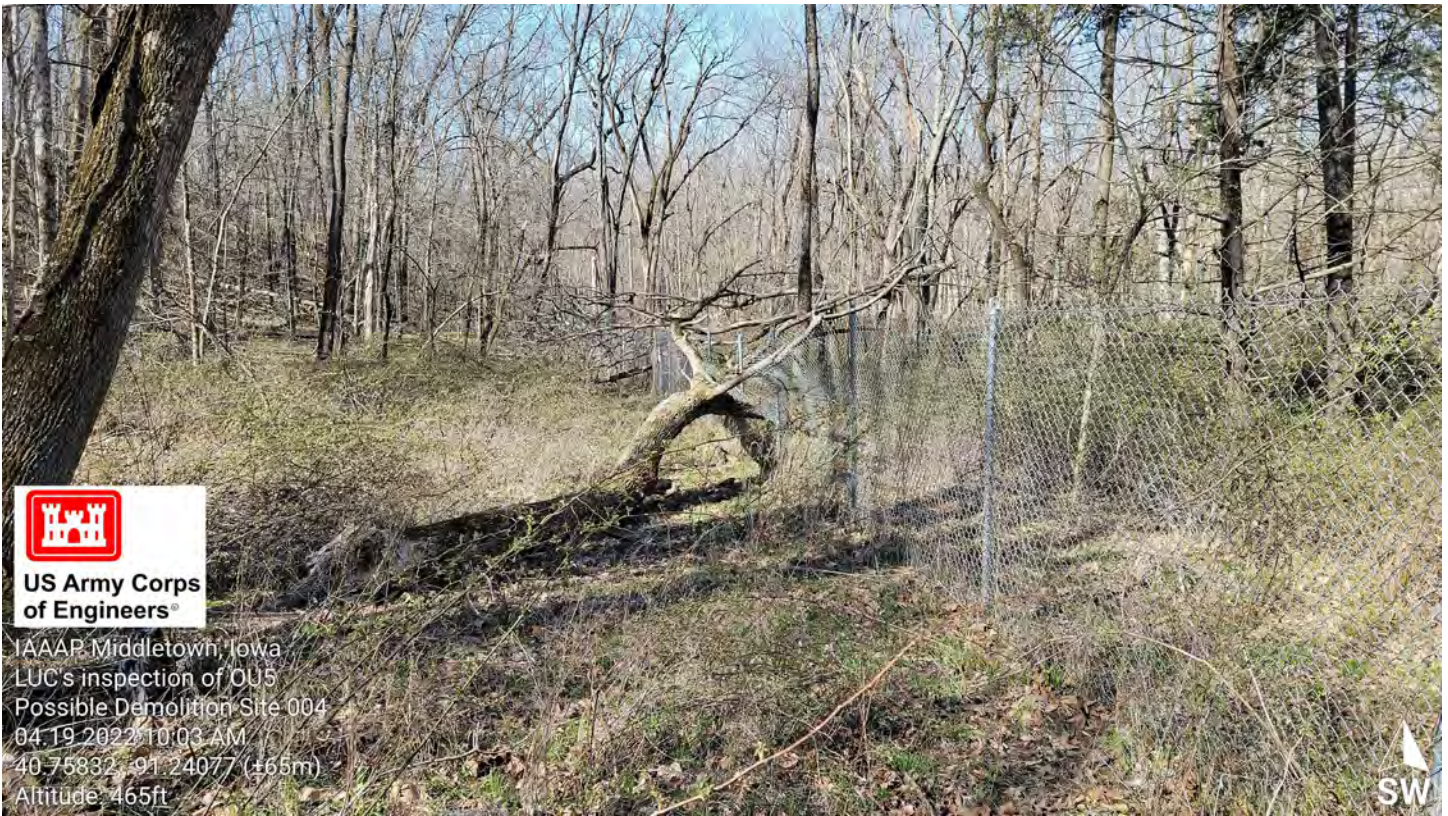
Photo 4 – PDS, Two 10 foot sections of damaged fence, approximately 30 feet apart. (Total of 20 feet fence damaged).

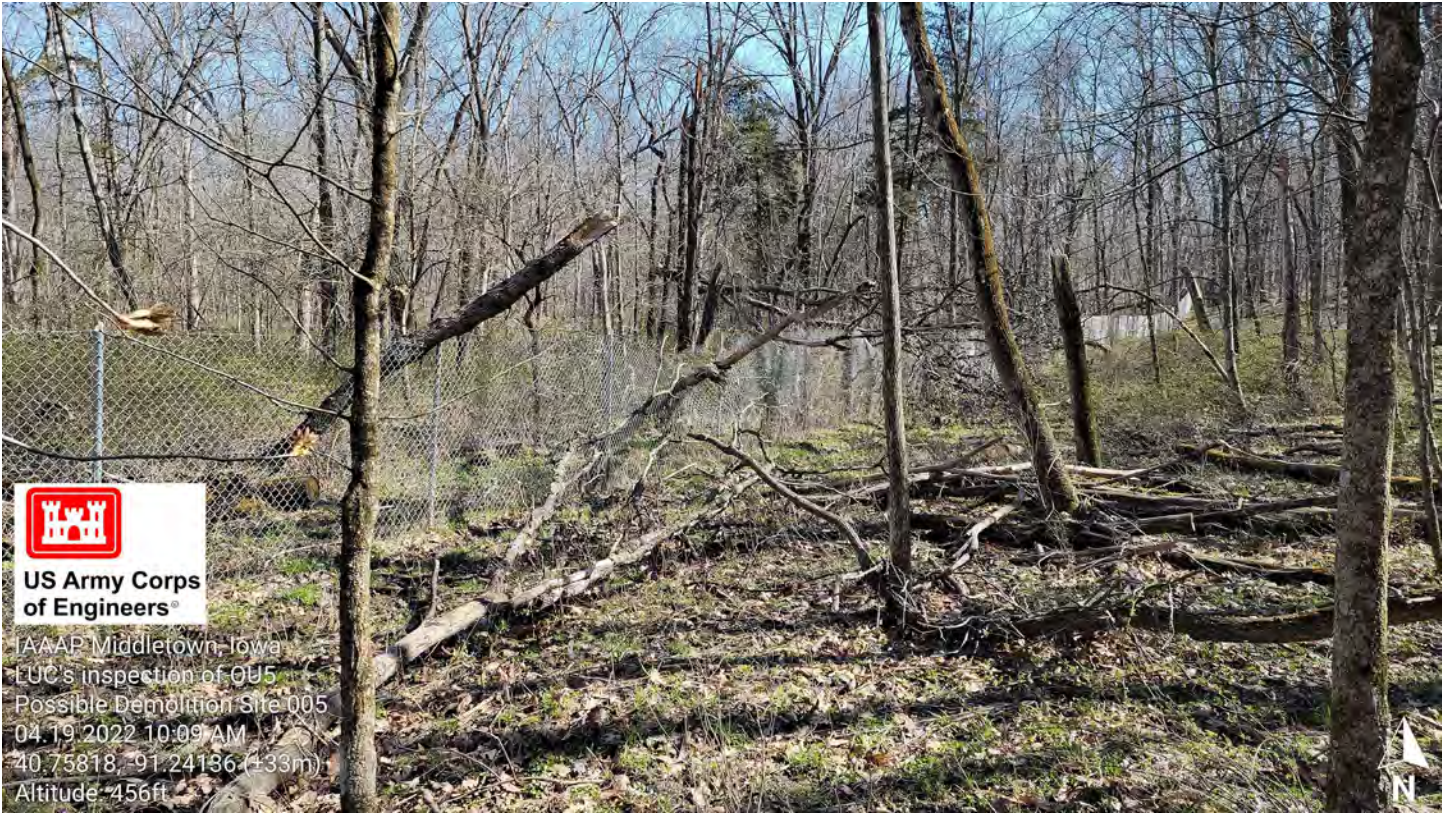
40.75818, -91.24136	Damage to fence is approximately 20 feet total. In two locations ~ 20ft. apart. Reattach/replace section of fence.	5
40.75812, -91.24133	Damage to fence is approximately 20 feet. Reattach/replace section of fence.	6

. Photo 5 – PDS, Two 10 foot sections of damaged fence (Total of 20 feet fence damaged).

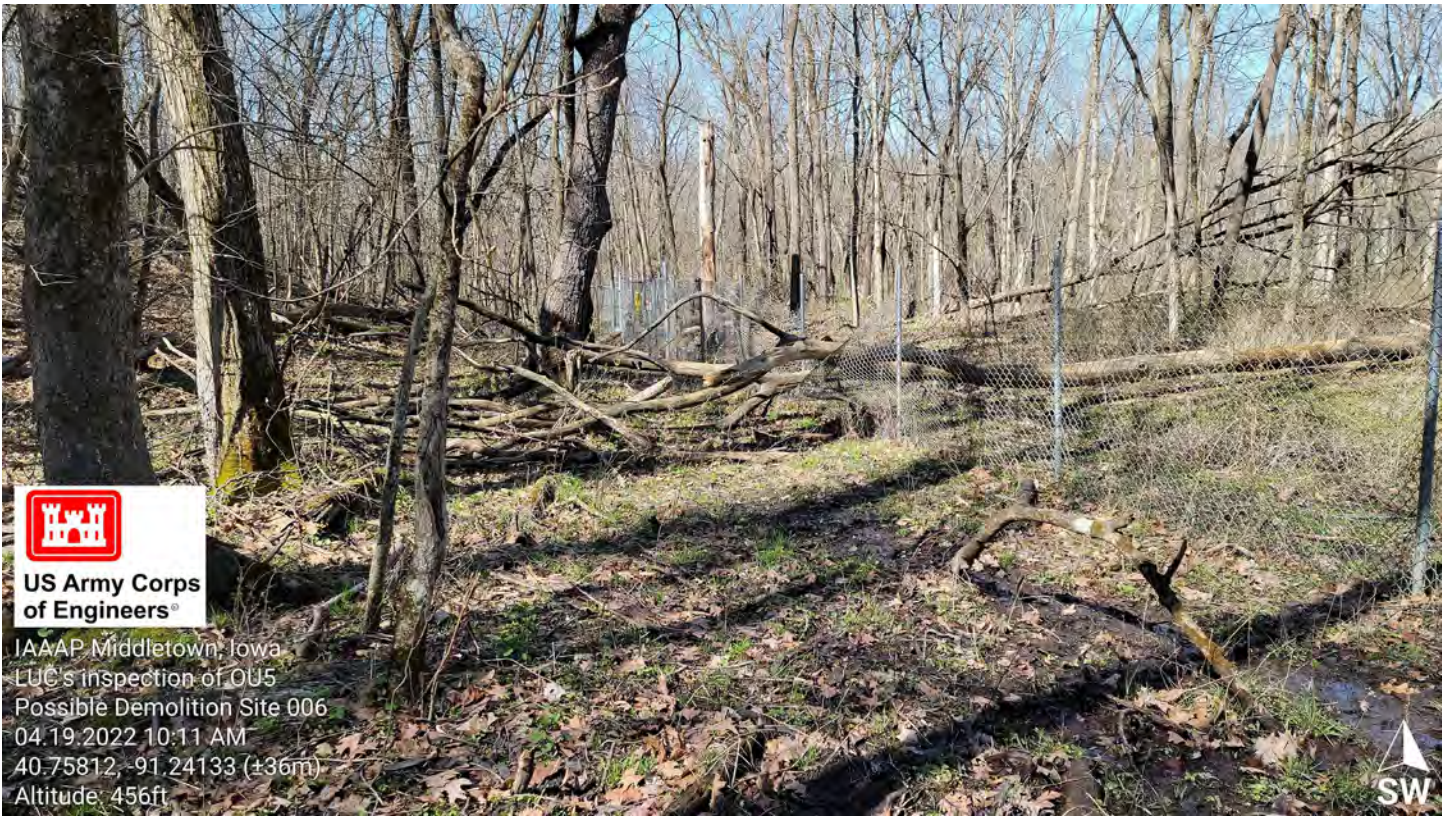
Photo 6 – PDS, Approximately 20 feet damaged fence.

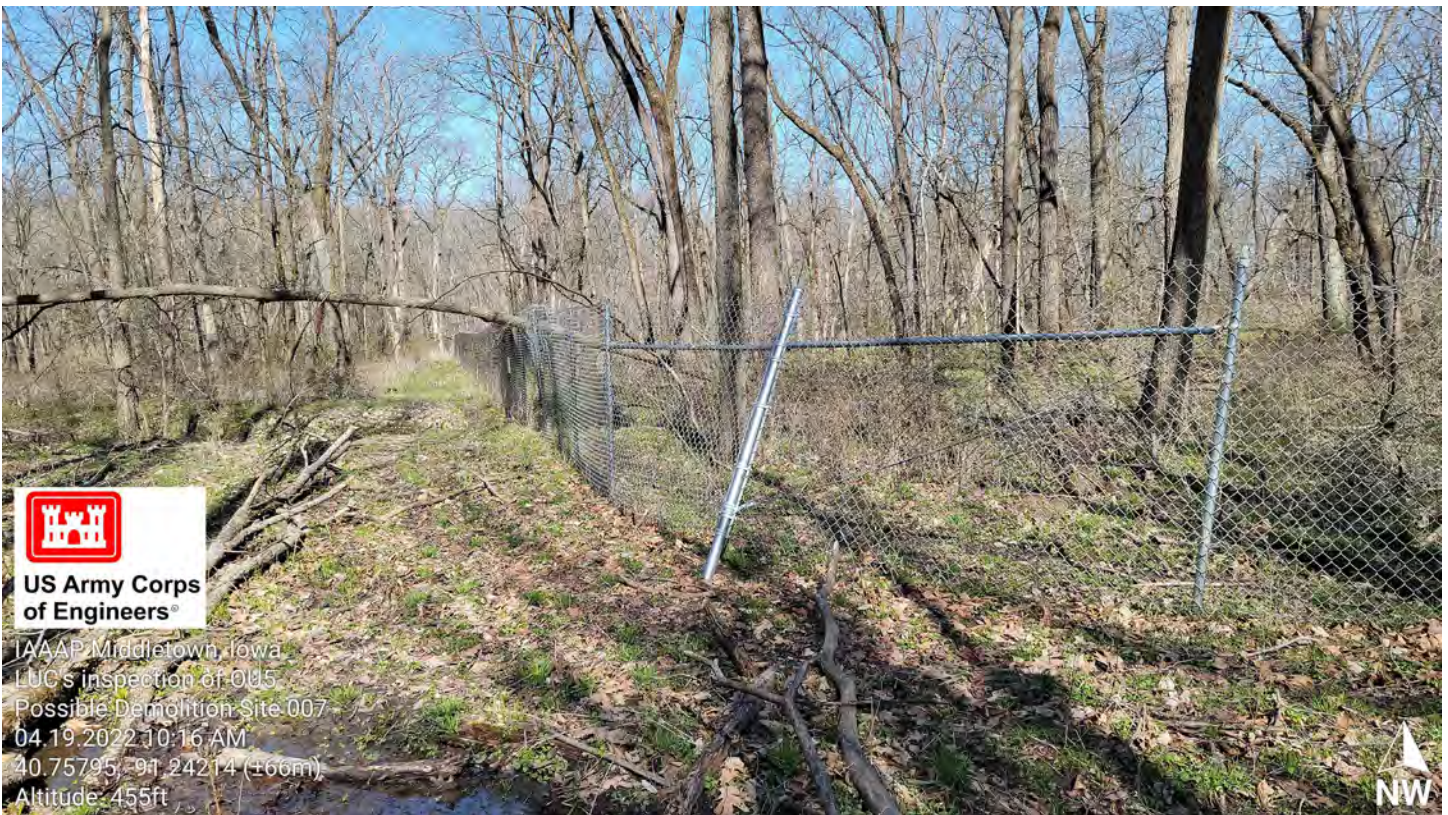
40.75795, -91.24214	Damage to fence is approximately 10 feet. Post is leaning but is still stable. The soil is very wet. Reattach/replace section of fence.	7

Photo 7– PDS, Approximately 10 feet damaged fence. Post is leaning but stable.

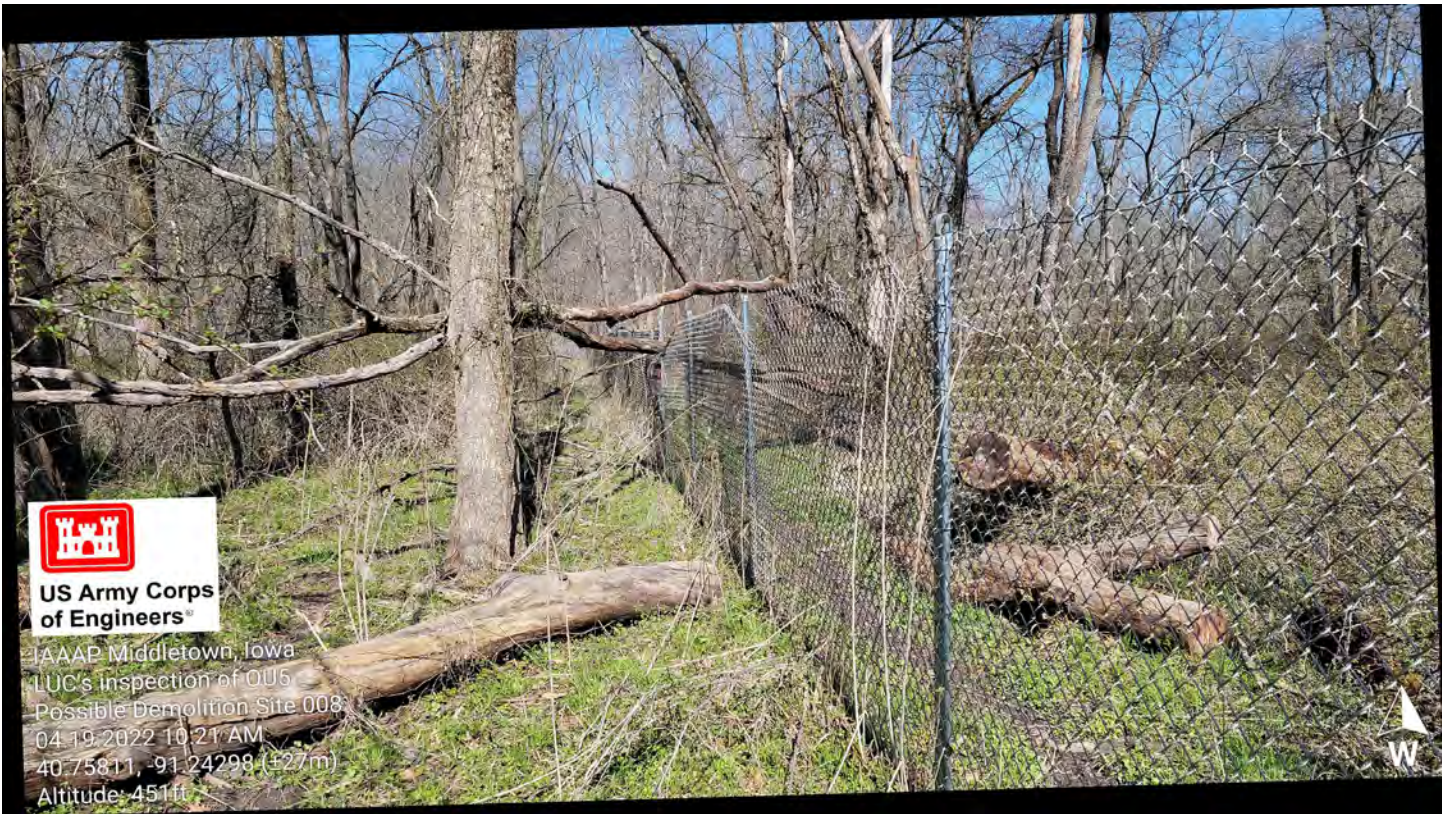
40.75811, -91.24298	Damage to fence is approximately 10 feet. Reattach/replace section of fence	8
40.75883, -91.24545	Damage to fence is approximately 10 feet. Reattach/replace section of fence.	9

Photo 8– PDS, Approximately 10 feet damaged fence

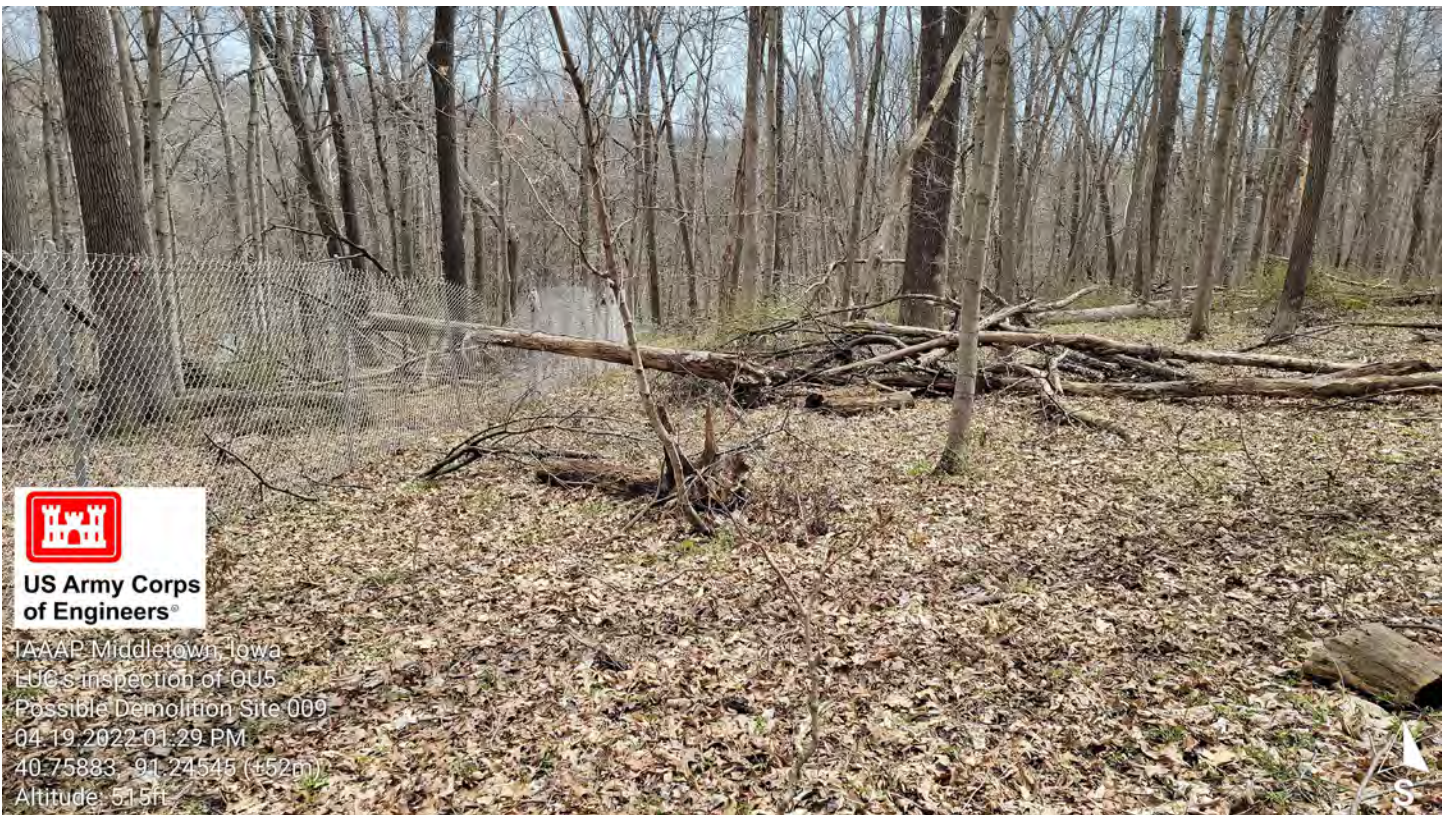
Photo 9– PDS, Approximately 10 feet damaged fence

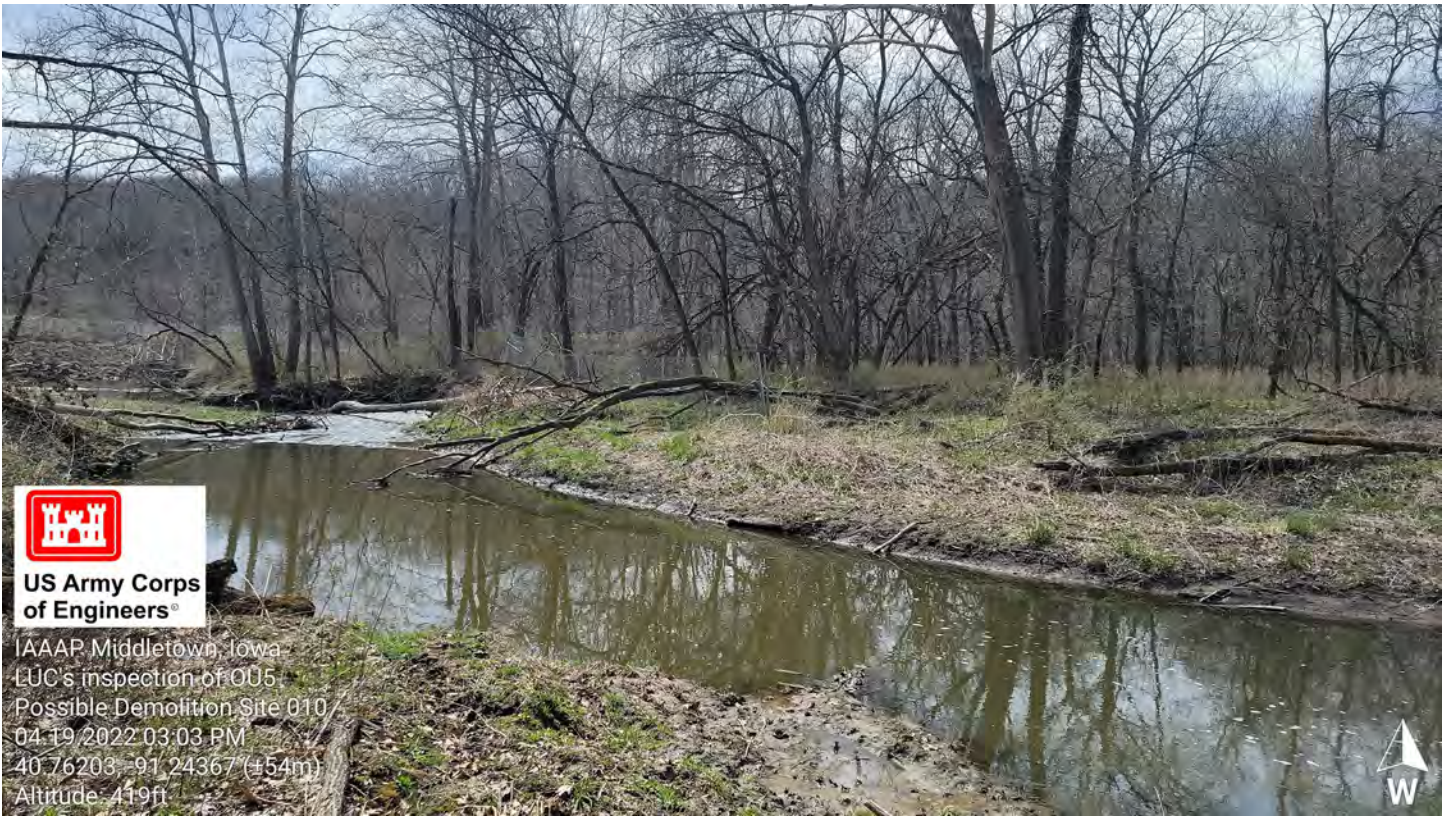
40.76203, -24367	Damage to fence is approximately 10 feet. Reattach/replace section of fence	10

Photo 10– PDS, Approximately 10 feet damaged fence

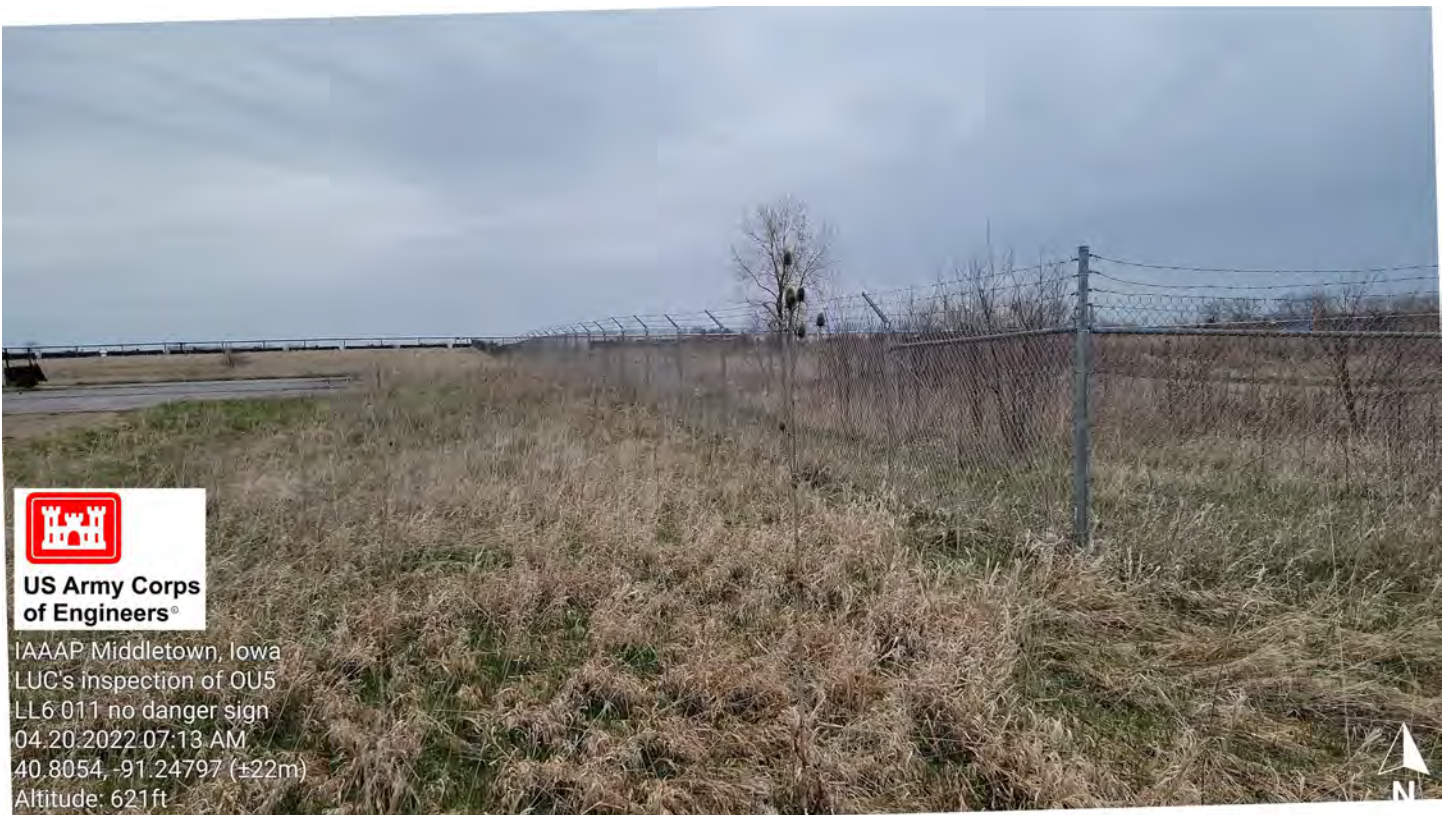
Location:	Description of deficiency and repair needed::	Photo ID:
40.8054, -91.24797	No UXO Danger Sign visible for a 200ft. span. Replace signage.	11

Photo 11 – LL6, Missing UXO Danger Sign

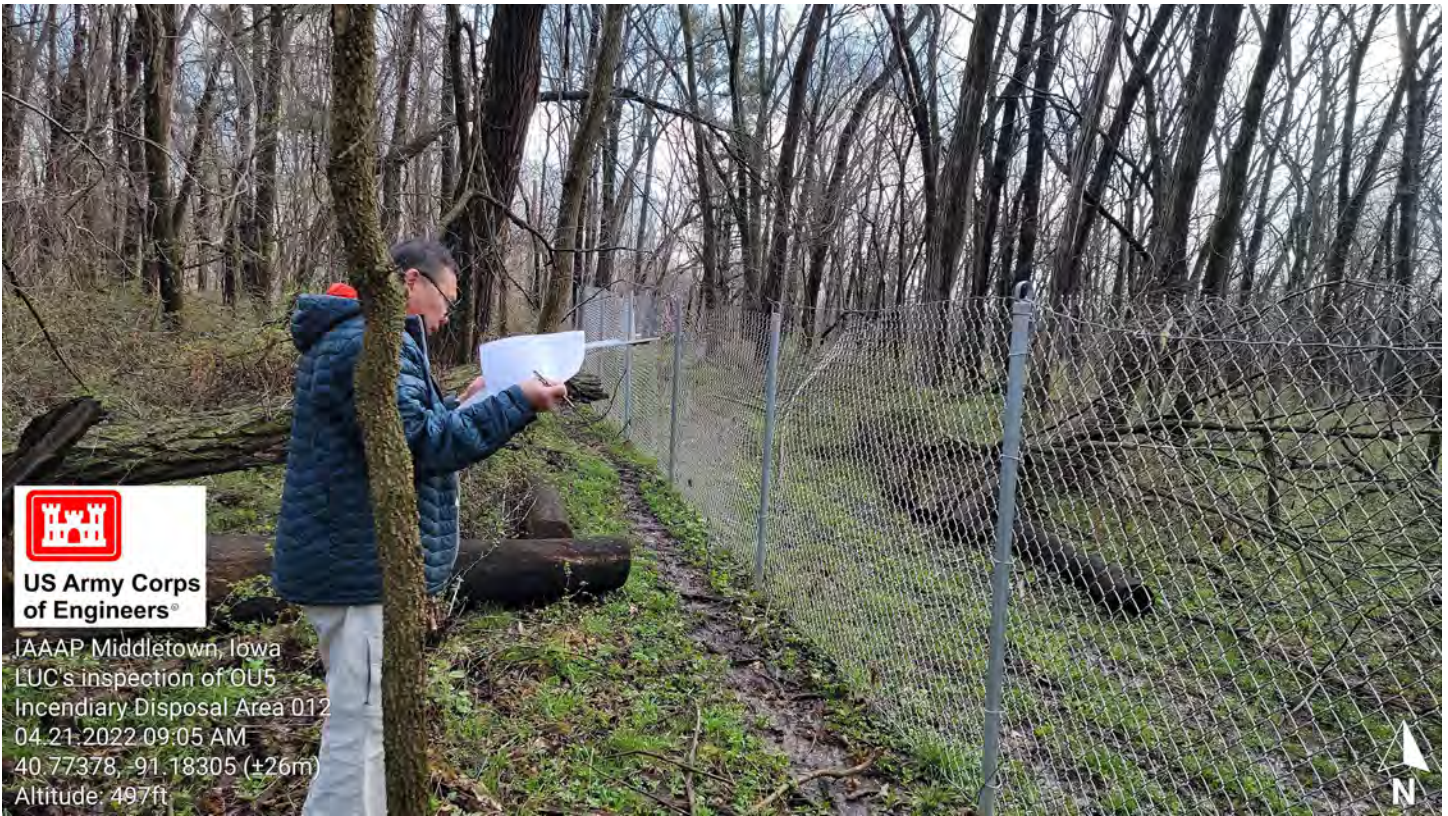
Location:	Description of deficiency and repair needed::	Photo ID:
40.77378, -91.18305	Damage to fence is approximately 10 feet in two locations. Reattach/replace section of fence	12
40.77378, -91.18303	Minimal damage to fence here ~2 ft. Reattach/replace section of fence.	13
40.77416, -91.18282	Damage to fence is approximately 10 feet. Reattach/replace section of fence.	14
40.77495, -91.18229	Damage to fence is approximately 10 feet. Reattach/replace section of fence.	15
40.77599, -91.18168	Damage to fence is approximately 20 feet. Reattach/replace section of fence	16

Photo 12 – InDA, Two 10 foot sections of damaged fence (Total of 20 feet fence damaged).

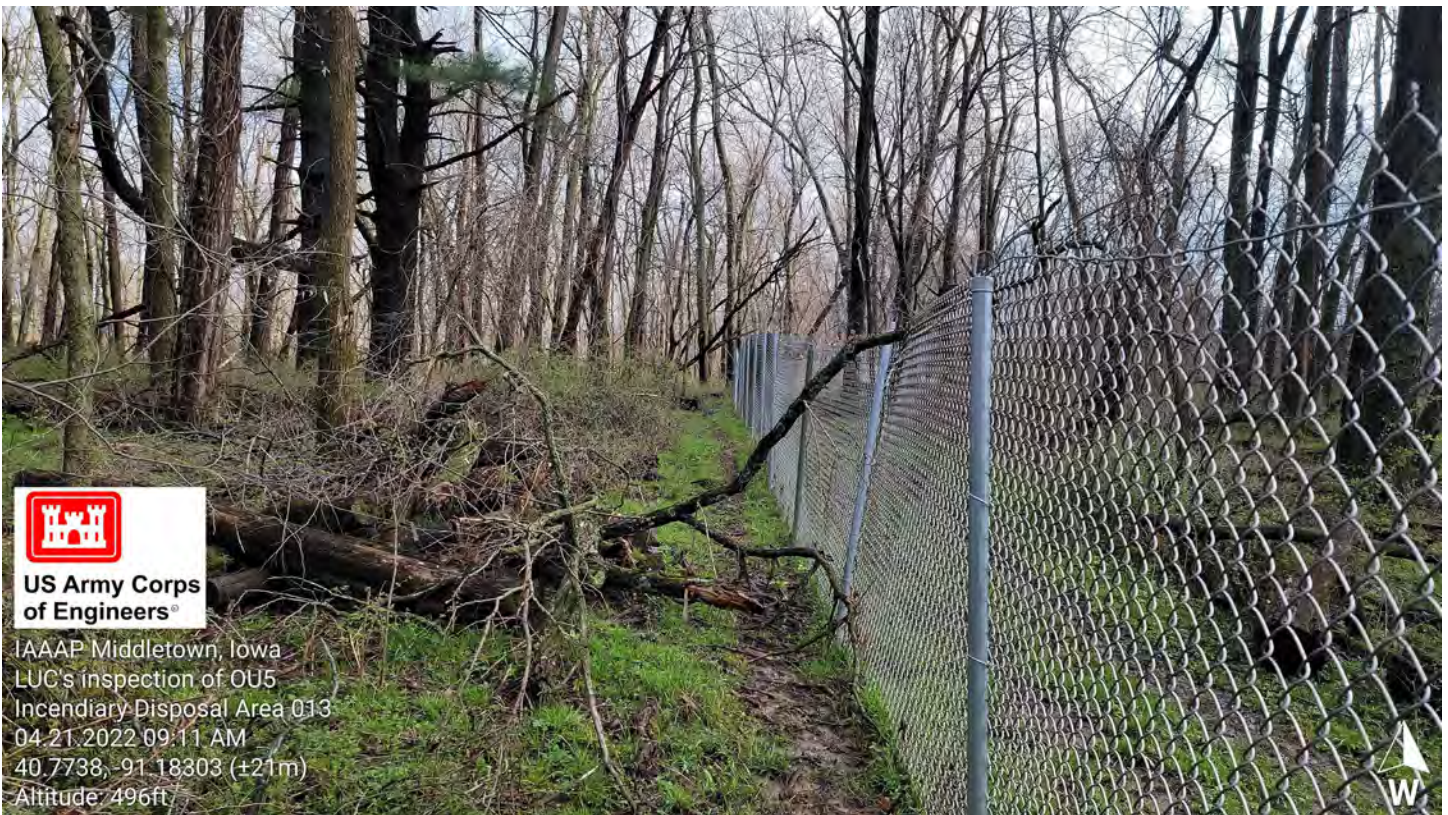
Photo 13 – InDA, Two foot section of damaged fence.

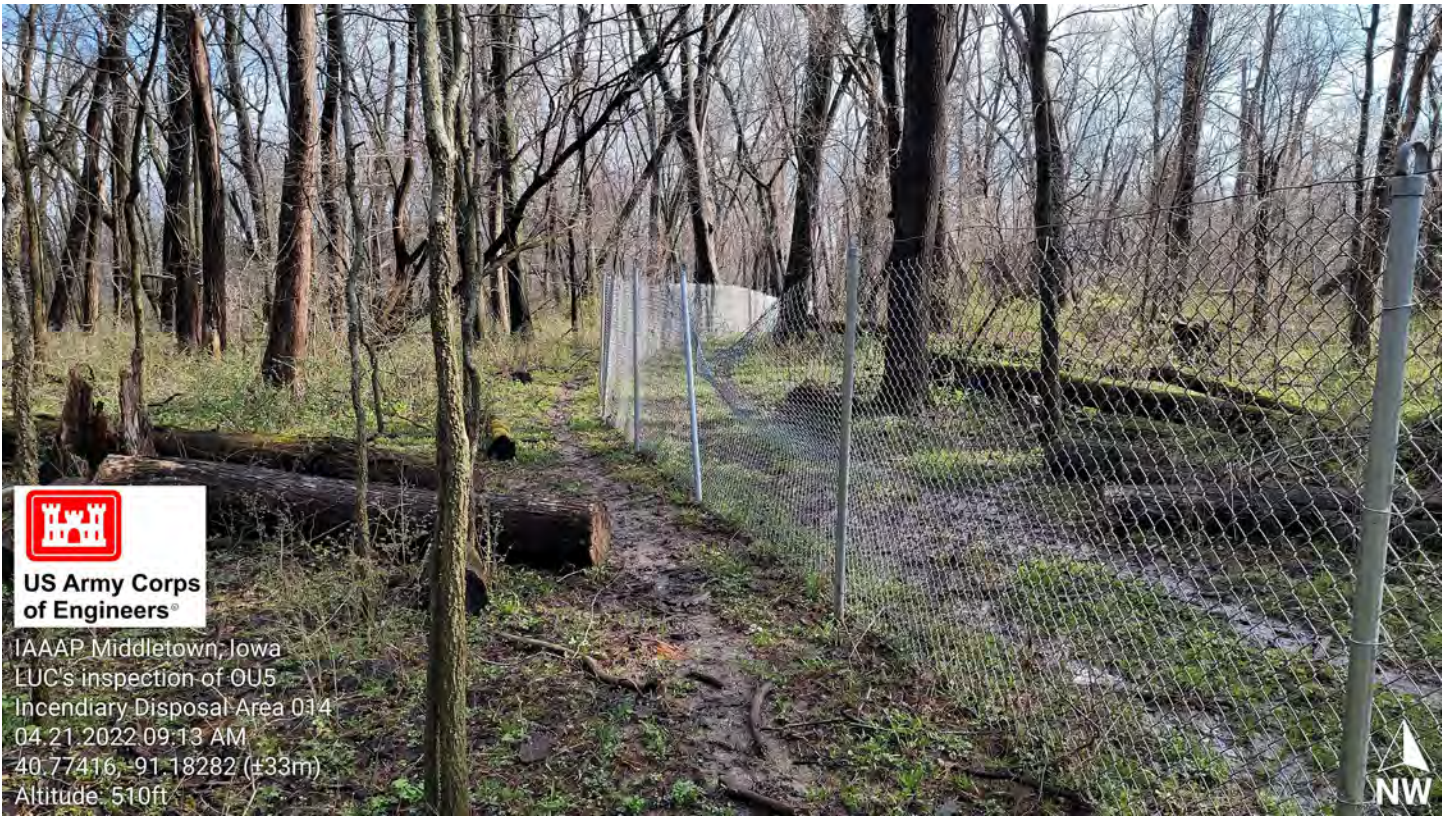
Photo 14 – InDA, 10 foot section of damaged fence.

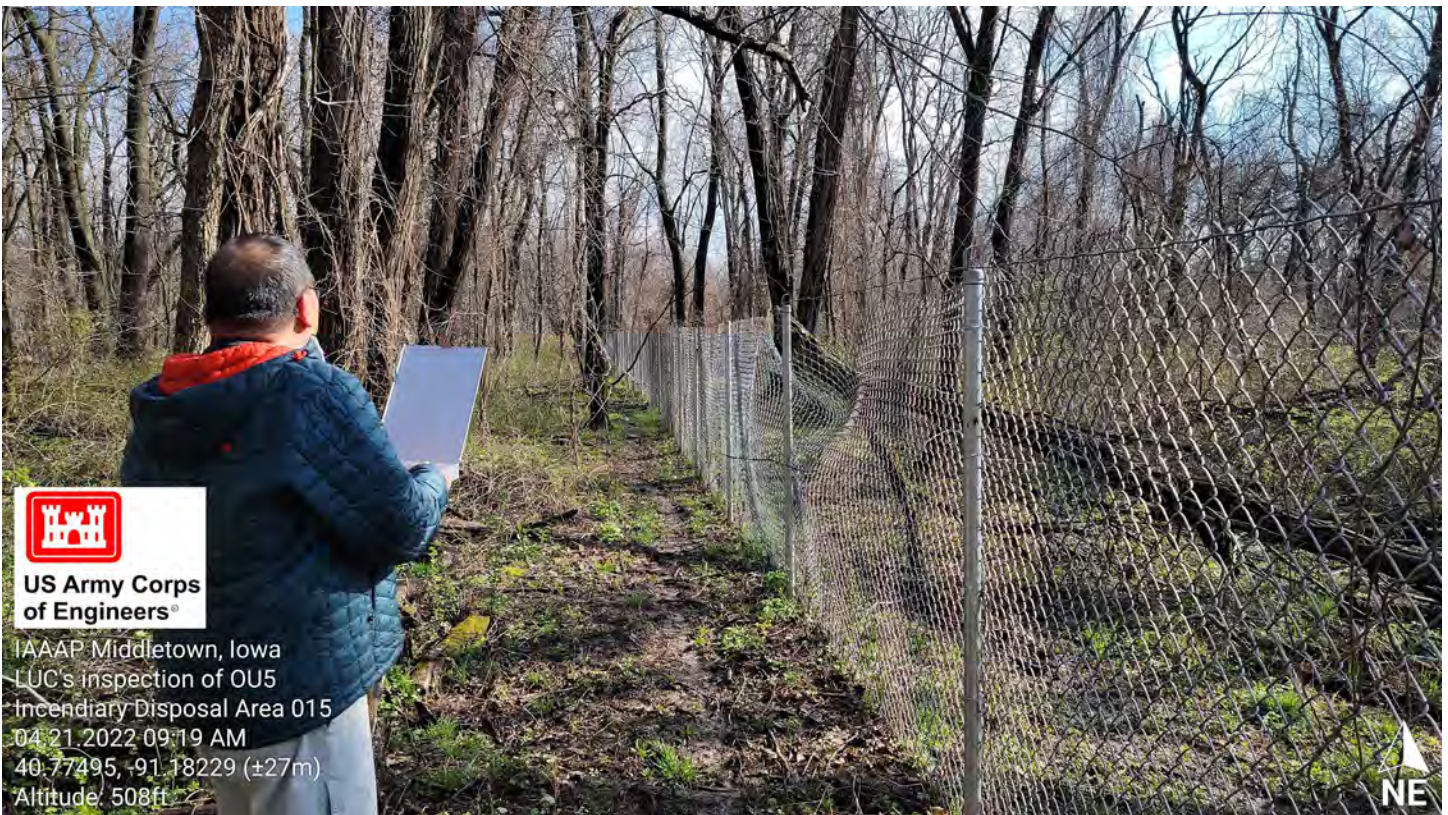
Photo 15 – InDA, 10 foot section of damaged fence.

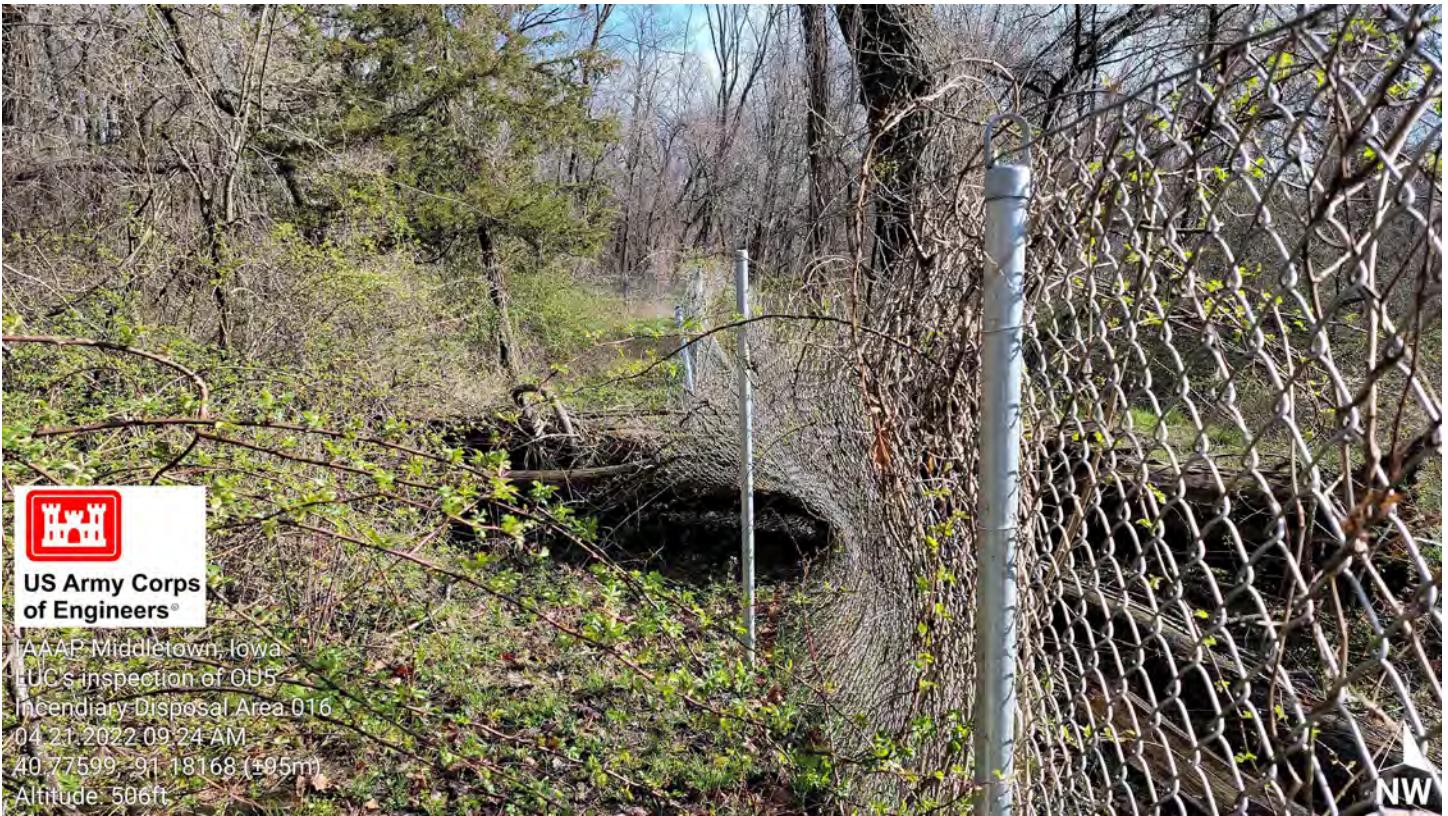
Photo 16 – InDA, 20 foot section of damaged fence.
