**Per the Federal Facility Agreement for Iowa Army Ammunition Plant, Article X.B.1, the attached document is the final version of the submitted document.**

US Army Corps  
of Engineers  
Omaha District

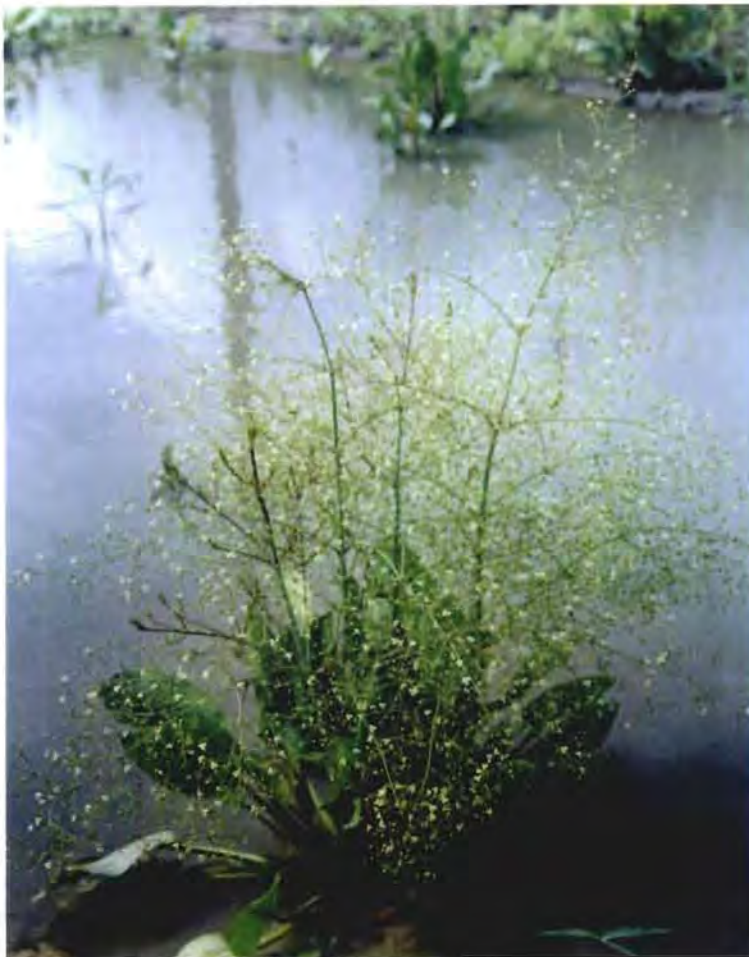
**Line 800 Lagoon**  
**Line 1 Impoundment**  
**Wetlands Borrow**  
**Stump Lake**  
**Inert Landfill**  
**CAMU**  
**Trench 6**  
**Explosive Sumps**  
**Burning Grounds**  
**Blue Sludge**  
**CAMU Sediment Dam**  
**Trench 6 Sediment Dam**

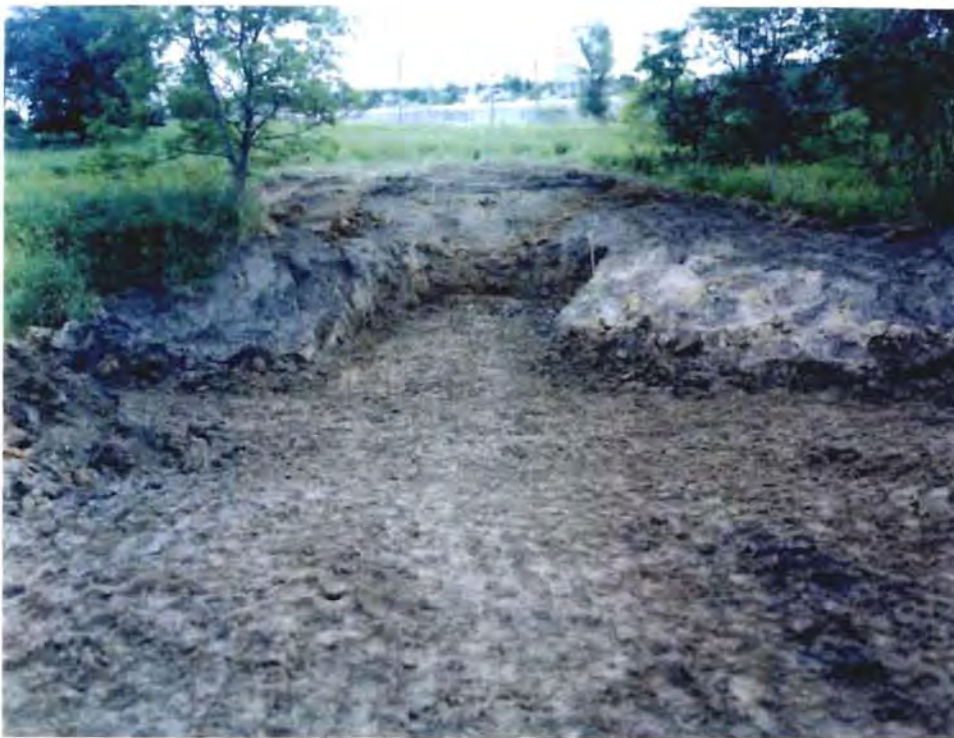
Photo No. 11: (15-16 July 1996) Looking northeast at the cutoff trench and outlet works foundation for the upstream wetlands hydraulic control structure.

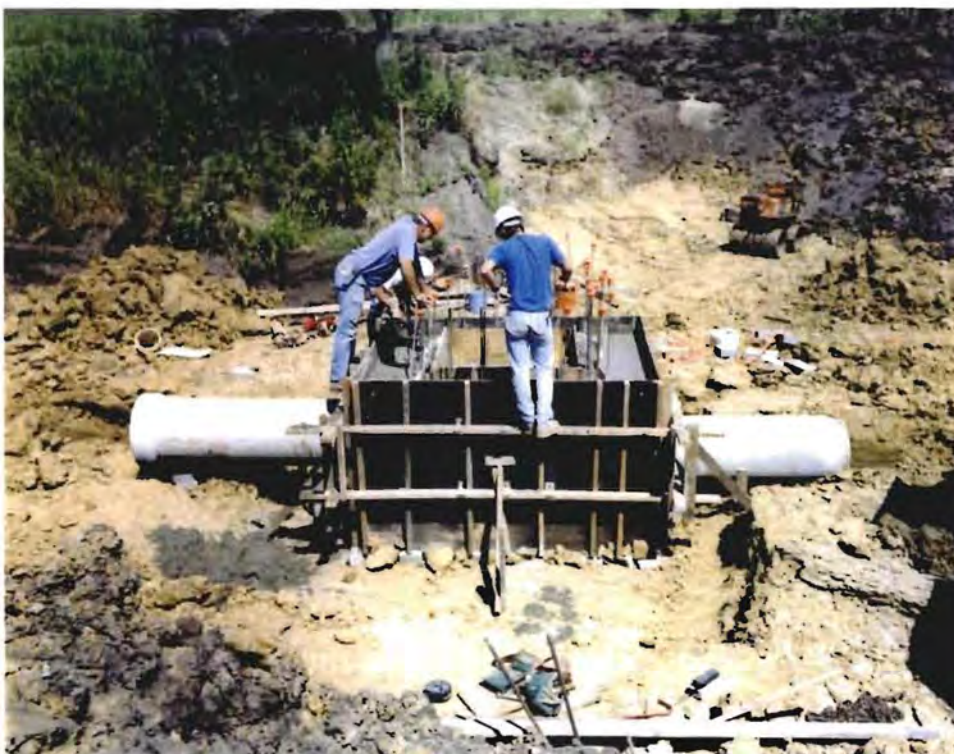
Photo No. 12: (6 August 1997) Looking northeast at the gatewell and outlet works for the upstream wetlands hydraulic control structure.

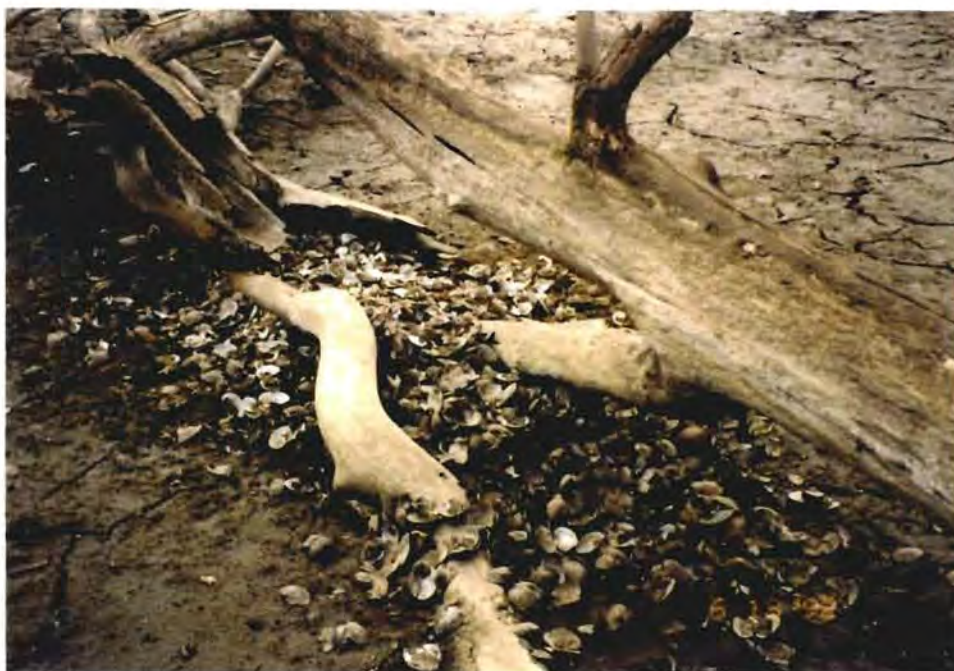
Photo No. 6: (March 1996) A close-up view of decaying organic matter found on the lake bottom.

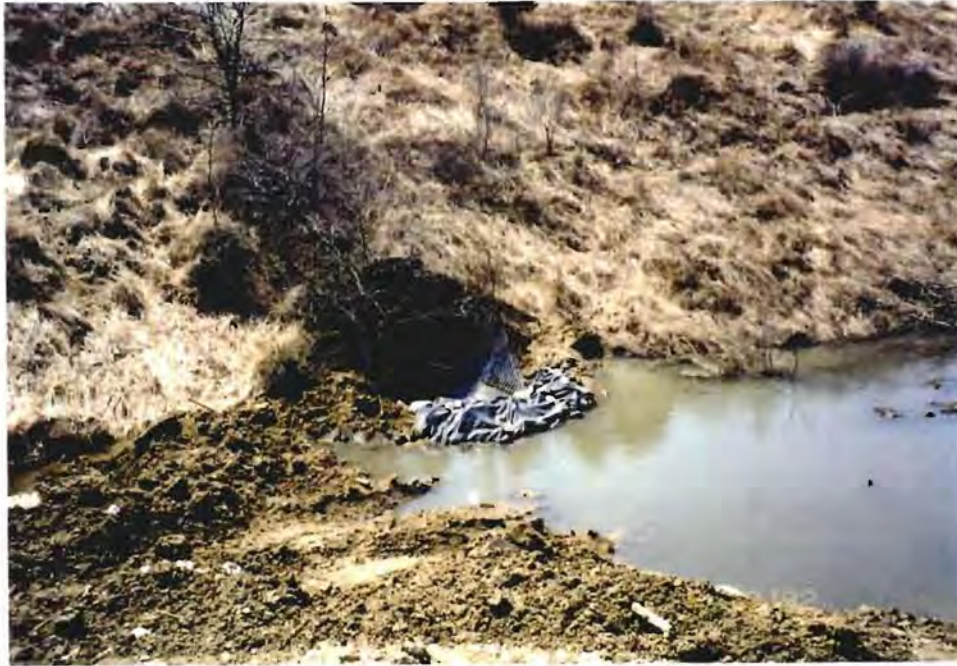
Photo No. 7: (March 1996) A granular sediment filter was constructed downstream of Stump Lake Dam, and immediately upstream of the railroad embankment conduit. This filter, constructed of graded granular material with a geotextile filter facing, prevented sediment from the lake from deteriorating water quality downstream.

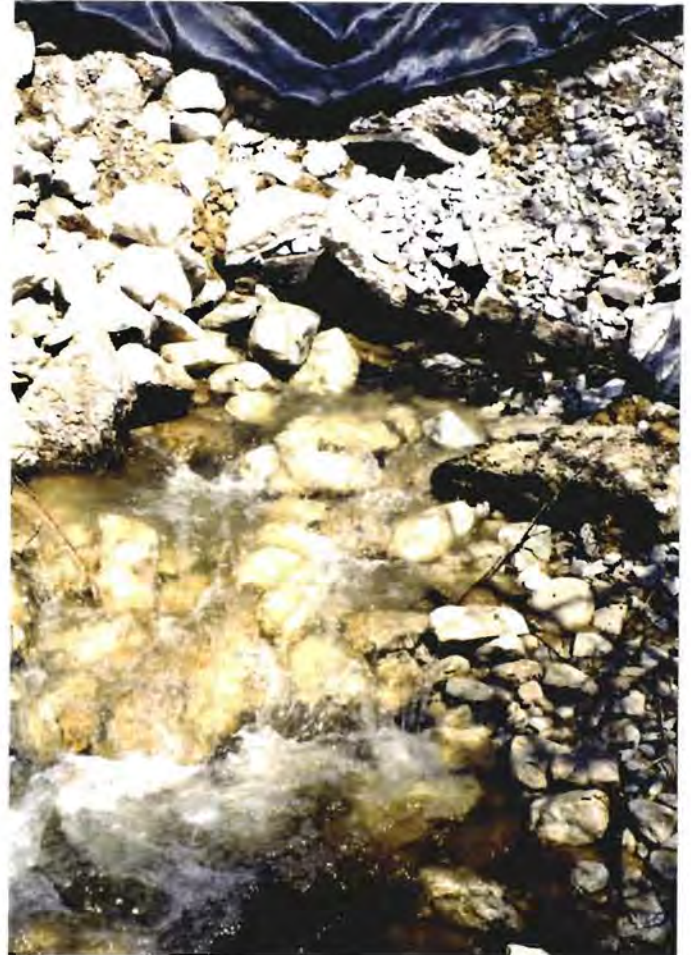
Photo No. 8: (March 1996) Close-up of the relatively clear water exiting the granular sediment filter shown in Photo No. 7.

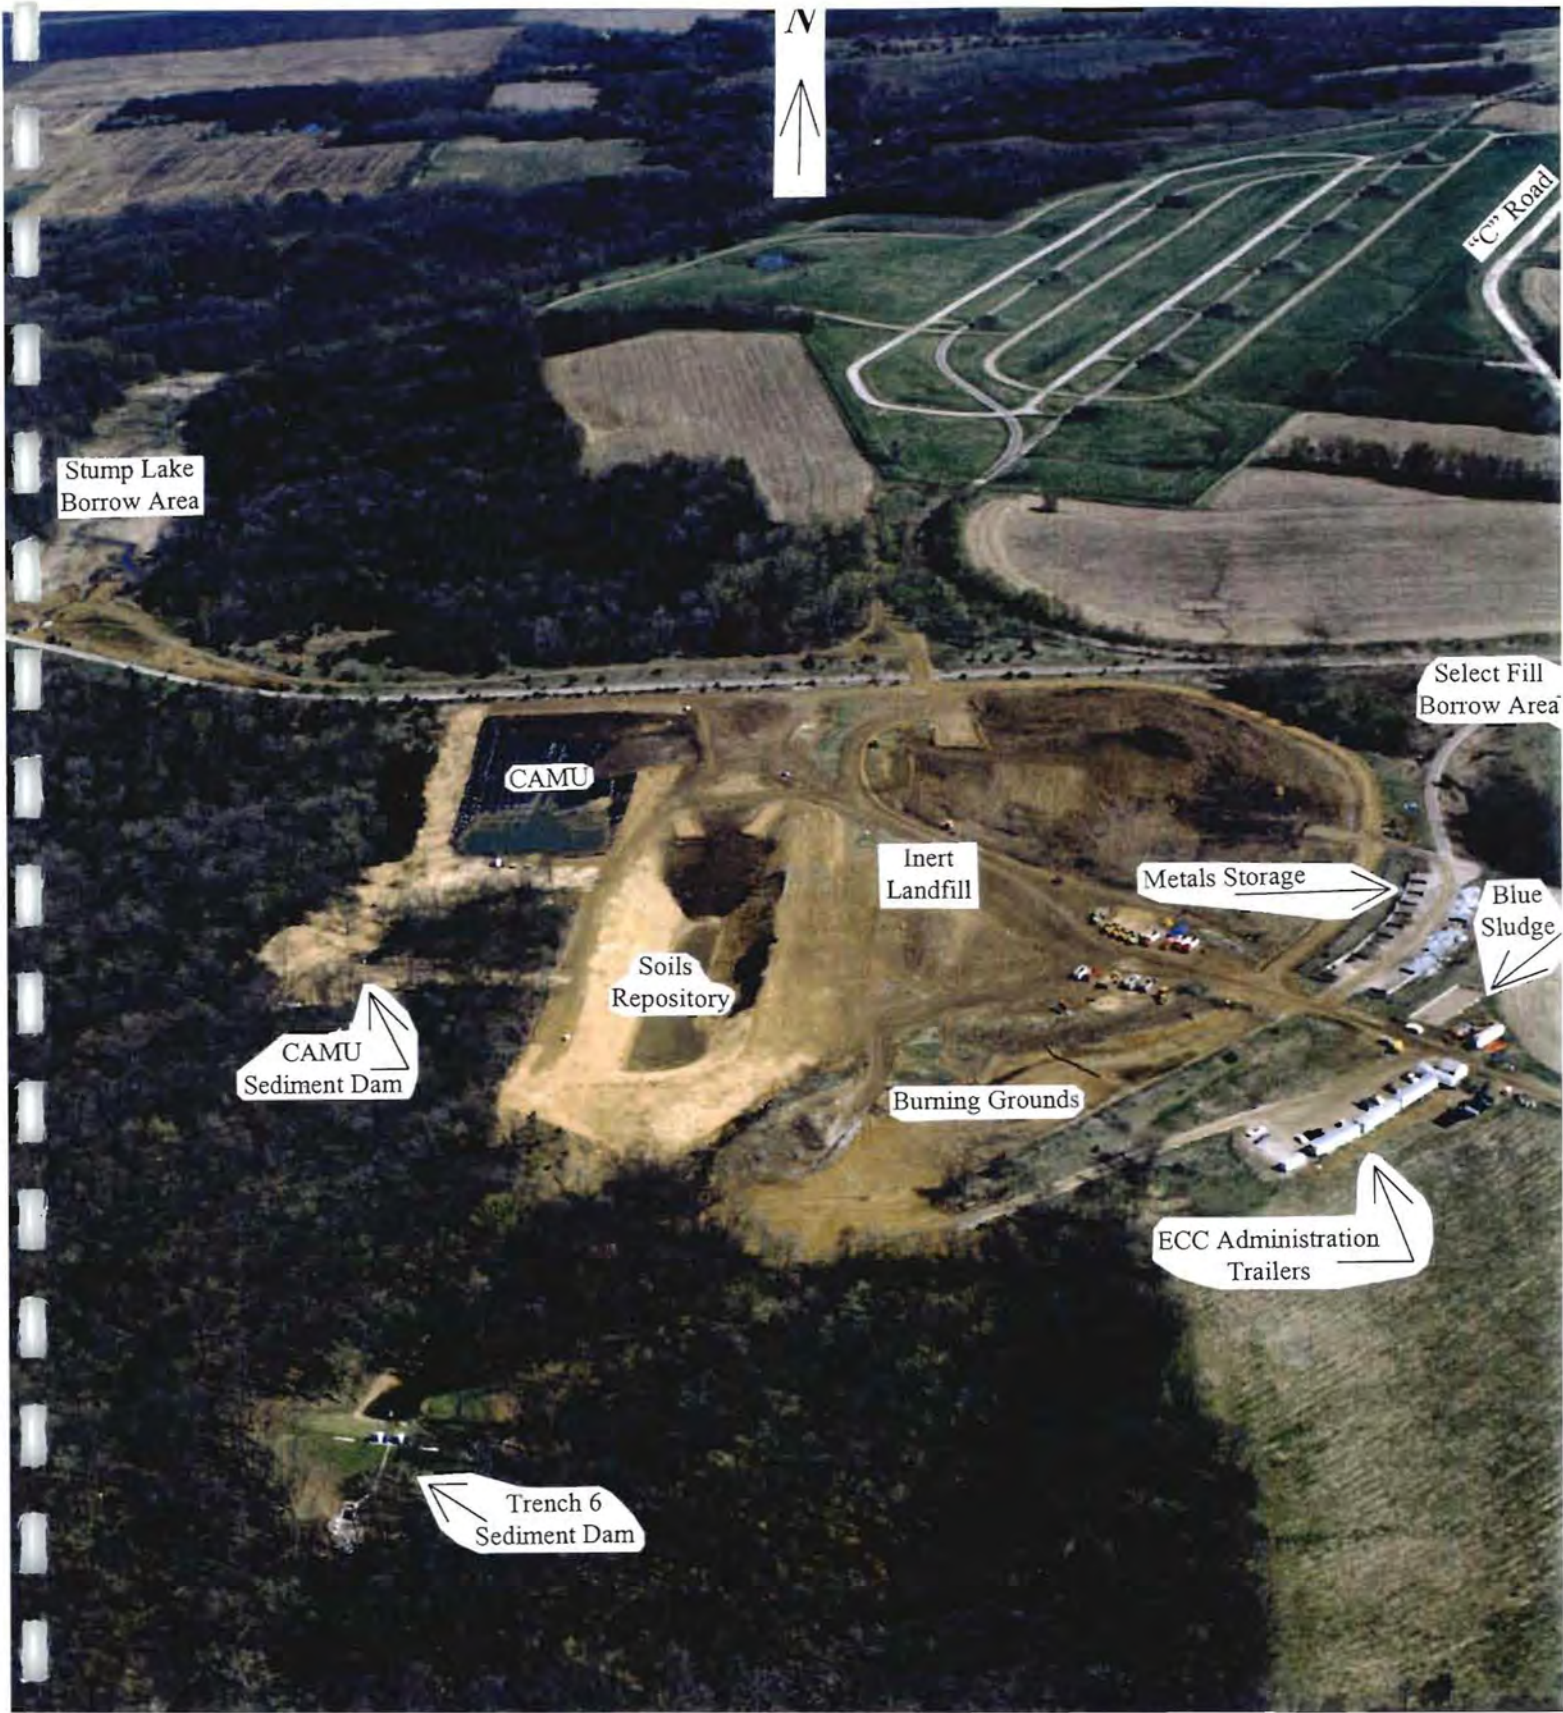
Photo No. 1: (30 April 1997) Aerial view of the Inert Disposal Area (IDA) looking north. The following features of the IDA can be viewed on this photograph: Inert Landfill, CAMU, Trench 6 Soils Repository, Sediment Dams, Stump Lake and Select Fill Borrow Sources, Burning Grounds, Metals Storage Area, Blue Sludge Drying Bin and ECC's administration trailers.

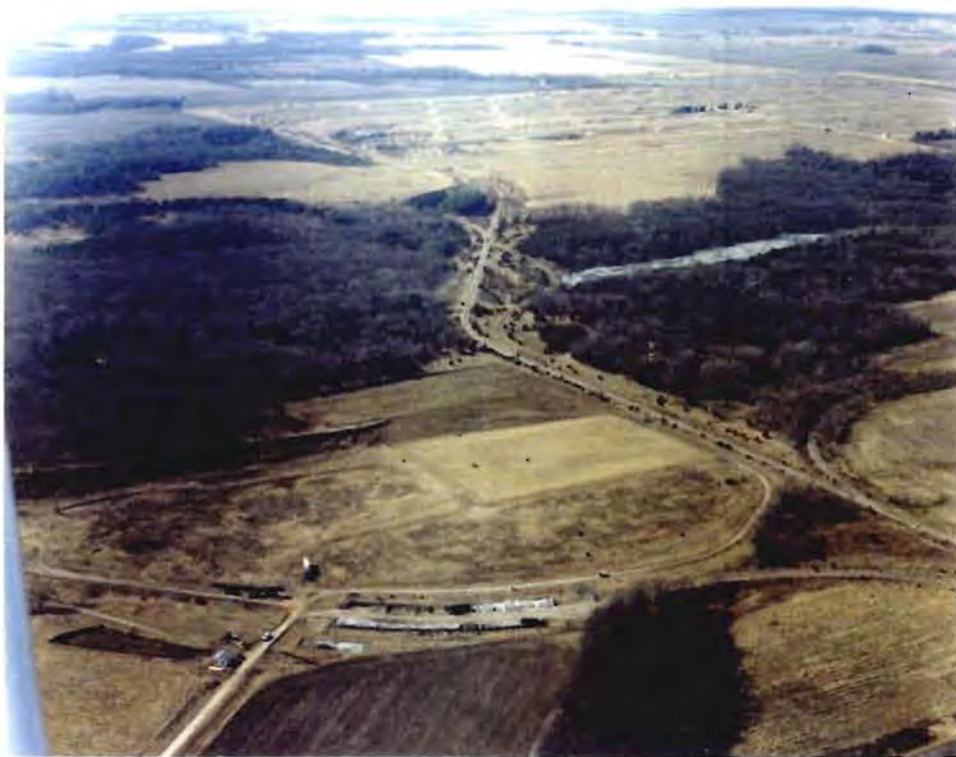
Photo No. 2: (12-16 March 1996) Preconstruction aerial view of Inert Landfill Area (IDA) looking northwest. Stump Lake (before breaching) can also be viewed in this photograph.

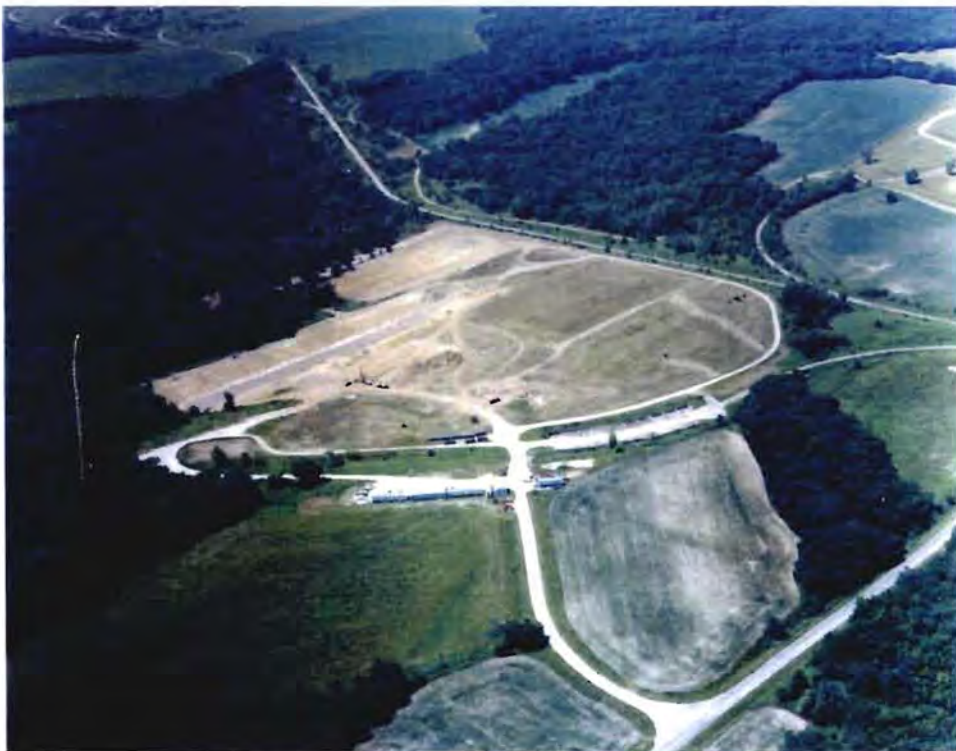
Photo No. 3: (15-16 July 1996) Aerial view of Inert Landfill Area (IDA) looking northwest. Stump Lake (after breaching) can also be viewed in this photograph. On this date, the CAMU foundation is prepared. The Trench 6 Soil Repository has been graded and the seep collection layer has also been placed.

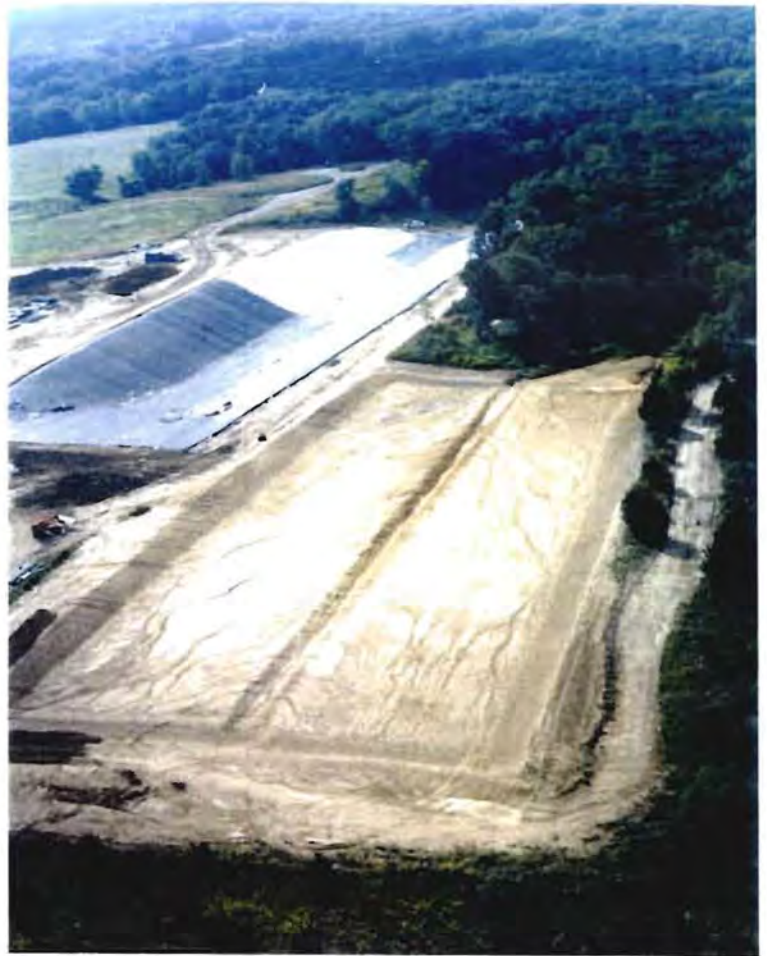
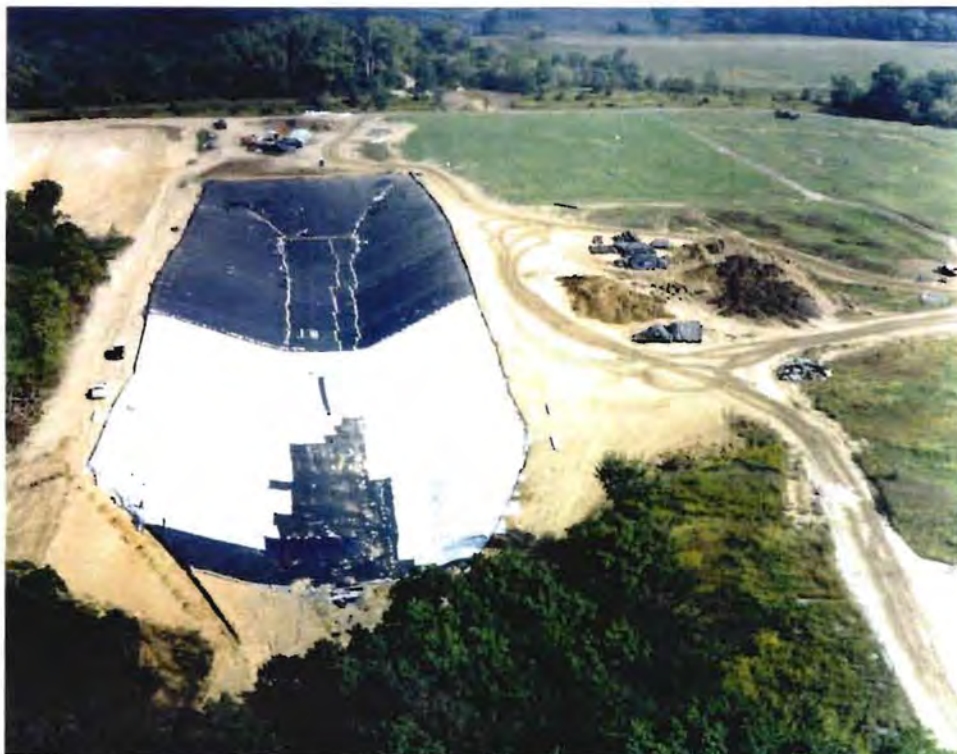
Photo No. 5: (17-18 Sept 1996) Looking north at the Trench 6 Soils Repository  
under construction at the IDA. The Inert Landfill is in the right of the photograph.

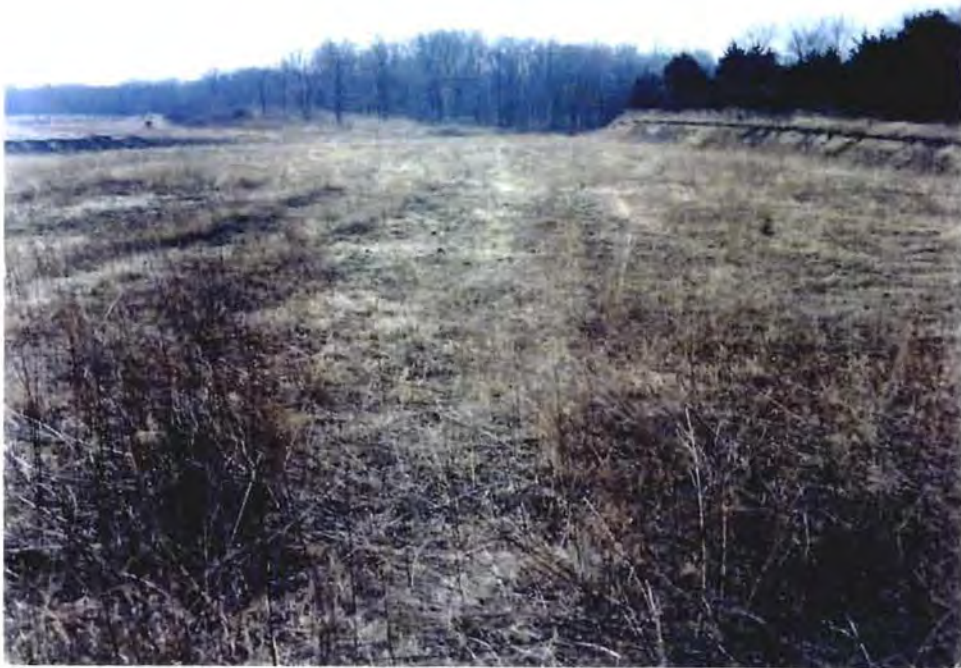
Photo No. 1: (March 1996) Preconstruction conditions at the CAMU site, looking south.

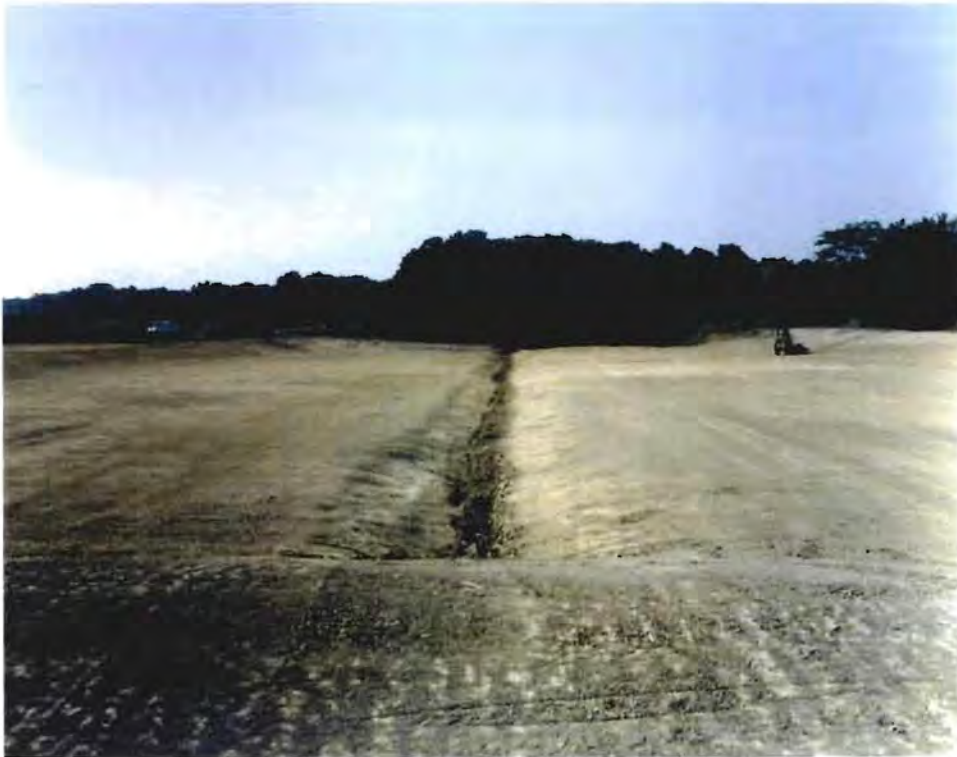
Photo No. 2: (15 August 1996) Initial grading of the CAMU, looking south.

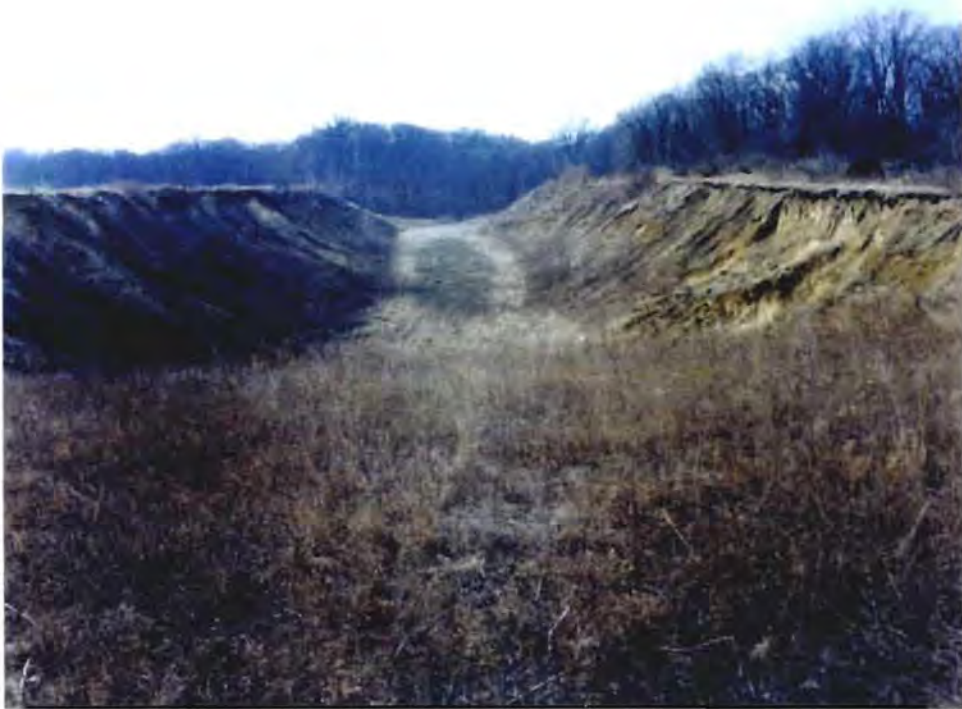
Photo No. 1: (12-16 March 1996) Preconstruction conditions along Trench 6, looking south.

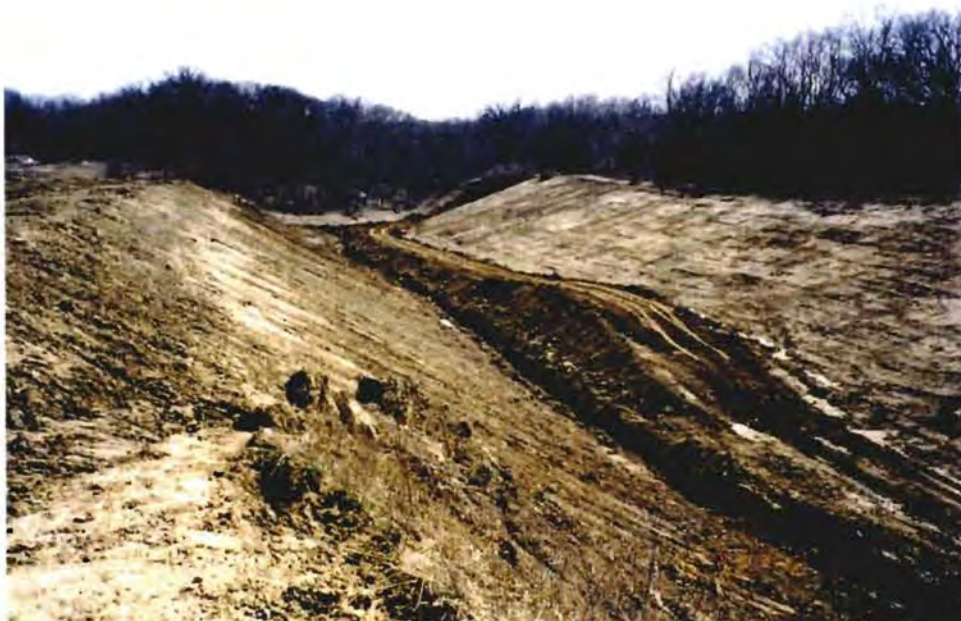
Photo No. 2: (March 1996) Initial grading of Trench 6, looking south.

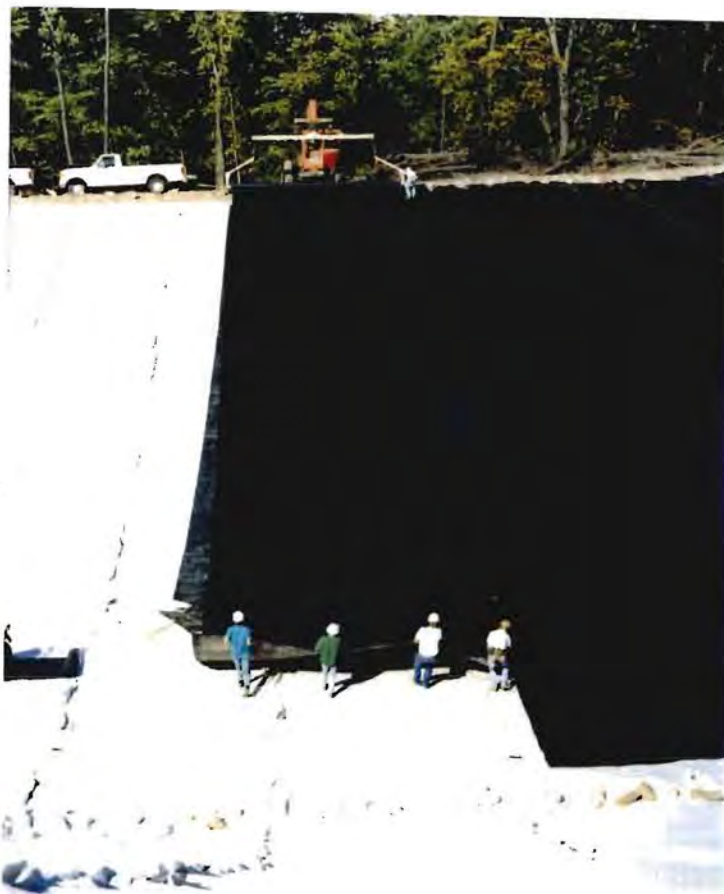
Photo No. 6: (17-18 September 1996) Placement of the primary geomembrane over the geocomposite leak detection layer.

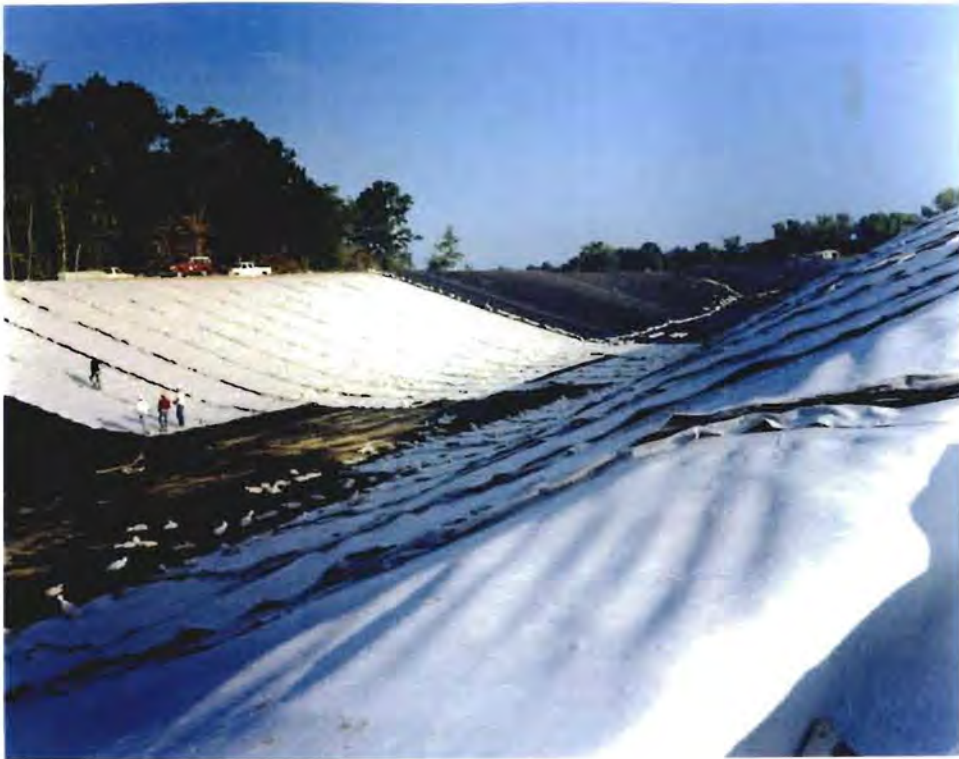
Photo No. 7: (17-18 September 1996) View of the progression of geosynthetic placement. Visible layers include the secondary geomembrane, the geocomposite leak detection layer, and the primary geomembrane.

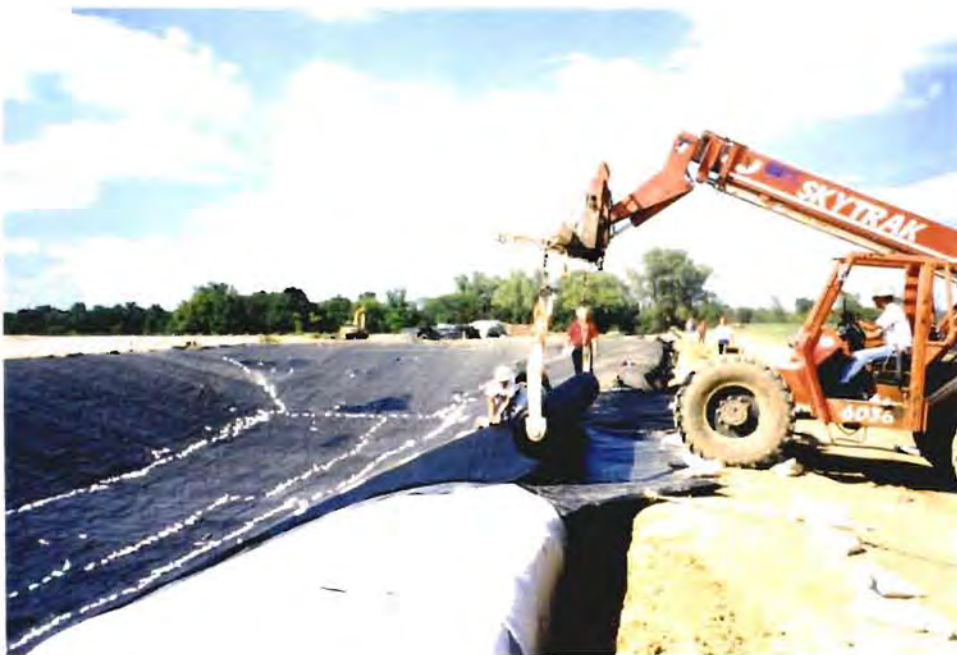
Photo No. 8: (September 1996) View of the geosynthetic anchor trench along the east side of Trench 6, looking north.

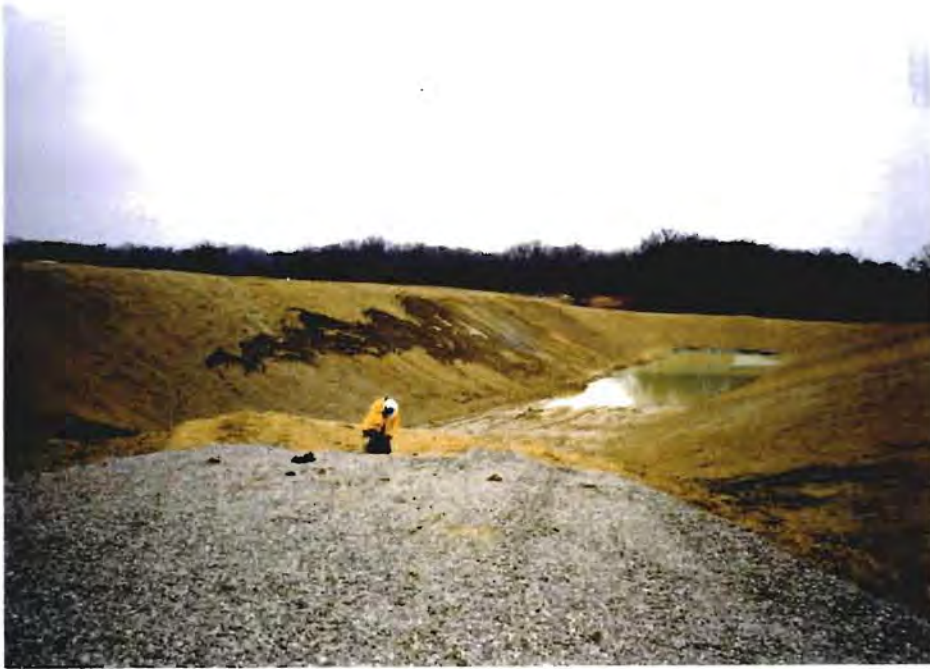
Photo No. 13: (March 1997) View of Trench 6 after the protective soil cover had been placed. The soil repository had just begun to receive contaminated materials. A slide of the cover soil had occurred on the east sideslope of the trench at the geogrid/soil interface. There was no damage to any of the geosynthetic layers.

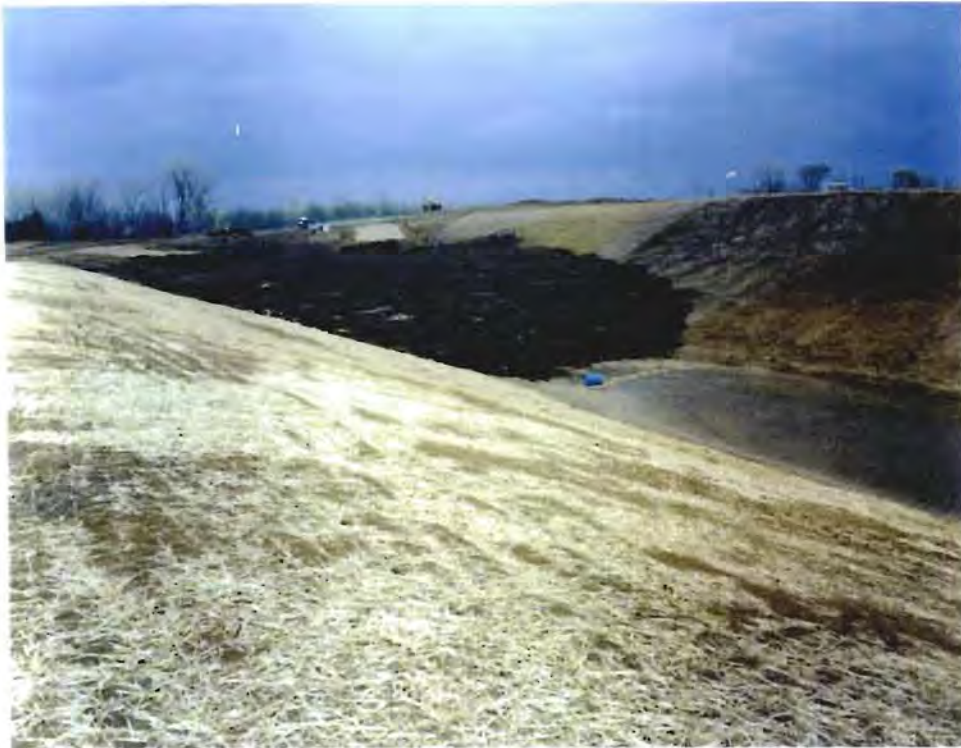
Photo No. 14: (1 May 1997) View of the north end of Trench 6 where contaminated soil from the Line 1 Impoundment and the Line 800 Lagoon has been placed.

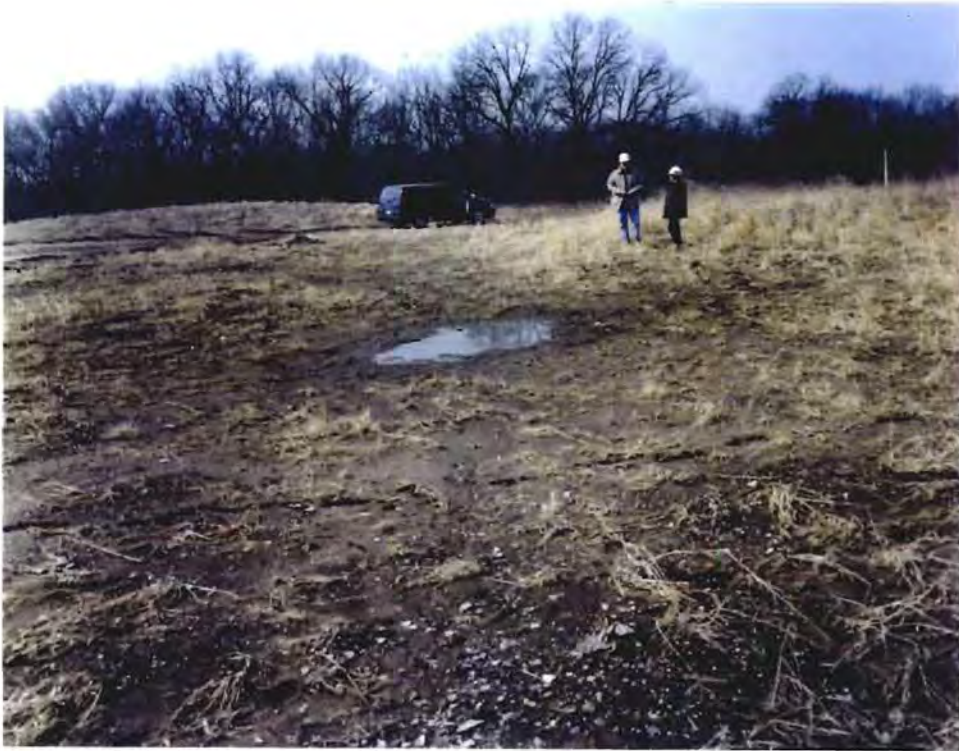
Photo No. 1: (12-16 March 1996) Preconstruction view of the Explosives Sumps Stockpile and the Burning Grounds as viewed looking southwest. The Explosives Sump Stockpile contained explosive contaminated soils.

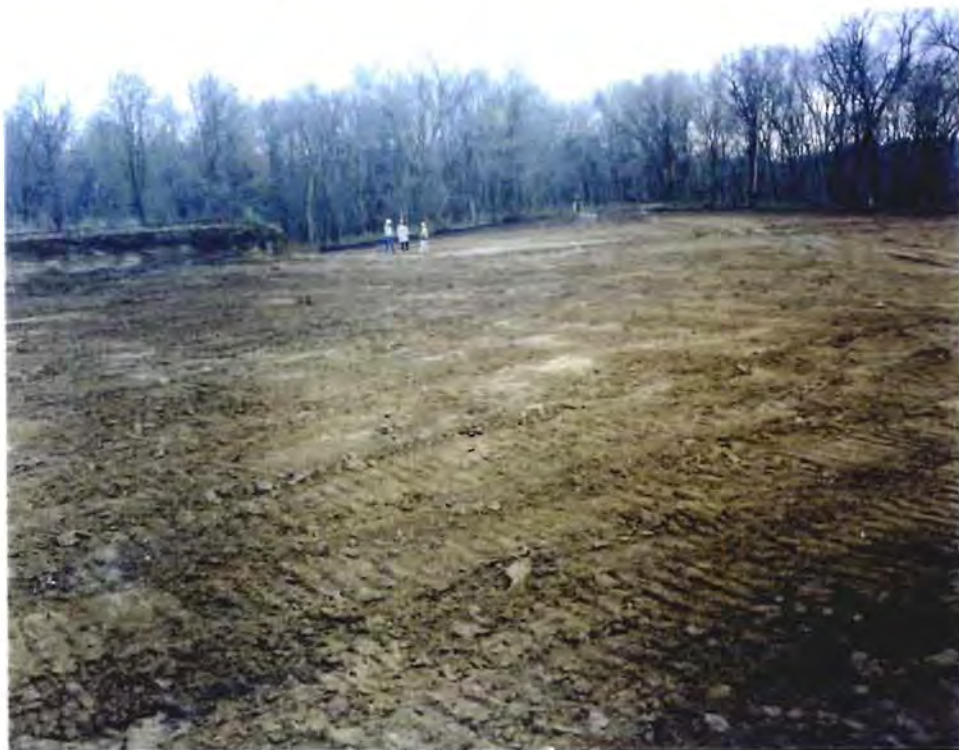
Photo No. 2: (1 May 1997) View of the remediated Explosives Sumps Stockpile and the Burning Grounds looking southwest. The Explosives Sumps Stockpile was placed into the Trench 6 Soils Repository.

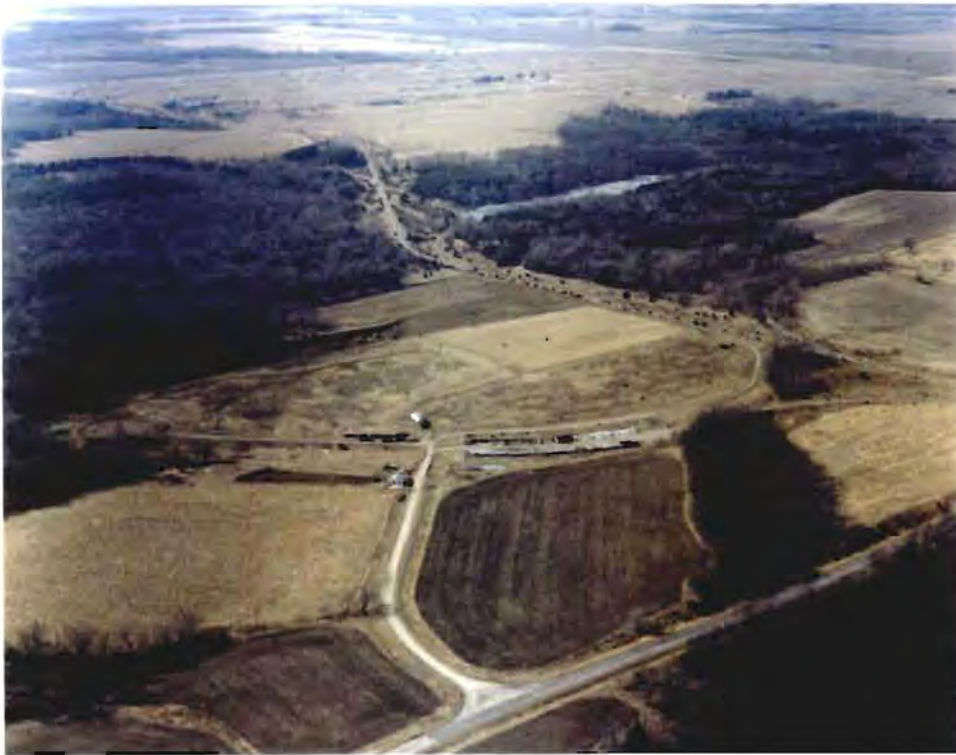
Photo No. 1: (12-16 March 1996) Preconstruction aerial view of Inert Landfill Area (IDA) looking northwest. The Burning Grounds and the Explosive Sumps Stockpile is located at the southern portion (left in photo) of the IDA.

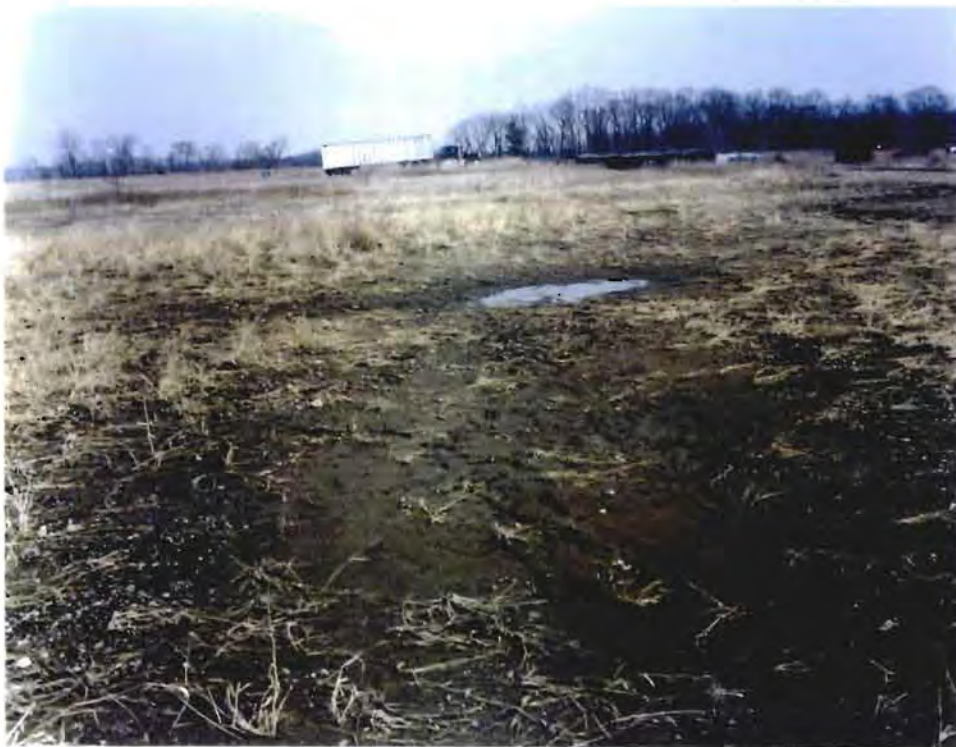
Photo No. 2: (12-16 March 1996) View of the Burning Grounds looking northeast. The Burning Grounds consisted of lead contaminated soils and ash and debris fill.

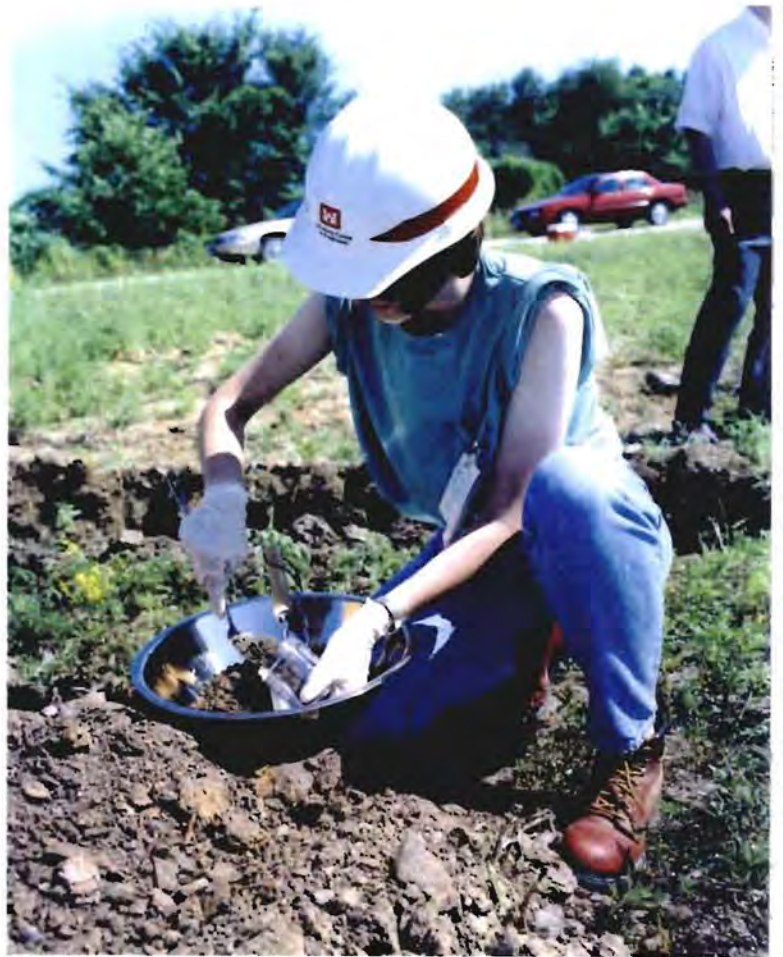
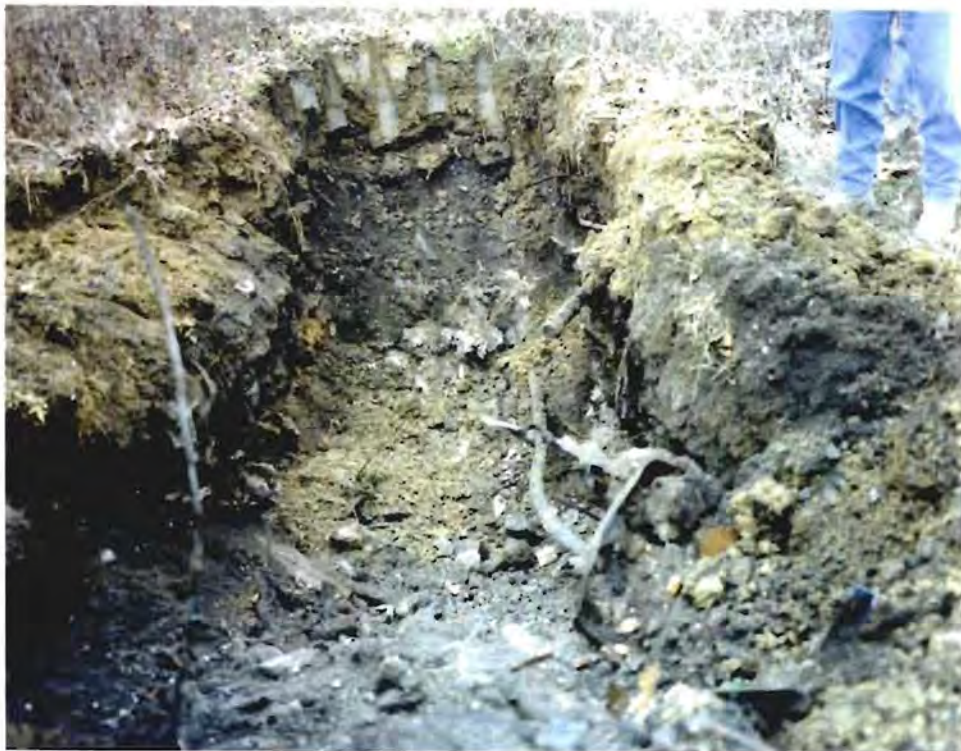
Photo No. 4: (19 November 1996) The Burning Grounds was trenched and sampled to determine the nature and extent of contamination. The ash material generally extended to a depth of three feet and extended over a three acre area.

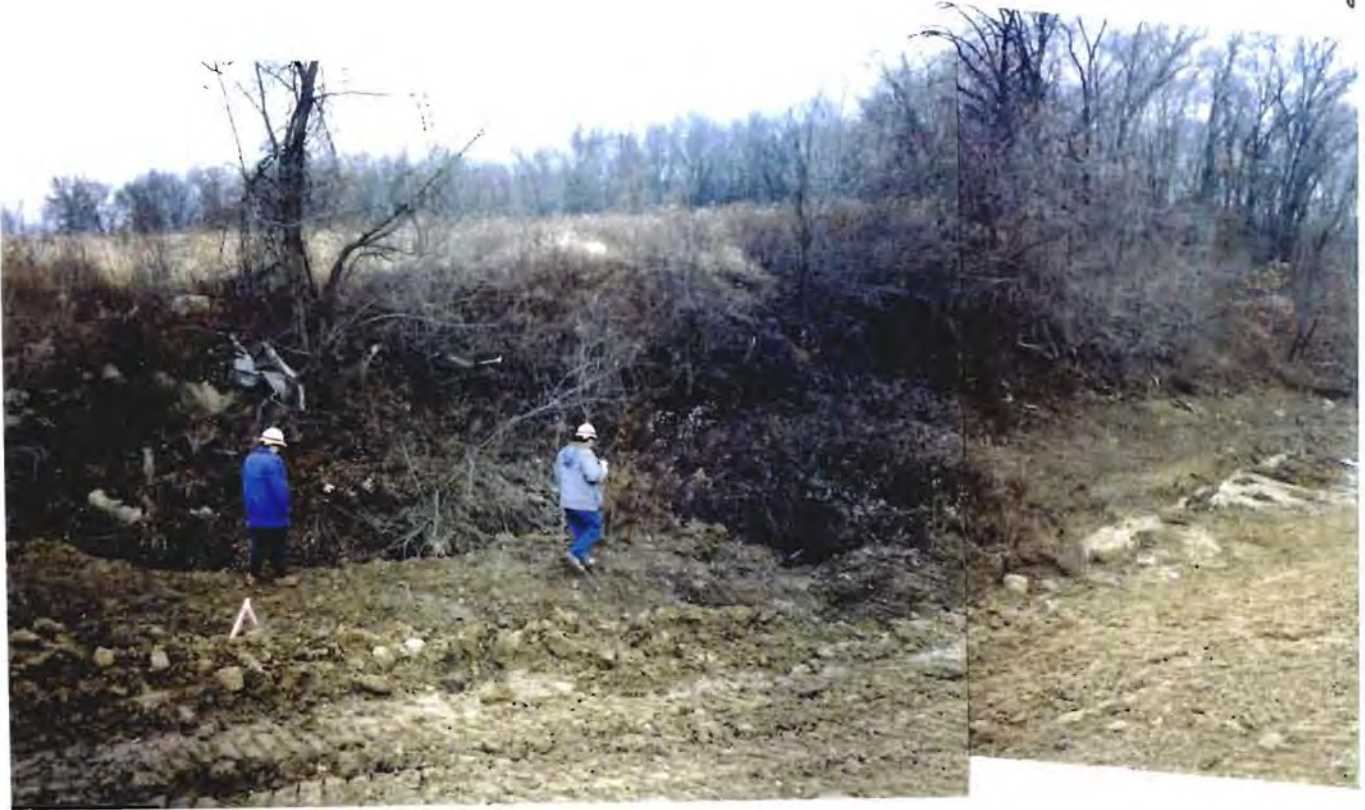
Photo No. 5: (19 November 1996) The Burning Grounds has been delineated to extend into the ravine located south of Trench 6. Ash and other debris was pushed into the ravine.

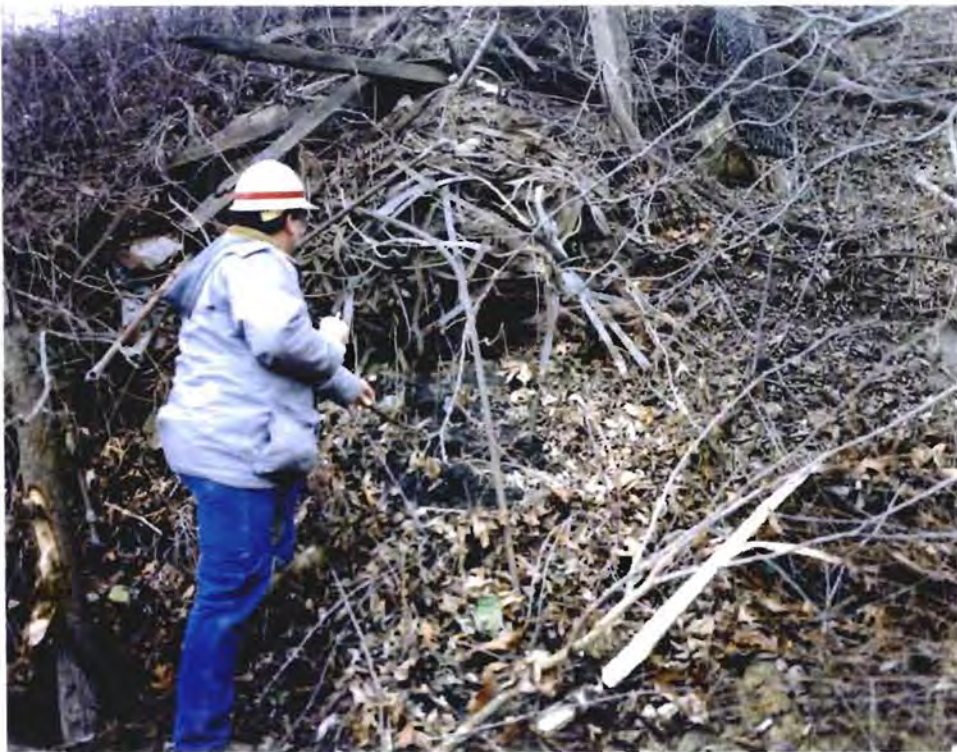
Photo No. 6: (19 November 1996) Close up view of the debris extending from the east bank of the ravine located south of Trench 6.
