**Per the Federal Facility Agreement for Iowa Army Ammunition Plant, Article X.B.1, the attached document is the final version of the submitted document.**

US Army Corps  
of Engineers  
Omaha District

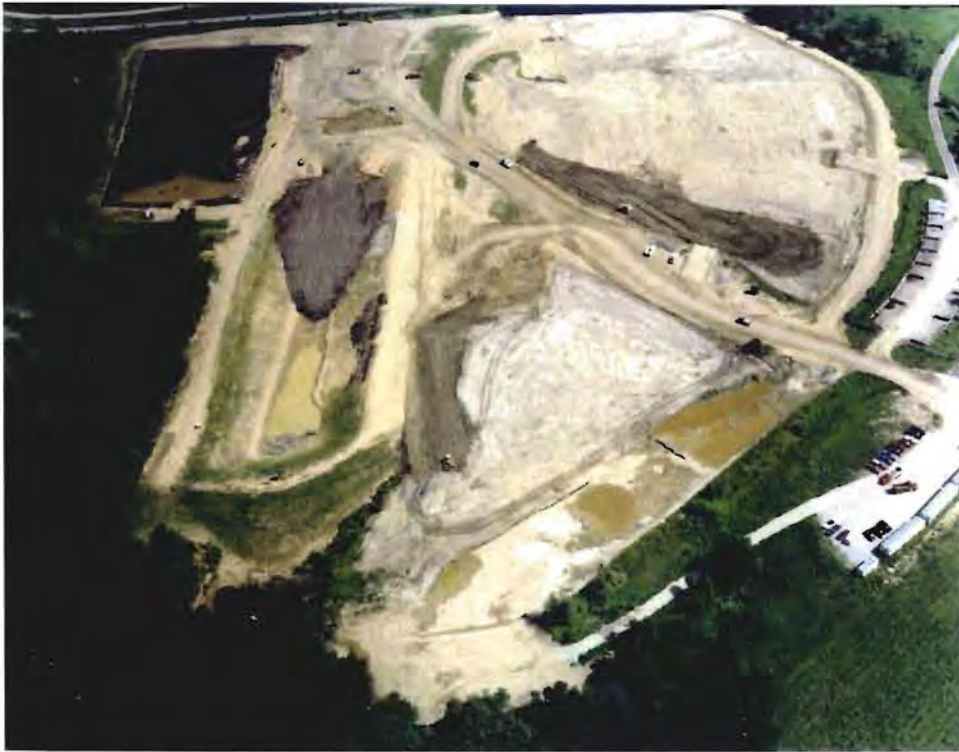
Photo No. 7: (24 June 1997) Aerial view of the IDA looking north. On this date, the Burning Grounds had been relocated in the random fill zone of the IDA cover. The Explosive Sumps Stockpile was relocated into Trench 6.

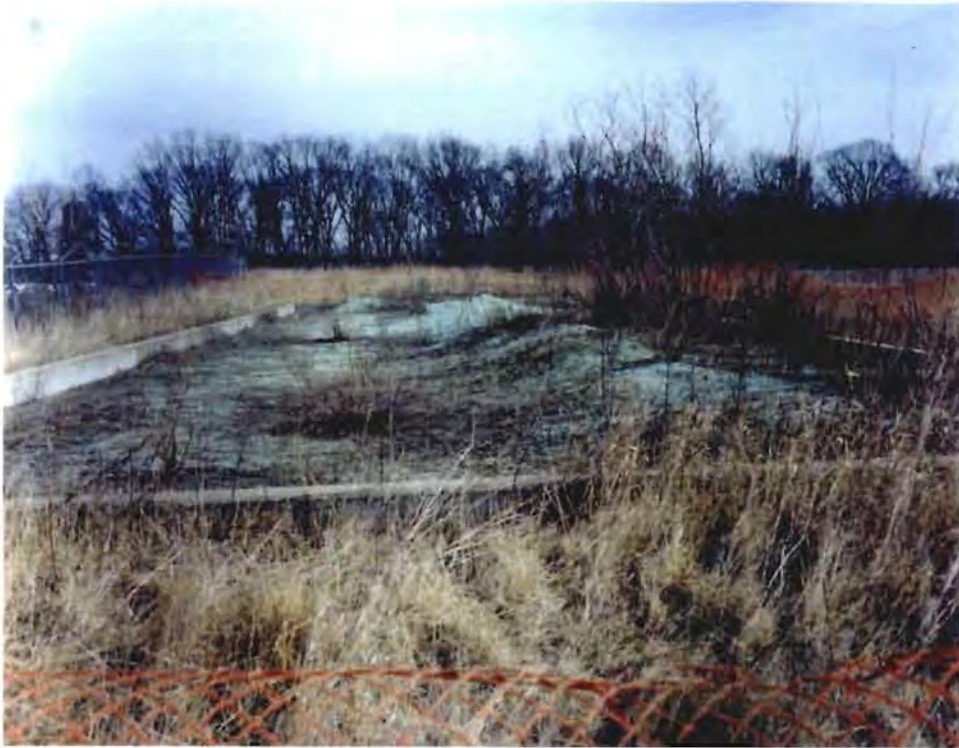
Photo No. 1: (March 1996) Blue Sludge Storage Area located at the Inert Disposal Area. This material was a by-product of metal plating operations.

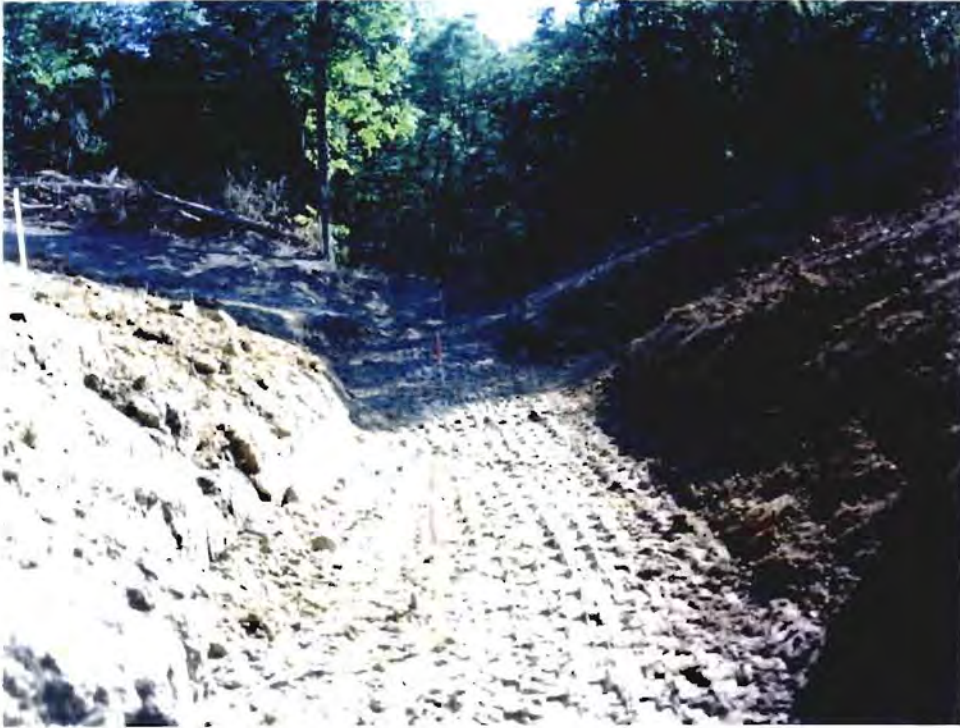
Photo No. 1: (15-16 July 1996) Excavation of the outlet works foundation for the CAMU Sediment Dam. Perpendicular to the excavation is the foundation inspection trench, located along the centerline of the dam alignment.

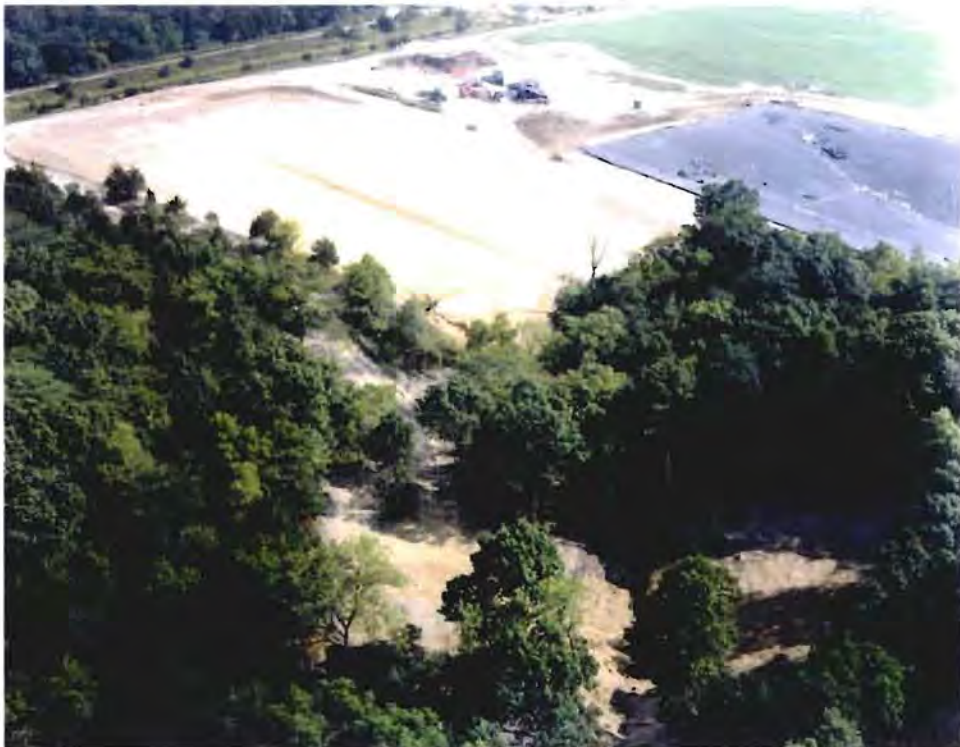
Photo No. 2: (17-18 September 1996) Aerial view of the future location of the CAMU Sediment Dam. The outlet works foundation is visible at the bottom-center of this photo. The CAMU site and Trench 6 are shown above.

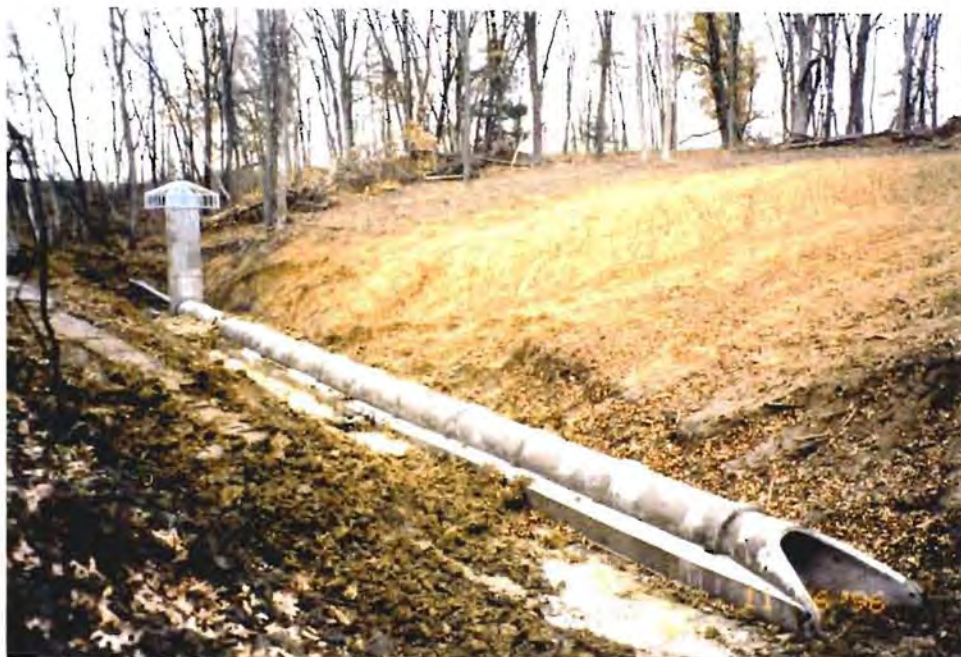
Photo No. 3: (6 November 1996) View of the completed intake structure and outlet works conduit, prior to construction of the embankment.

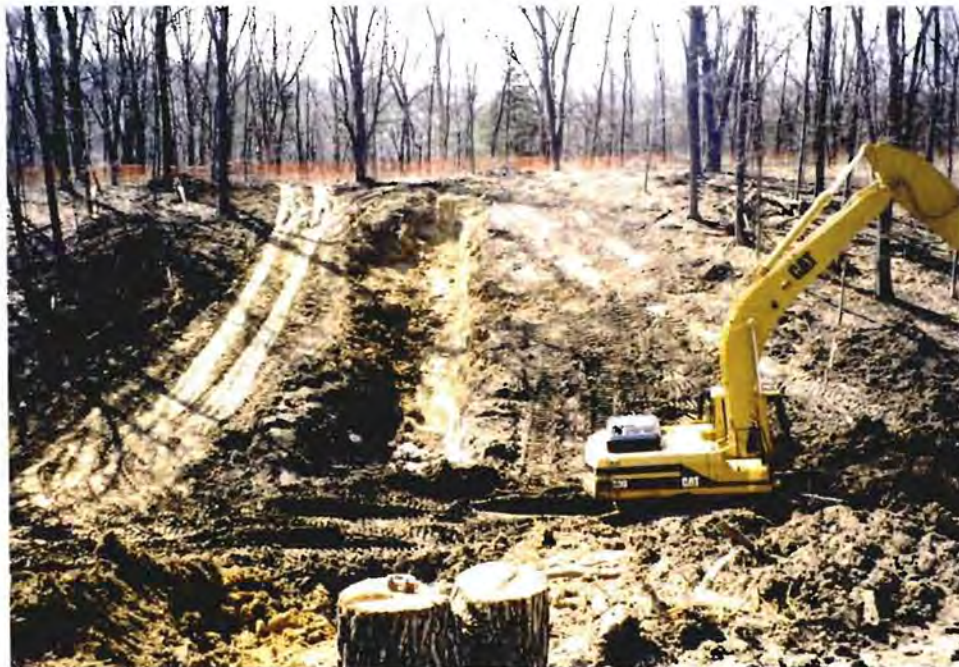
Photo No. 4: (March 1996) Clearing is complete and excavation of the outlet works foundation is in progress. The excavation for the inspection trench in the west abutment can be seen in the center of the photo.

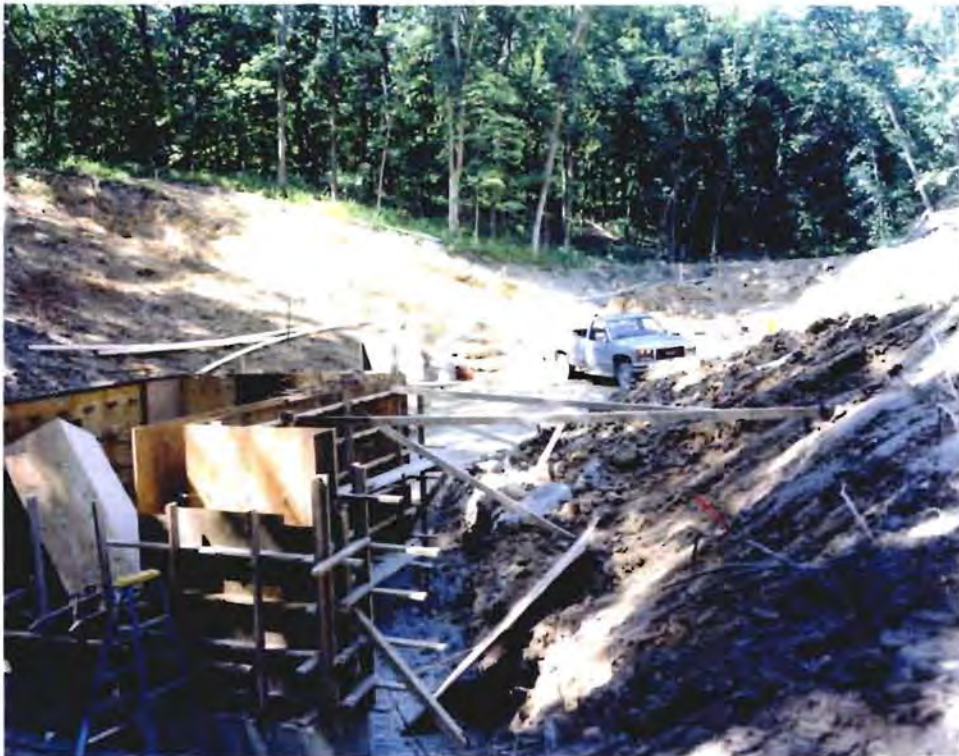
Photo No. 5: (15-16 July 1996) Forms for the reinforced concrete stilling basin are being constructed. The truck is parked at the approximate location of the embankment centerline.
