Draft
Operable Unit (OU-4)
After Action Report for Boundary Fence Installation
at the
Inert Disposal
Area
Iowa Army Ammunition Plant
Middletown, Iowa

November 2016

Prepared by:
Aerostar SES LLC
1006 Floyd Culler Court
Oak Ridge, Tennessee 37830
under
Contract No. W9128F-10-D-0099
Task Order No. 0004

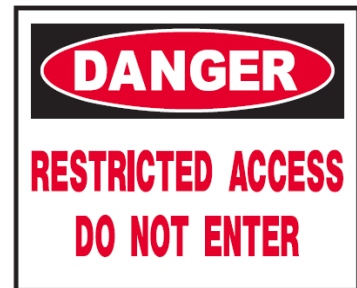
Figure 1 Warning signs

Warning signs were attached to the fence in 100-foot intervals, as specified in the LUCIP (Tetra Tech, 2014). The warning signs comply with Occupational Safety and Health Administration standard danger design specified by 29 CFR 1926.200b, as shown in Figure 1. Additional signs at entry points were mounted to list the points of contact for entry.

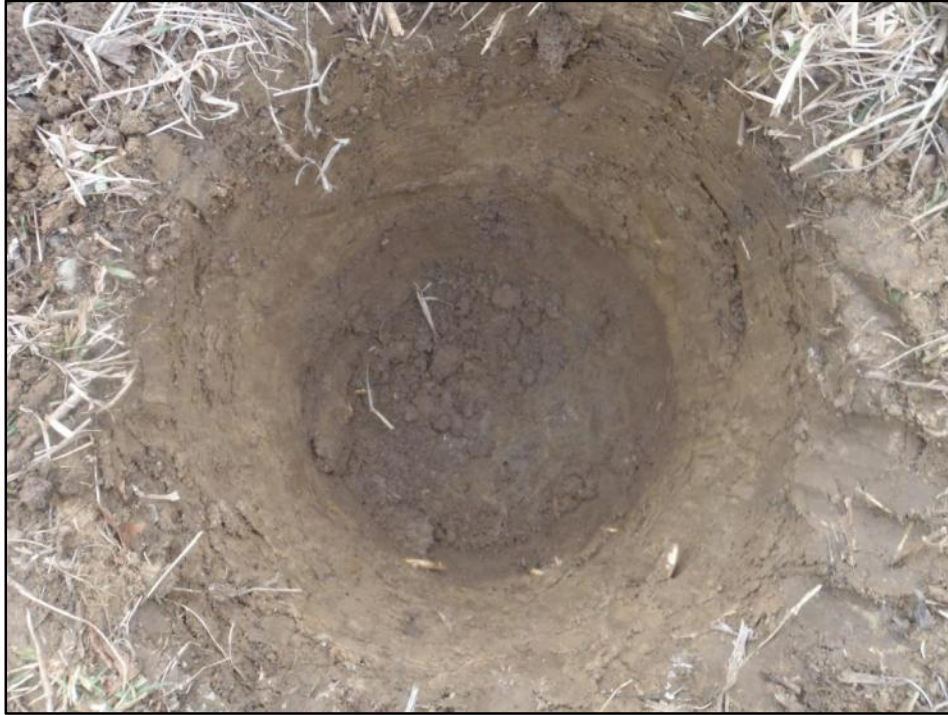
Photograph 3. Disturbed soils encountered in STP B2.

disturbance (Figure 3). STPs B1-B4 contained disturbed fill while STP B5 exhibited intact soils typical for an upland landscape. In STP B2, for example, a brown (10YR 4/3) silt loam CA1 horizon was found above a yellowish brown (10YR 5/4) mixed with gray (10YR 6/1) and very dark grayish brown (10YR 3/2) clay loam CA2 horizon. A grayish brown (10YR 5/2) and gray (10YR 6/1) clay loam CA3 horizon with iron oxide staining was found below the CA2 horizon (Figure 4; Photograph 3). The interface between CA1 and CA2 horizons was noted at 11 centimeters (4.3 inches) below ground surface (bgs), and the CA2/CA3 interface was reached at 33 centimeters (12.9 inches) bgs.

Excavation of STP B2 was terminated at 50 centimeters (19.6 inches) bgs. The intact soil profile encountered in STP B5 consisted of a very dark grayish brown (2.5Y 3/2) silt loam Ap horizon overlying a brownish yellow (10YR 6/6) silty clay loam B horizon (Figure 4). The Ap/B interface was noted at 33 centimeters (12.9 inches) bgs, and STP B5 was terminated at 50 centimeters (19.6 inches) bgs. No cultural resources were identified in this northeastern portion of the supplemental APE.

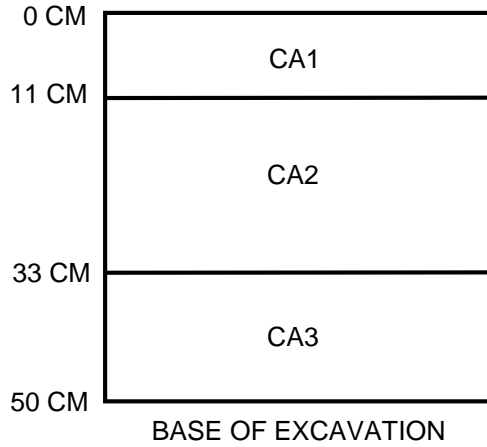
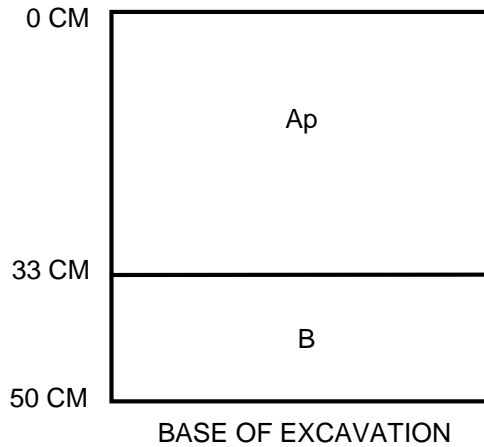
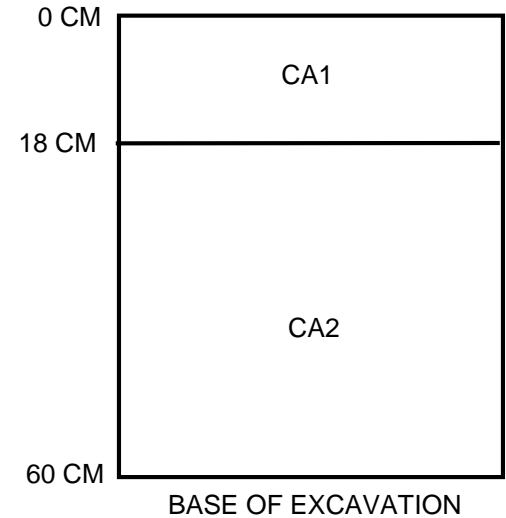
FIGURE 4, SHEET 1 OF 2
REPRESENTATIVE STP PROFILES

CA1 – BROWN (10YR 4/3) SILT LOAM

CA2 – YELLOWISH BROWN (10YR 5/4) MIXED WITH GRAY (10YR 6/1) AND VERY DARK GRAYISH BROWN (10YR 3/2) CLAY LOAM

CA3 – GRAYISH BROWN (10YR 5/2) AND GRAY (10YR 6/1) CLAY LOAM WITH IRON OXIDE STAINING

Ap – VERY DARK GRAYISH BROWN (2.5Y 3/2) SILT LOAM

B – BROWNISH YELLOW (10YR 6/6) SILTY CLAY LOAM

CA1 – YELLOWISH BROWN (10YR 5/4) AND LIGHT GRAY (10YR 7/1) COURSE SAND

CA2 – GRAYISH BROWN (10YR 5/4) MIXED WITH GRAY (10YR 6/1) CLAY LOAM WITH ROAD GRAVELS AND REDOXIMORPHIC FEATURES

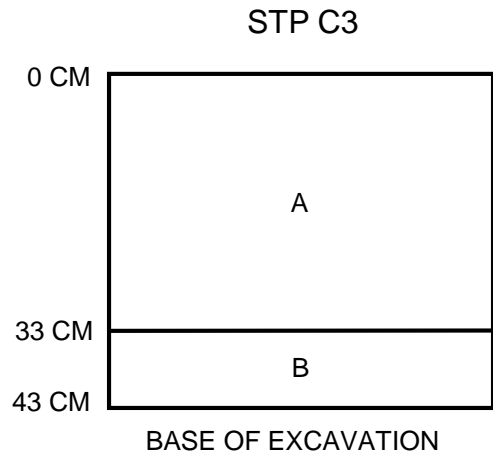
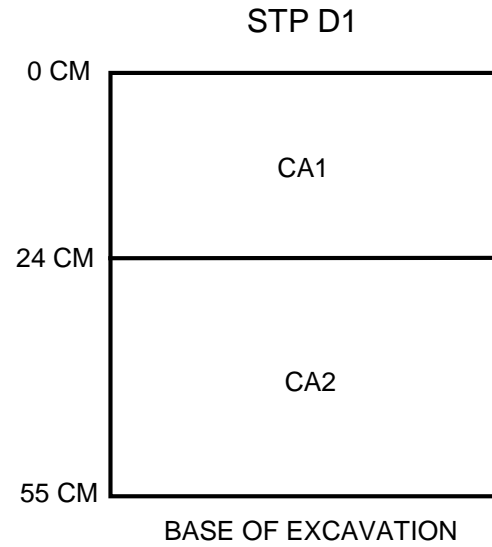
FIGURE 4, SHEET 2 OF 2
REPRESENTATIVE STP PROFILES

A – WET VERY DARK GRAYISH BROWN (10YR 3/2) SILT LOAM

B – WET GRAY (10YR 6/1) AND YELLOW (10YR 7/8) CLAY LOAM WITH REDOXIMORPHIC FEATURES

CA1 – COMPACT VERY DARK GRAYISH BROWN (10YR 3/2) MIXED WITH BROWNISH YELLOW (10YR 6/6) SILTY CLAY LOAM

CA2 – COMPACT DARK GRAYISH BROWN (10YR 4/2) MIXED WITH GRAY (10YR 6/1) AND BROWNISH YELLOW (10YR 6/6) SILTY CLAY LOAM WITH IRON AND MANGANESE STAINING

silty clay loam CA2 horizon with iron and manganese staining (Figure 4; Photograph 9). The CA1/CA2 interface was noted at 24 centimeters (9.4 inches) bgs, and excavation of STP D1 was terminated at 55 centimeters (21.6 inches) bgs. No cultural resources were identified as a result of pedestrian reconnaissance and shovel testing efforts in the western portion of the supplemental APE.

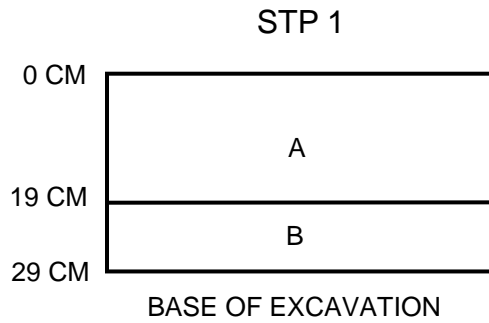
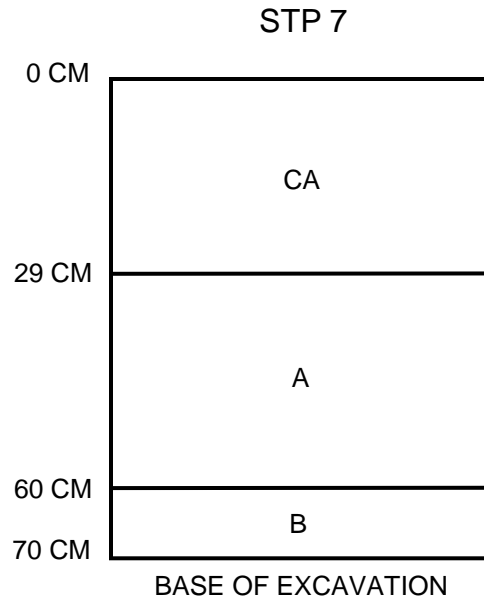
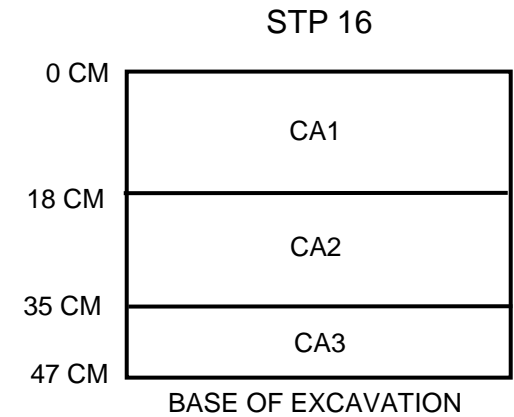
**FIGURE 5
 REPRESENTATIVE STP PROFILES**

A – VERY DARK GRAY (10YR 3/1) MIXED WITH DARK GRAYISH BROWN (10YR 4/2) SILTY CLAY LOAM WITH IRON OXIDE
 B – YELLOWISH BROWN (10YR 5/4) CLAY LOAM

CA – DARK GRAYISH BROWN (10YR 4/2) MIXED WITH DARK YELLOWISH BROWN (10YR 4/6) AND VERY DARK GRAY (10YR 3/1) SILTY CLAY LOAM
 A – VERY DARK GRAY (10YR 3/1) SILT LOAM
 B – YELLOWISH BROWN (10YR 5/6) SILTY CLAY LOAM

CA1 – COMPACT DARK YELLOWISH BROWN (10YR 4/4) MIXED WITH VERY PALE BROWN (10YR 7/3) CLAY LOAM
 CA2 – COMPACT YELLOWISH BROWN (10YR 5/8) MIXED WITH DARK GRAYISH (10YR 4/2) CLAY LOAM
 CA3 – COMPACT DARK GRAYISH BROWN (10YR 4/2) MIXED WITH LIGHT BROWNISH GRAY (10YR 6/2) CLAY LOAM WITH 25 PERCENT GRAVELS

Of the 18 total STPs excavated within the project APE, nine contained intact soils characteristic of an upland landform, while the remaining nine STPs exhibited disturbed soils. STP 1 consisted of intact soils, specifically a very dark gray (10YR 3/1) mixed with dark grayish brown (10YR 4/2) silty clay loam A horizon with iron oxide staining overlying a yellowish brown (10YR 5/4) clay loam B horizon (Figure 5). The A/B interface was reached at 19 centimeters (7.48 inches) below ground surface, and excavation of STP 1 was terminated at 29 centimeters (11.41 inches).

STP 7 contained a horizon of disturbed fill overlying intact upland soils. The soil profile of STP 7 consisted of a dark grayish brown (10YR 4/2) mixed with dark yellowish brown (10YR 4/6) and very dark gray (10YR 3/1) silty clay loam CA overlying a very dark gray (10YR 3/1) silt loam A horizon and a yellowish brown (10YR 5/6) silty clay loam B horizon (see Figure 5). The interface between the CA and A horizons was noted at 29 centimeters (11.41 inches) below ground surface, and the A/B interface at 60 centimeters (23.62 inches). STP 7 was terminated at 70 centimeters (27.55 inches) below ground surface.

In STP 16, GAI archaeologists encountered three strata of disturbed fill. The CA1 horizon consisted of a compact dark yellowish brown (10YR 4/4) mixed with very pale brown (10YR 7/3) clay loam, which was found above a compact yellowish brown (10YR 5/8) mixed with dark grayish brown (10YR 4/2) clay loam CA2 horizon. A compact dark grayish brown (10YR 4/2) mixed with light brownish gray (10YR 6/2) clay loam CA3 horizon with 25 percent gravels was found below the CA2 horizon (see Figure 5). The CA1/CA2 interface was reached at 18 centimeters (7 inches) below ground surface, and the CA2/CA3 interface at 35 centimeters (13.77 inches). Excavation of STP 16 was terminated at 47 centimeters (18.5 inches) below ground surface.

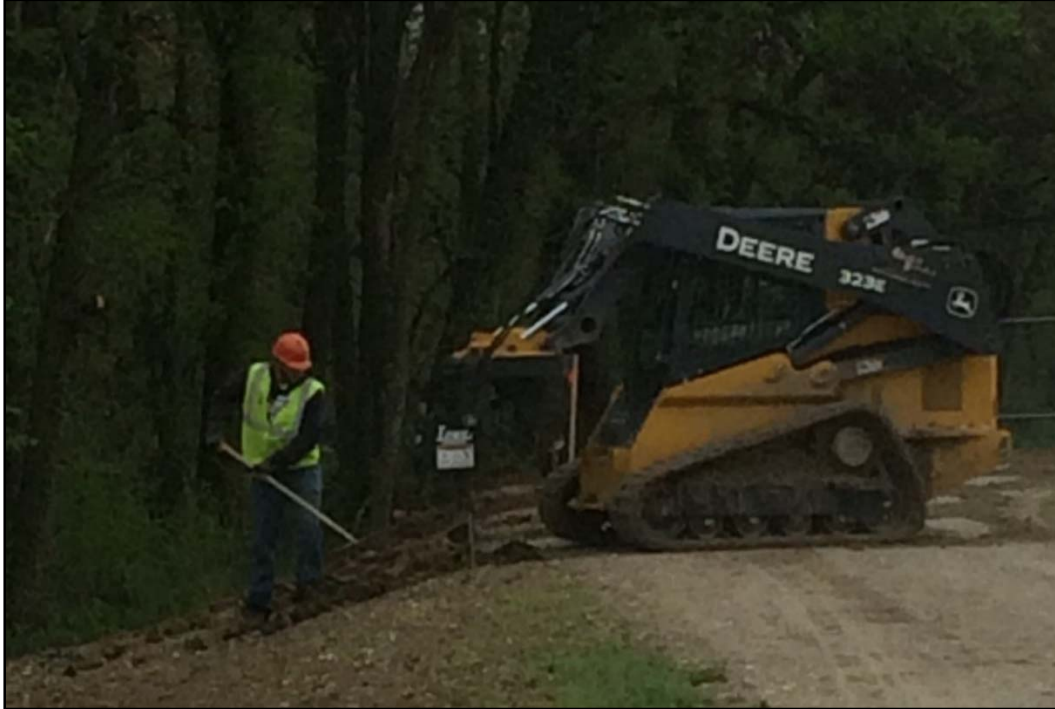
Photo 1. View southwest of the access road toward the Fixed Facility Water Treatment Plant. Skid steer using 12-inch auger to advance fence post holes.

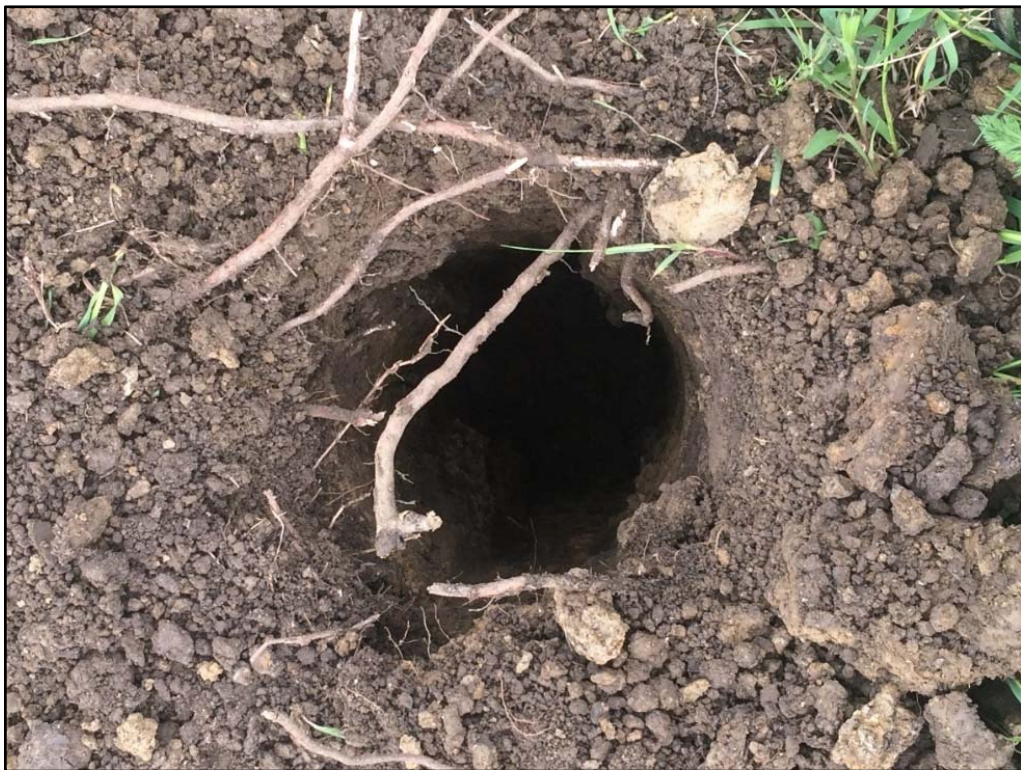
Photo 2. Ground view of a completed 12-inch fence post hole.

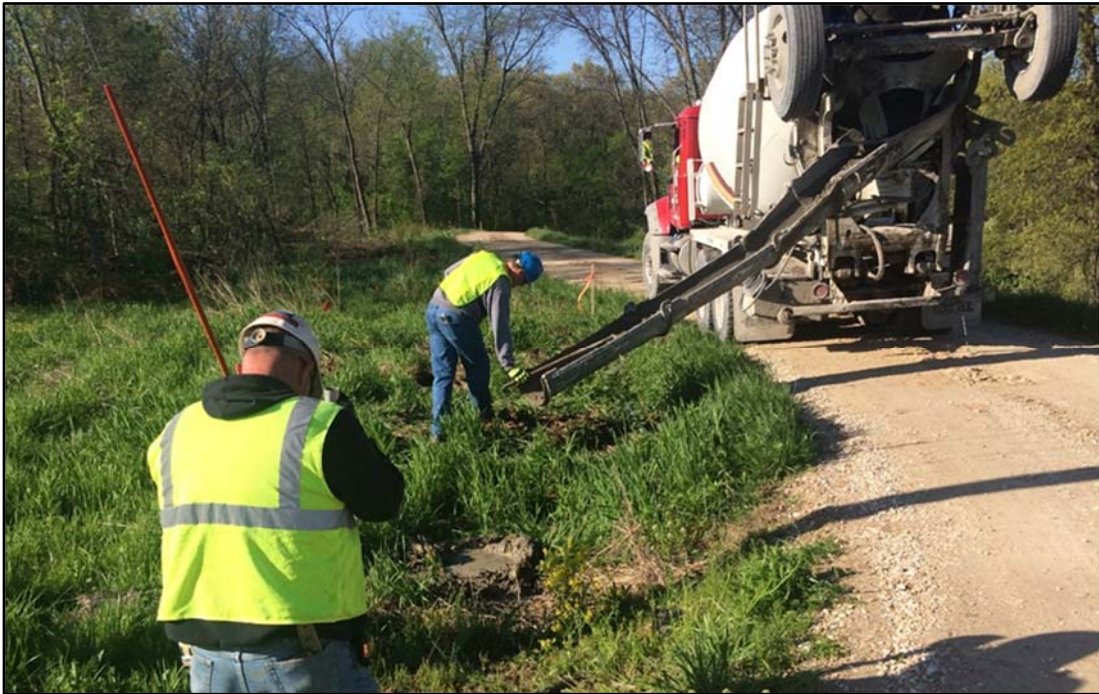
Photo 3. View south along access road heading toward the IDA office. Concrete truck filling the fence post holes with concrete.

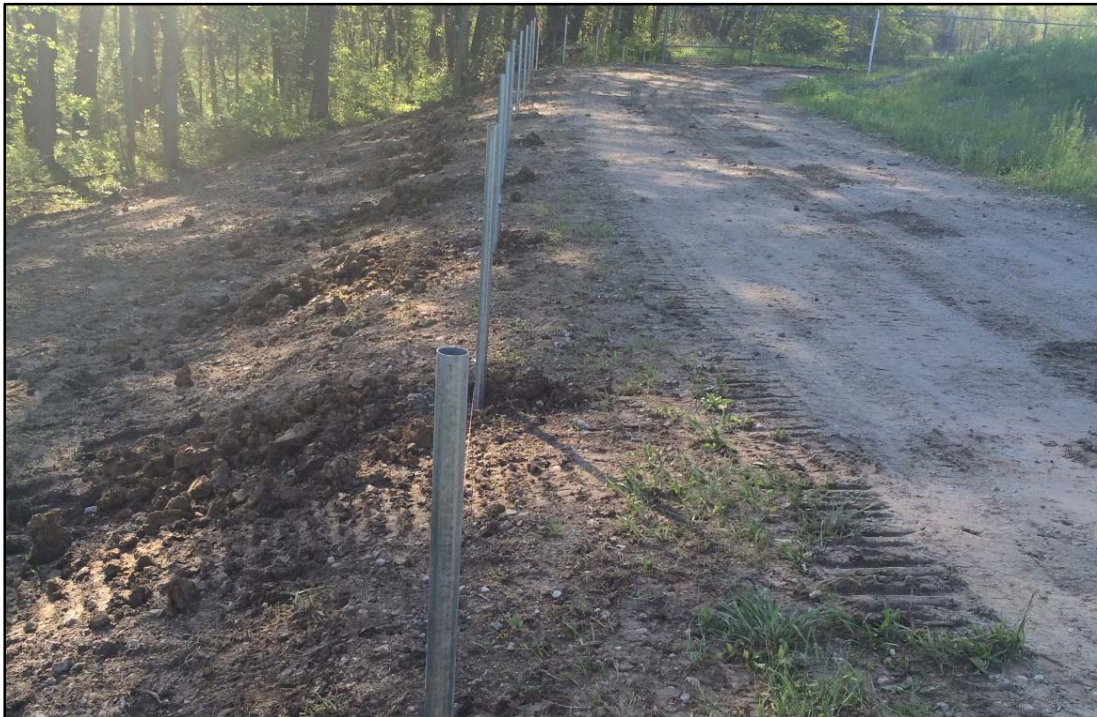
Photo 4. View southeast along access road heading toward the Fixed Facility Water Treatment Plant. Installed fence posts.

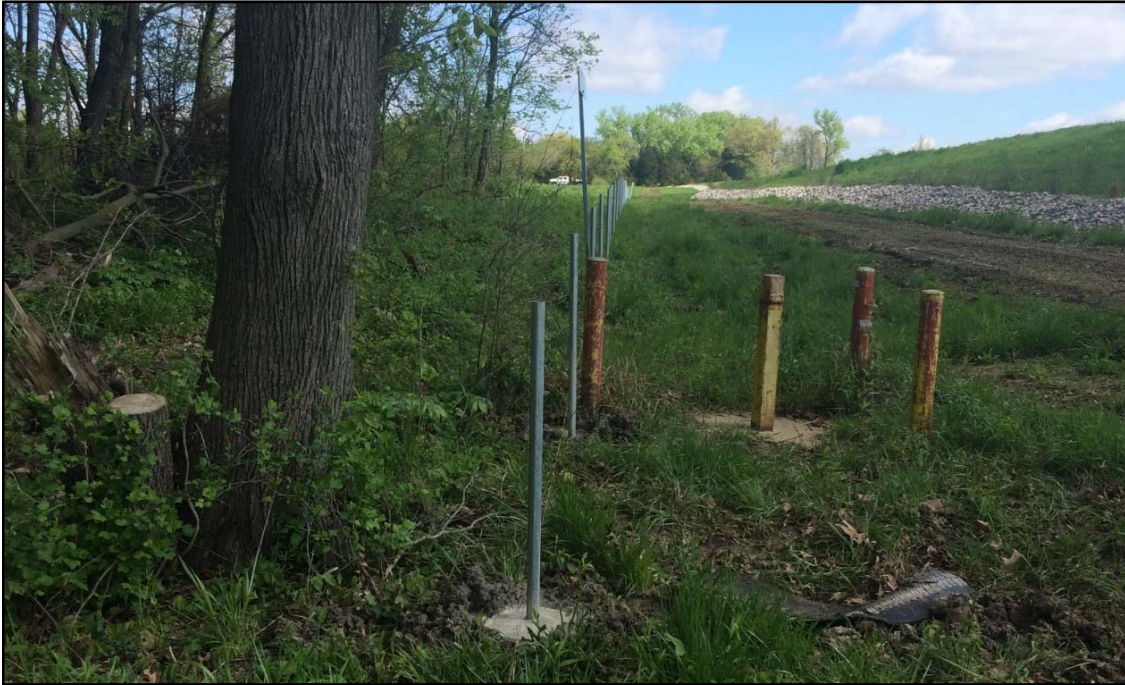
Photo 5. View north along the west side of Trench 6 Landfill. Showing fence posts secured in concrete.

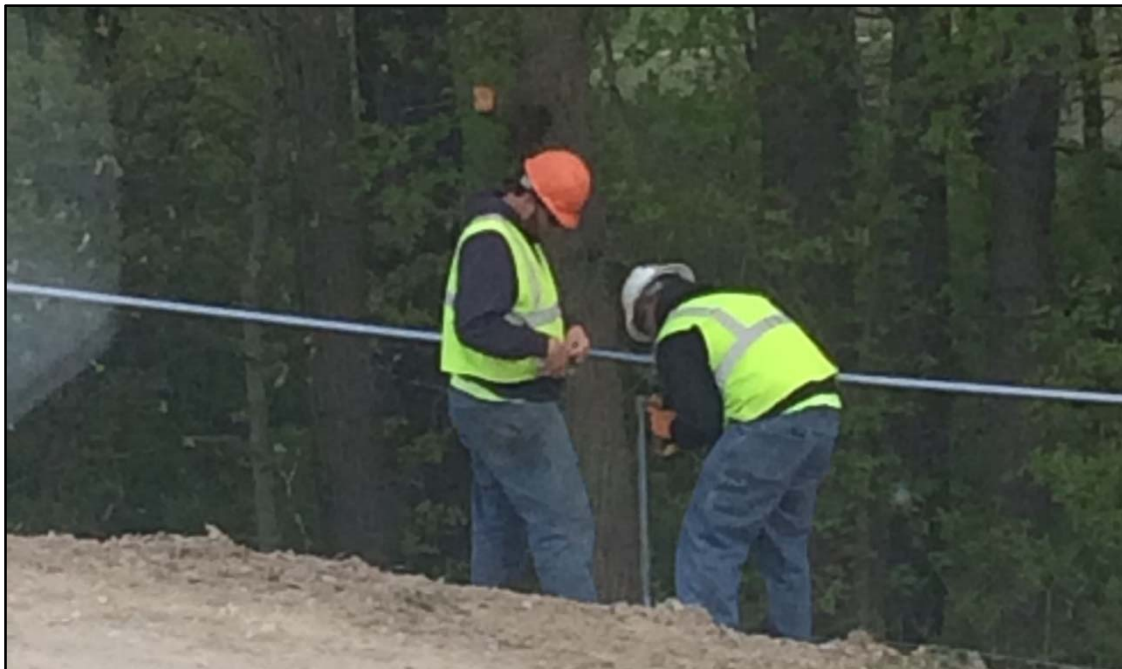
Photo 6. View west along access road to the IDA office. Installation of the fence top bar.

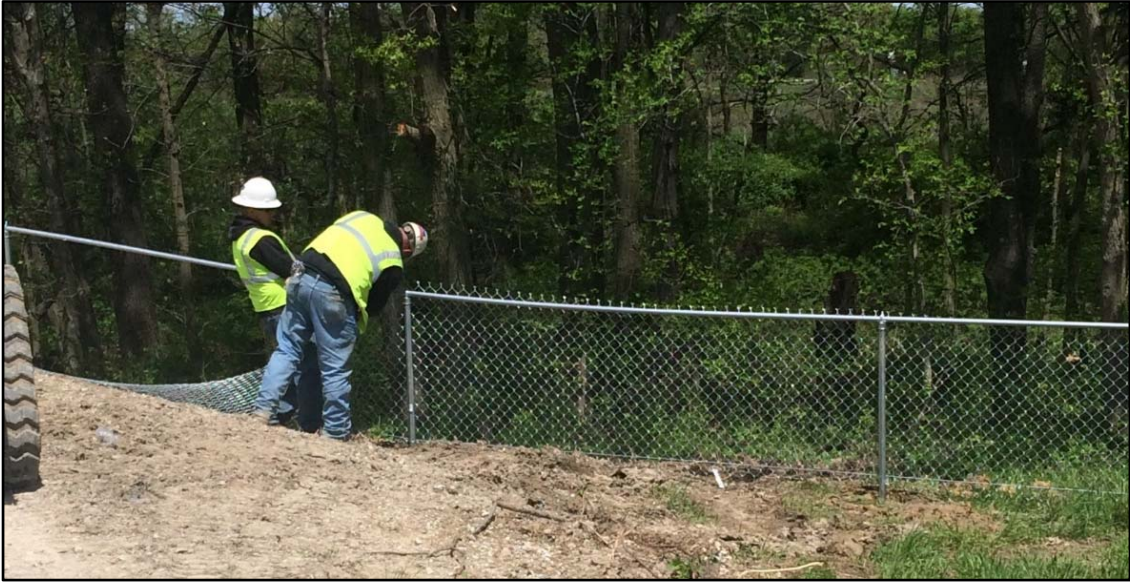
Photo 7. Camera facing west from the west side of trench 6. Attaching the chain link to the frame.

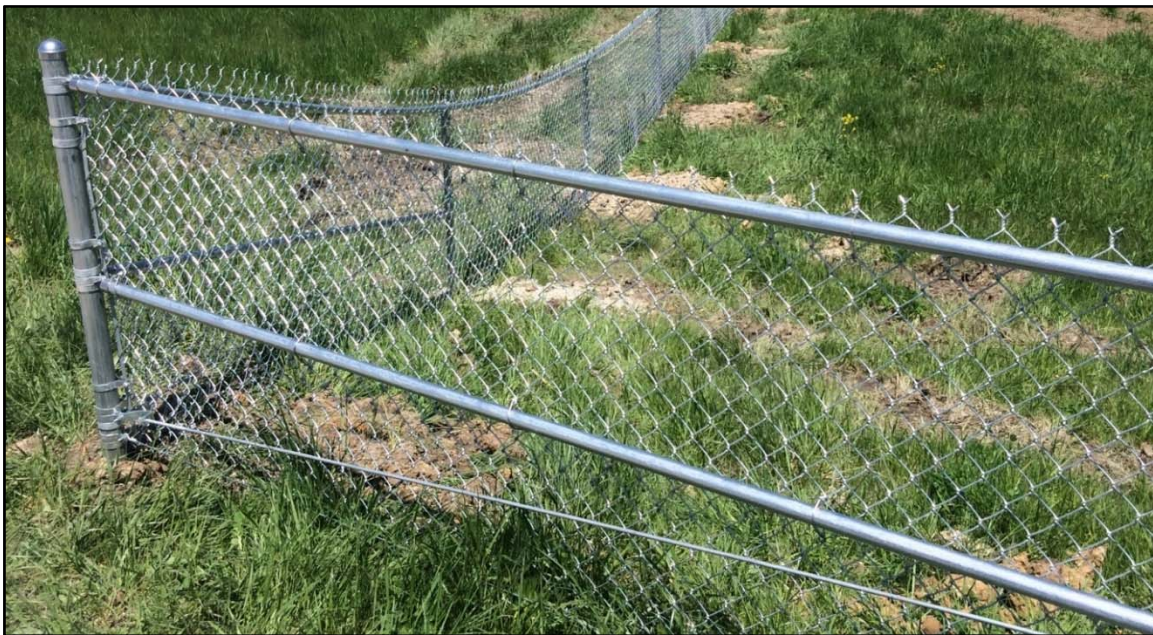
Photo 8. Camera facing north from the east side of the IDA. Showing corner section of fencing with larger end/corner post, tie wire, truss rod, and brace band supplying necessary reinforcement.

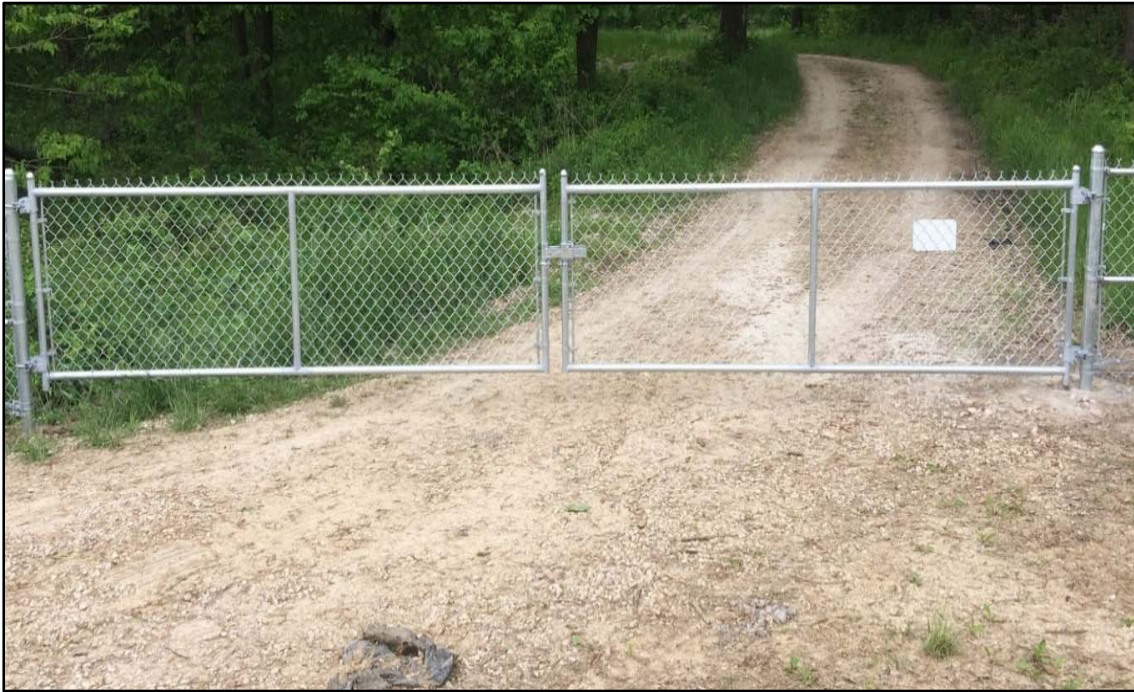
Photo 9. Camera facing northwest from the west side of the IDA. Gate #5.

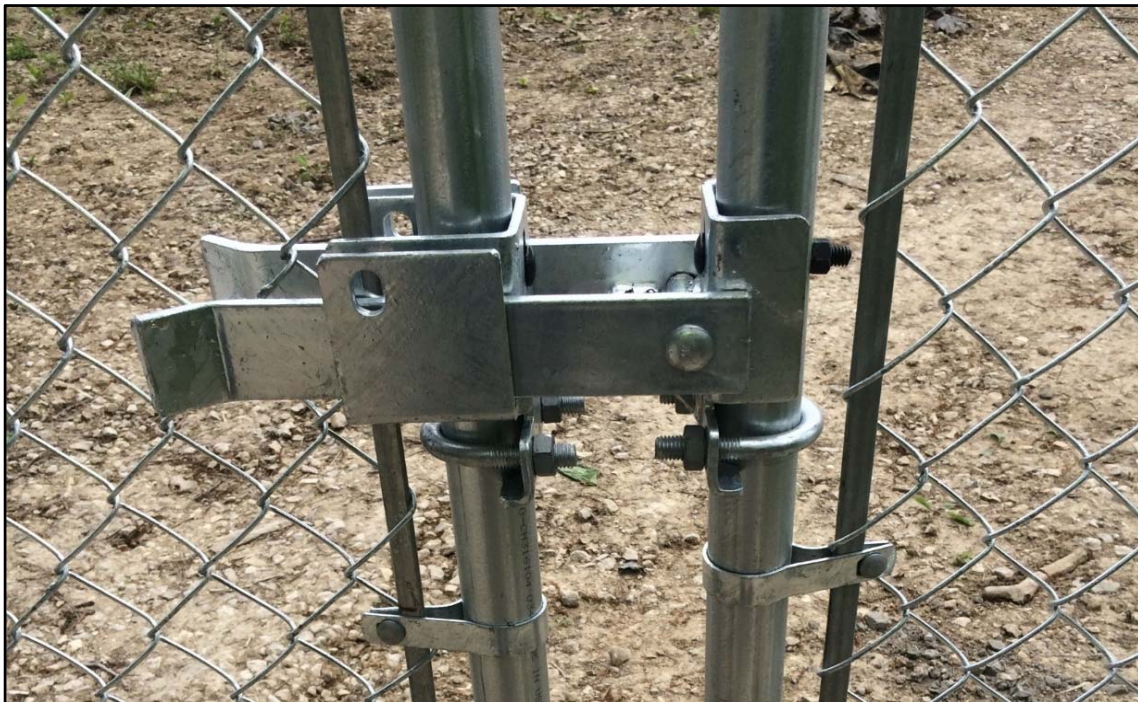
Photo 10. Latch mechanism at Gate #5. Mechanism is the same at all installed double gates.

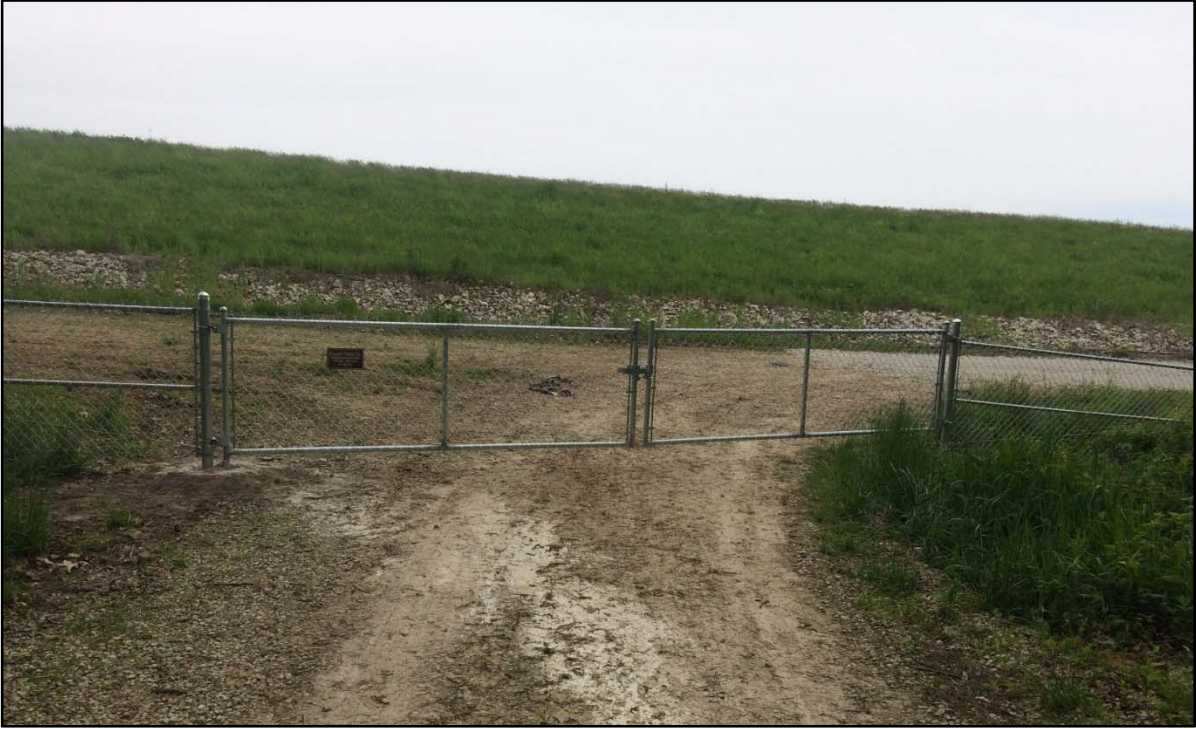
Photo 11. Camera facing southeast from the west side of trench 6. Gate #4.

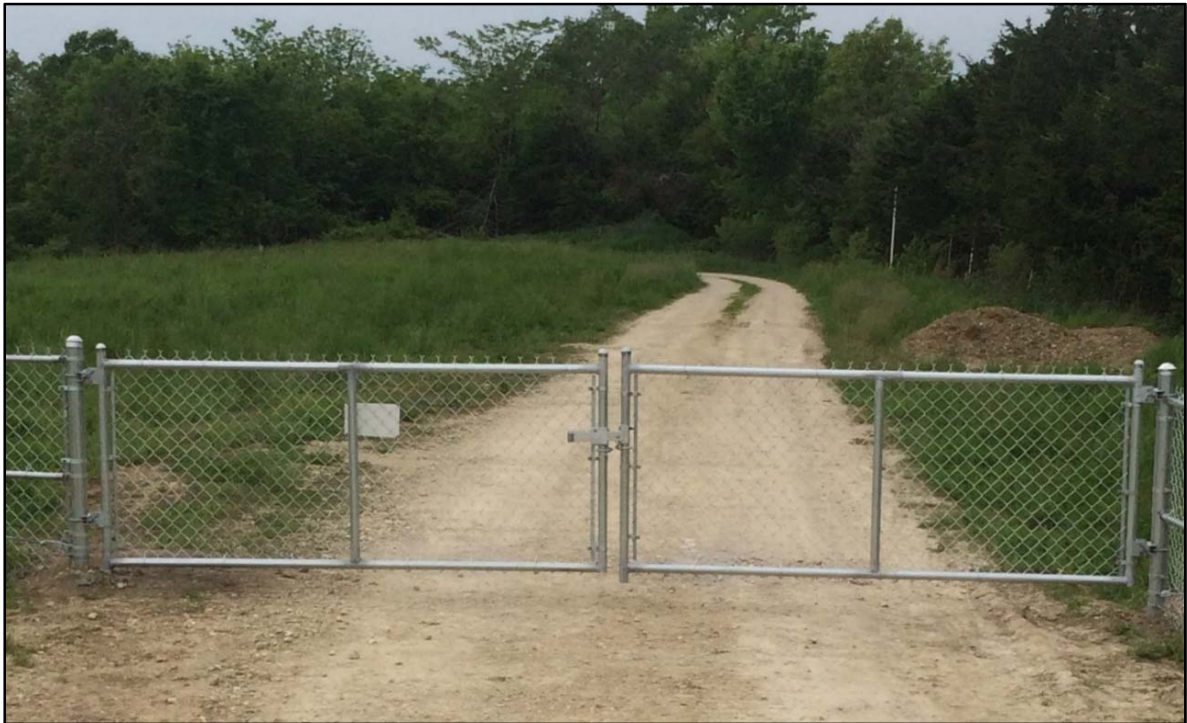
Photo 12. Camera facing west from the northeast corner of trench 6. Gate #3.

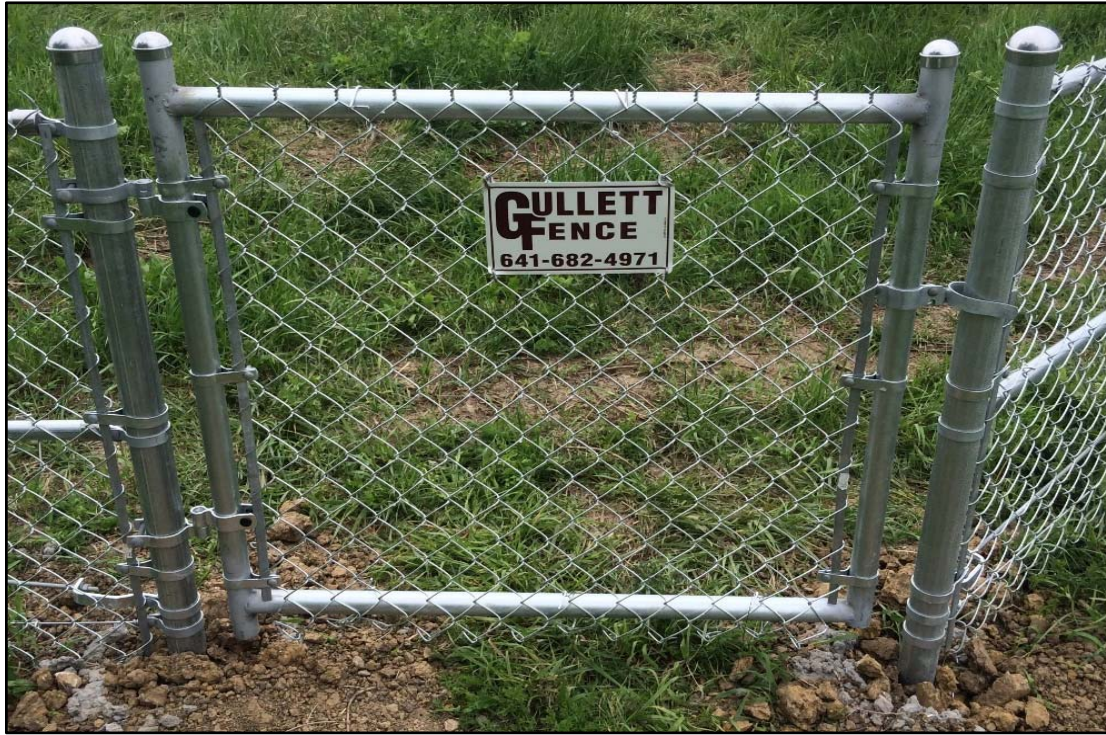
Photo 13. Walkthrough gate on the east side of the IDA perimeter fence.

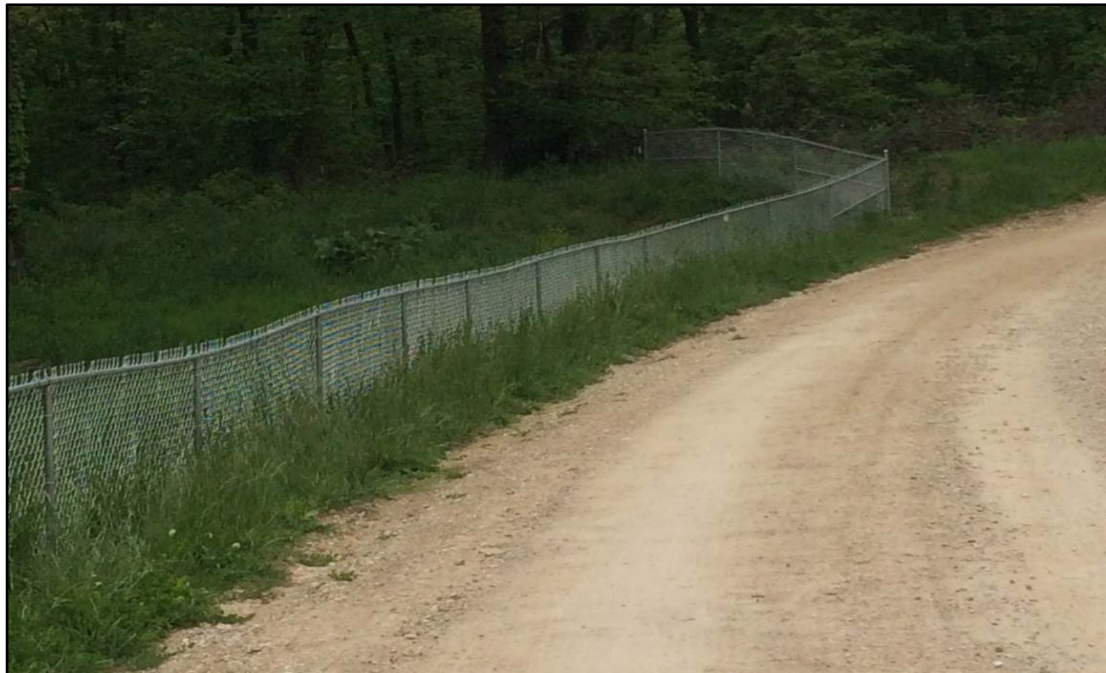
Photo 14. Showing where the newly constructed fence meets with the existing barbed wire fence that is the border of the active range.

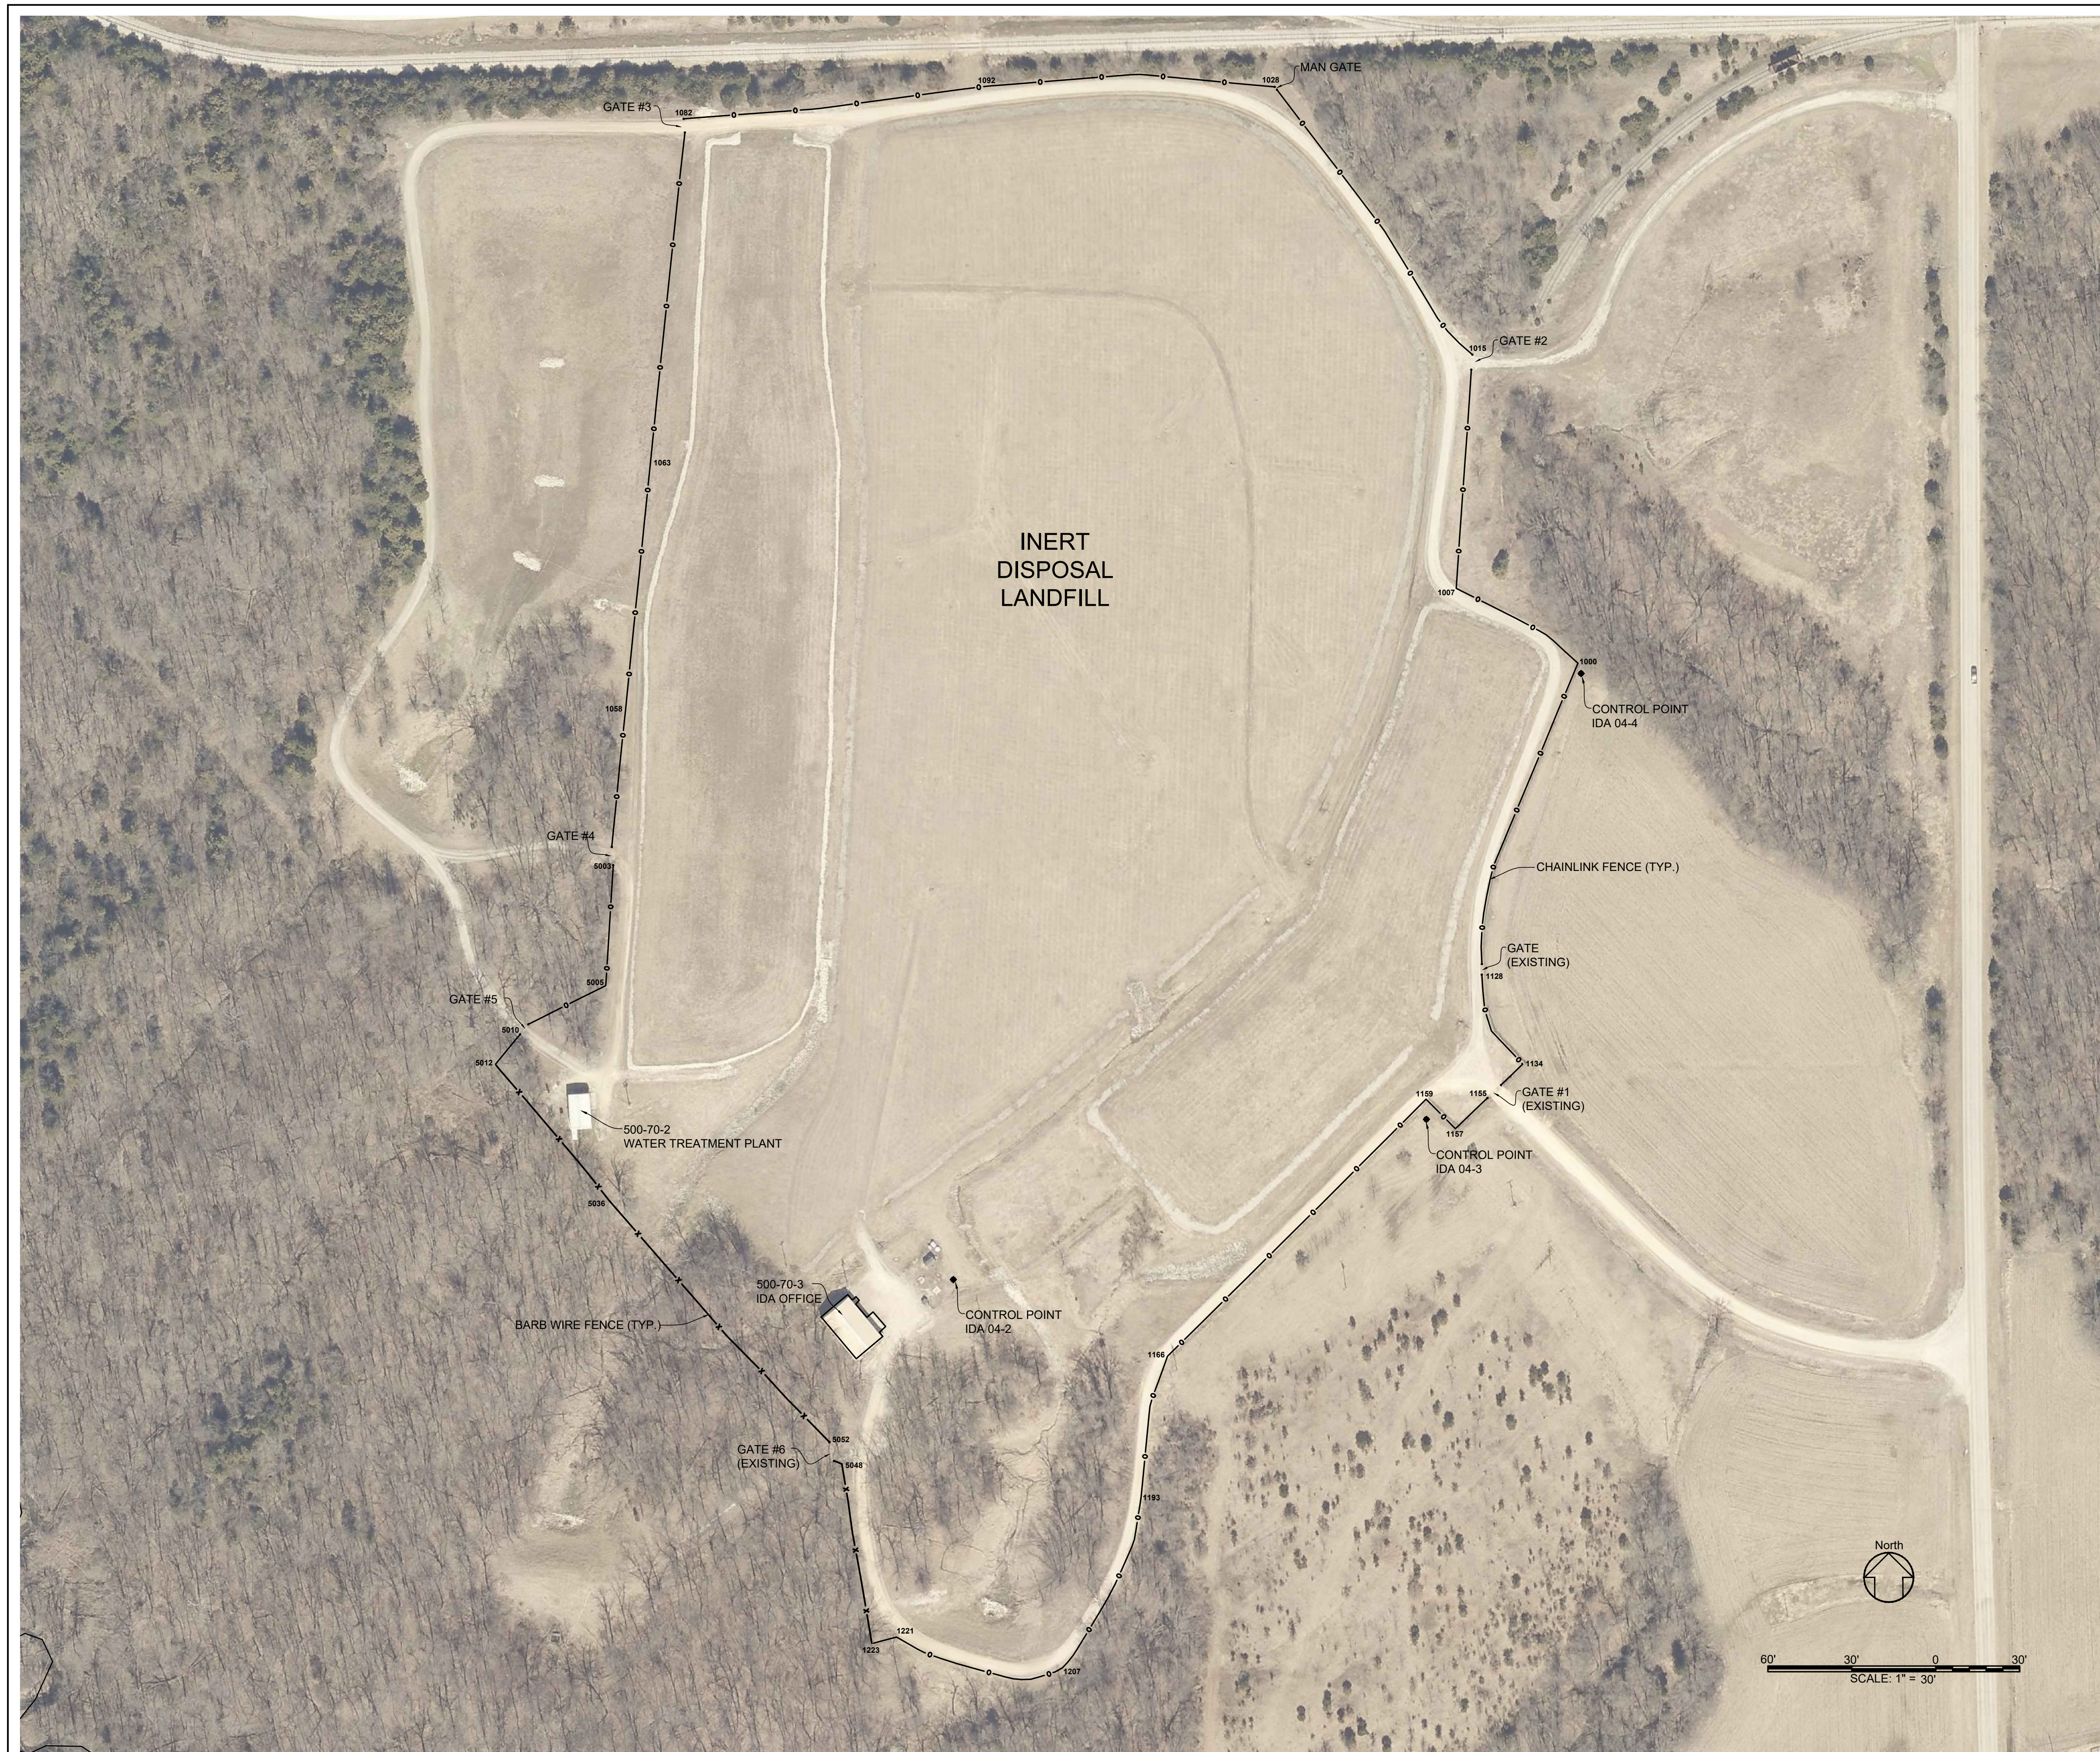
AS-CONSTRUCTED FENCE INERT DISPOSAL AREA					
IOWA ARMY AMMUNITION PLANT			MIDDLETOWN, IOWA		
Point#	Northing (M)	Eastings (M)	Elevation (M)	Description	Fence Height (M)
1000	91203.038	688293.118	213.789	FENCE "C-LINK"	1.097
1001	91207.136	688288.551	214.001	FENCE "C-LINK"	1.036
1002	91211.265	688284.148	214.651	FENCE "C-LINK"	1.006
1007	91228.778	688249.622	214.777	FENCE "C-LINK"	1.128
1008	91235.662	688250.008	213.693	FENCE "C-LINK"	1.036
1011	91274.721	688232.722	213.712	FENCE "C-LINK"	1.067
1014	91307.887	688255.001	214.273	GATE POST	1.067
1015	91313.366	688255.373	214.242	GATE POST	1.036
1018	91326.488	688242.878	214.576	FENCE "C-LINK"	1.036
1022	91357.599	688223.948	214.988	FENCE "C-LINK"	1.097
1027	91408.086	688185.518	214.987	GATE POST	1.067
1028	91409.085	688184.744	214.959	GATE POST	1.097
1058	91186.481	687952.716	213.460	FENCE "C-LINK"	1.067
1060	91216.844	687955.733	213.684	FENCE "C-LINK"	1.036

1063	91274.291	687961.583	213.831	FENCE "C-LINK"	1.036
1068	91338.180	687968.089	215.089	FENCE "C-LINK"	1.067
1069	91352.749	687973.906	216.907	GATE POST	1.036
1082	91387.709	687973.659	216.744	GATE POST	1.067
1086	91401.356	688021.881	217.002	FENCE "C-LINK"	1.067
1088	91404.207	688043.075	216.819	FENCE "C-LINK"	1.067
1092	91409.343	688082.064	216.092	FENCE "C-LINK"	1.067
1096	91413.556	688136.307	215.495	FENCE "C-LINK"	1.036
1118	91186.465	688286.183	214.528	FENCE "C-LINK"	2.073
1121	91130.880	688283.049	213.808	FENCE "C-LINK"	2.073
1122	91065.469	688285.804	213.423	GATE POST	2.134
1128	91091.689	688258.740	213.304	GATE POST	2.195
1132	91071.502	688282.215	213.356	FENCE "C-LINK"	2.073
1134	91059.719	688273.375	213.119	FENCE "C-LINK"	2.103
1136	91052.232	688265.628	213.437	GATE POST	1.951
1155	91047.587	688260.744	213.334	GATE POST	2.012
1157	91038.589	688249.296	213.160	FENCE "C-LINK"	2.073
1159	91047.173	688238.823	213.274	FENCE "C-LINK"	2.073

SURVEY CONDUCTED: MAY 31, 2016 BY KLINGER & ASSOCIATES.

A formal as-built survey was conducted on 31 May 2016 by a licensed surveyor. Coordinates obtained during the survey were incorporated into the as-built drawing provided as Appendix E.
