**Annual Land Use Control Implementation Report
for Operable Unit 5 Munitions Response Sites
Military Munitions Response Program**

**Iowa Army Ammunition Plant
Middletown, Iowa**

September 2022

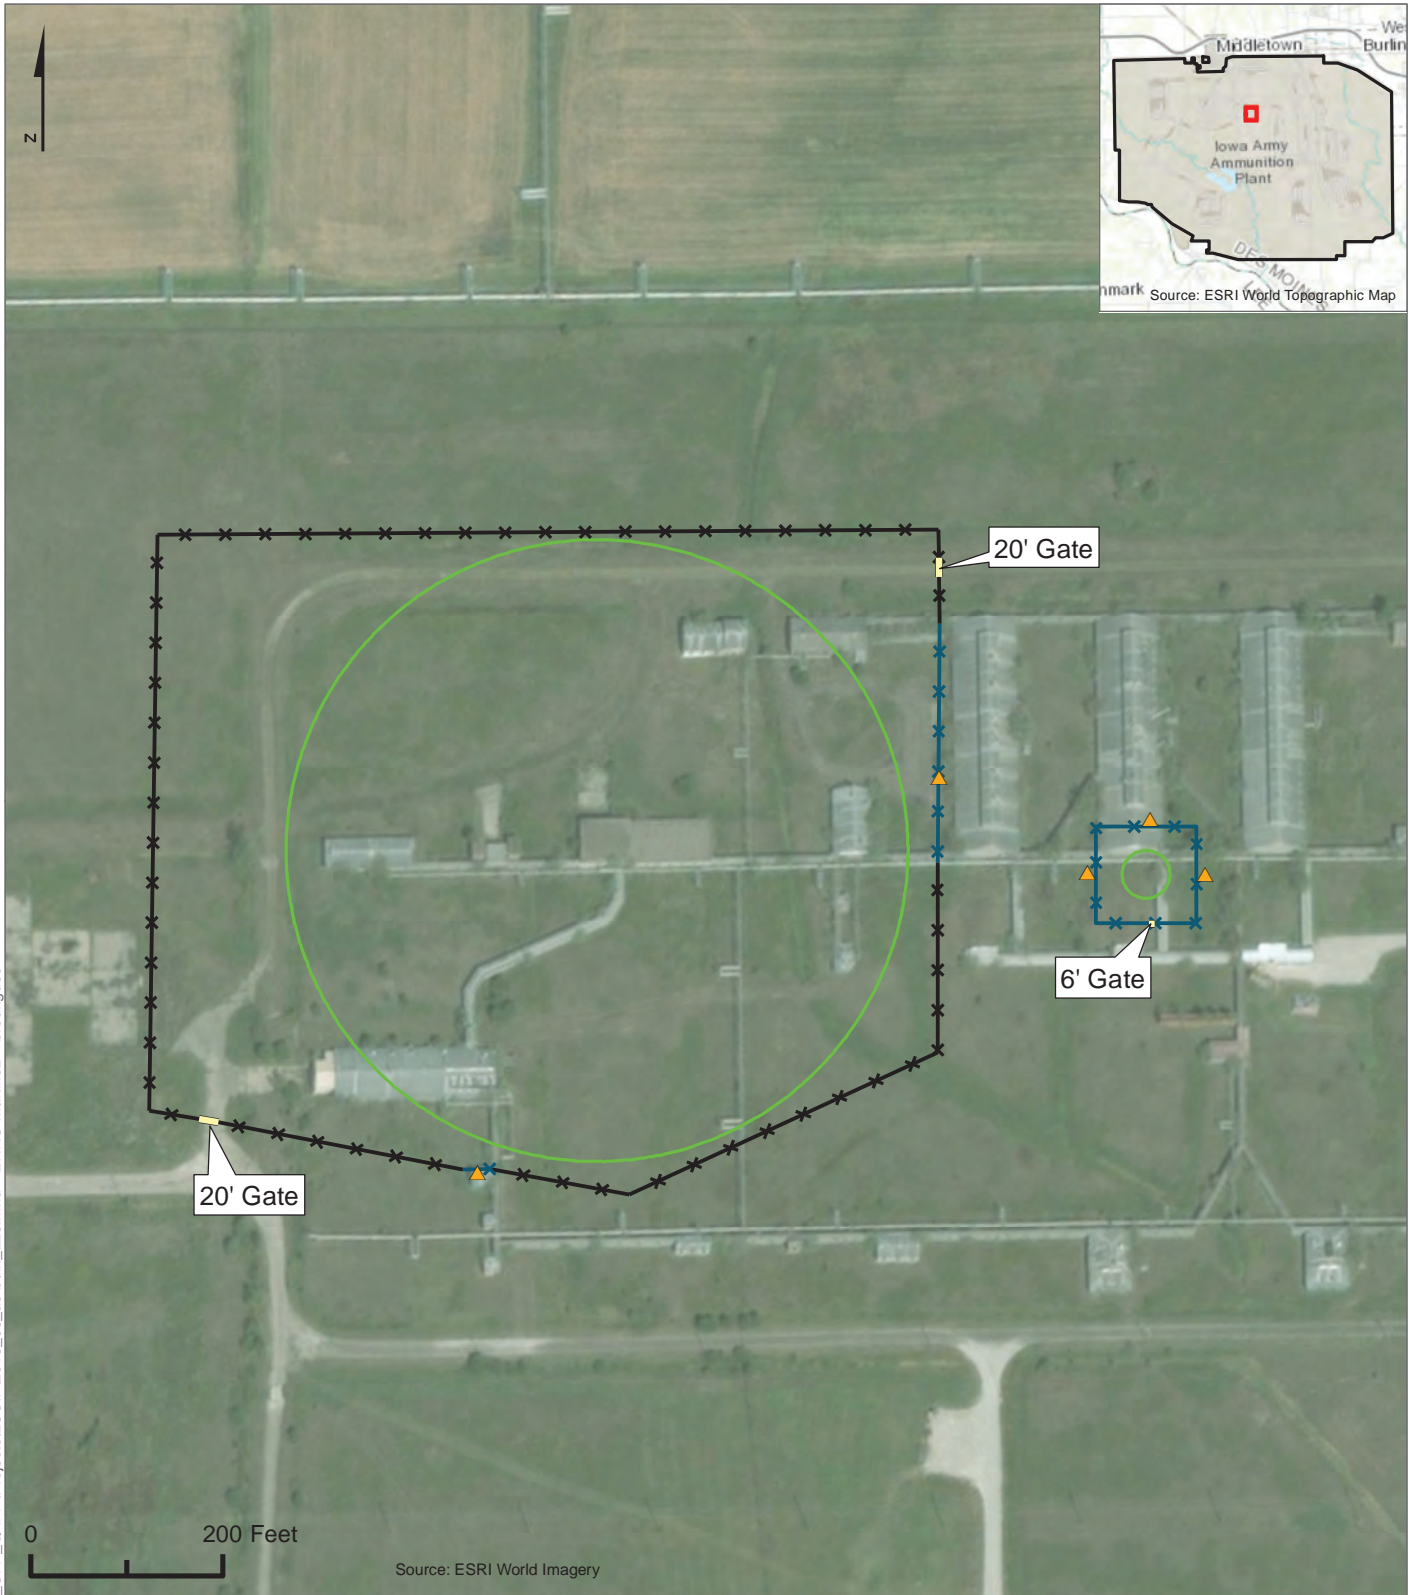
Figure 3. As-Built Fencing Layout for the Line 6 Ammo Production Area - Inside Blast Radii
 Annual Land Use Control Implementation Report, Operable Unit 5 Munitions Response Sites
 Iowa Army Ammunition Plant, Middletown, Iowa

LL6 – Inside Blast Radii is an 8-acre MRS defined by the blast radii of two explosions that occurred in 1968 and 1970 at Buildings 6-34-2 and 6-92, respectively (Figure 3). The topography of LL6 – Inside Blast Radii is flat, with no surface water bodies, and the vegetative cover consists of tall grass with shrubs. Access to LL6 – Inside Blast Radii is very limited because it is located inside a locked and secured Line 6 fence inside the IAAAP, which has additional access restrictions because it is located immediately adjacent to the active 40-millimeter Test Range (CB&I, 2014).

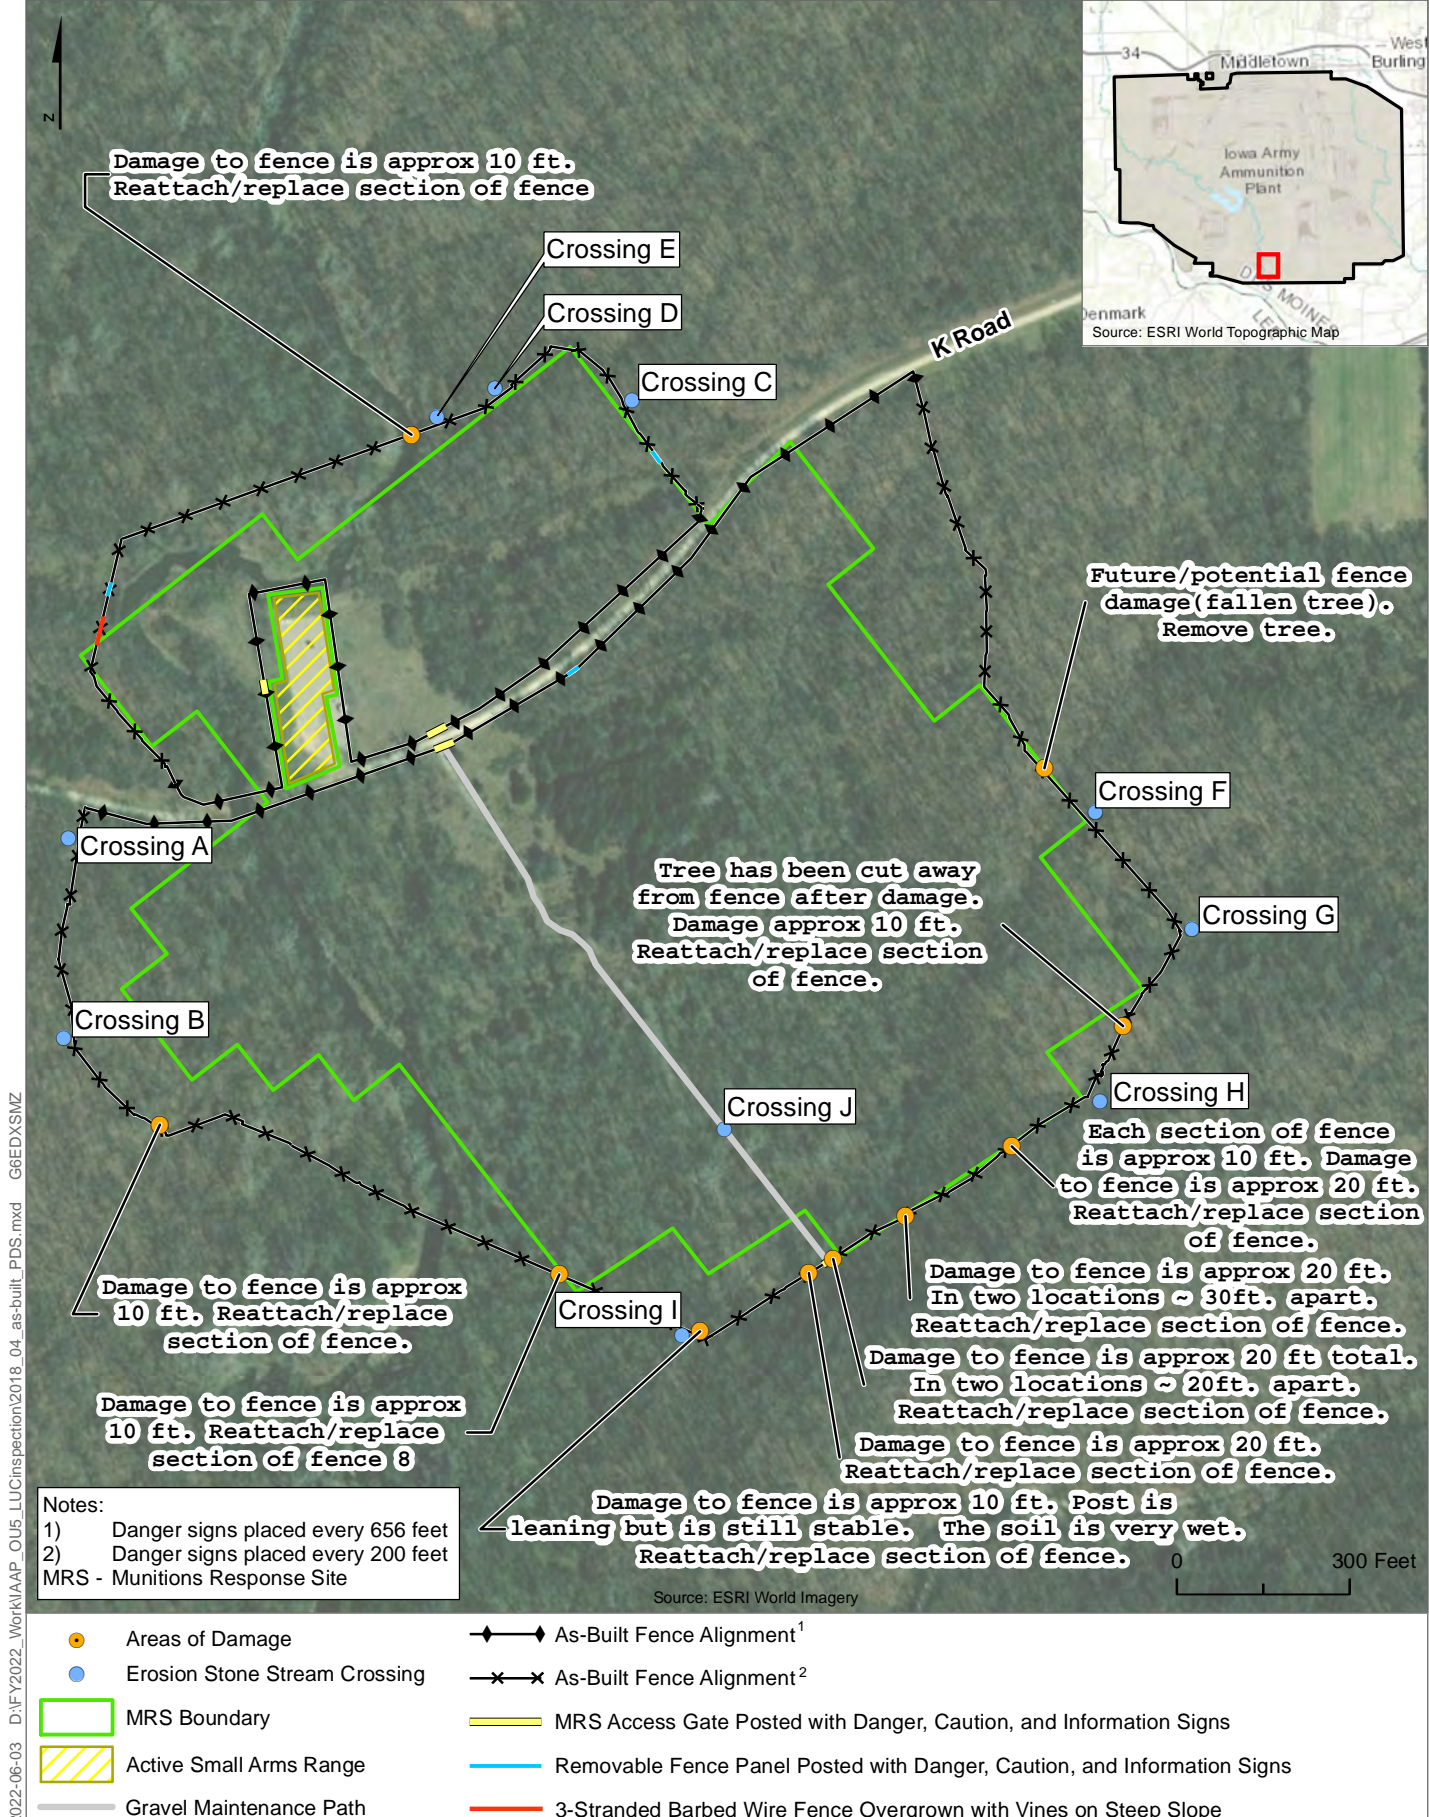
Figure C3. Results from 2022 Inspection, Possible Demolition Site
 Annual Land Use Control Implementation Report, Operable Unit 5 Munitions Response Sites
 Iowa Army Ammunition Plant, Middletown, Iowa

Location:	Description of deficiency and repair needed::	Photo ID:
40.76047, -91.23987	Future/potential fence damage (fallen tree). Remove tree.	1
40.75926, -91.23955	Tree has been cut away from fence after damage. Damage approximate 10 feet. Reattach/replace section of fence.	2

40.75871, -91.24013	Each section of fence is approximately 10 feet. Damage to fence is approximately 20 feet. Reattach/replace section of fence.	3
40.75832, -91.24077	Damage to fence is approximately 20 feet. In two locations ~ 30ft. apart. Reattach/replace section of fence.	4

40.75818, -91.24136	Damage to fence is approximately 20 feet total. In two locations ~ 20ft. apart. Reattach/replace section of fence.	5
40.75812, -91.24133	Damage to fence is approximately 20 feet. Reattach/replace section of fence.	6

40.75795, -91.24214	Damage to fence is approximately 10 feet. Post is leaning but is still stable. The soil is very wet. Reattach/replace section of fence.	7
