# Iowa Army Ammunition Plant

## Proposed Plan for 27 Iowa Army Ammunition Plant Sites Proposed for No Further Action

### Operable Unit 11

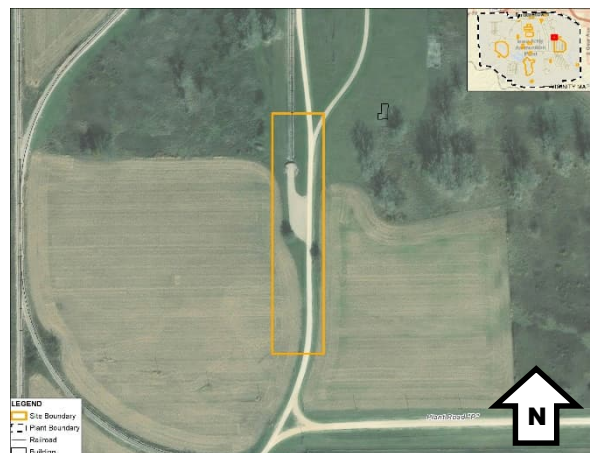
Figure 2 – Layout of Boxcar Unloading Area (IAAP-014 and IAAP-014G)

The Boxcar Unloading Area (BCU) is located in the northeast portion of the IAAAP site (Figure 2). This Proposed Plan includes both soil and **groundwater** at the BCU, which fall under IRP sites IAAP-014 and IAAP-014G, respectively. Note, although the 1992 Site Inspection (SI) (JAYCOR and CDM, 1992) concluded that the potential for a release at this area was negligible, the IRP site for groundwater (IAAP-014G) was created in 2012 to facilitate the management of environmental work at the IAAAP.

The BCU, which encompasses approximately 7 acres, is surrounded by agricultural fields, vegetation, and trees, and is adjacent to railroad tracks and Plant Road O. The BCU is located within a recreational hunting area. Surface water and sediment are not present at the BCU.

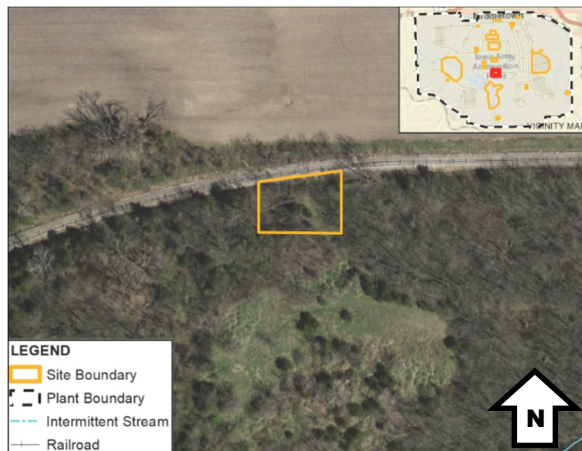
Figure 3 – Layout of Unidentified Substance Waste Site (IAAP-022 and IAAP-022G)

The Unidentified Substance Waste Site (USWS) is located in the central portion of the IAAAP (Figure 3). This Proposed Plan includes both soil and groundwater at the USWS, which fall under IRP sites IAAP-022 and IAAP-022G, respectively. Note, although the 1992 SI (JAYCOR and CDM, 1992) concluded there was not widespread or significant contamination present, the IRP site for groundwater (IAAP-022G) was created in 2012 to facilitate the management of environmental work at the IAAAP.

The USWS includes an area located south of the railroad track bed where an irregularly shaped spill measuring roughly 20 feet by 20 feet was described. The Construction Debris Landfill (CDL) is located to the south. The site is located within a forested area that is designated for recreational use.

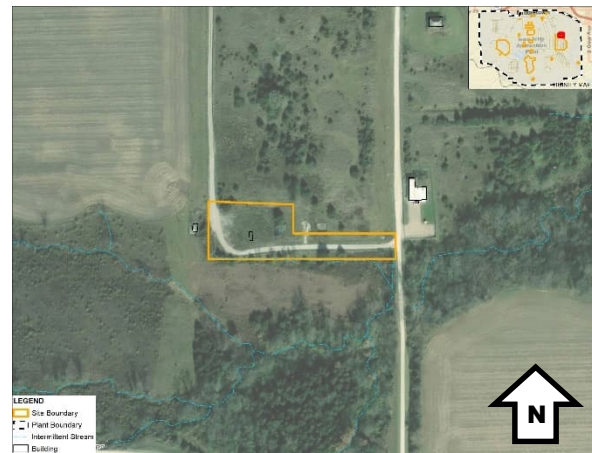
**Figure 4 – Layout of Explosive Waste Incinerator (IAAP-025 and IAAP-025G)**

Area (EDA), in the northeastern portion of the IAAAP site (Figure 4). This Proposed Plan includes both soil and groundwater at the EWI, which fall under IRP sites IAAP-025 and IAAP-025G, respectively.

The EWI is enclosed in Building BG-199-1. The EWI is in a recreational area and covers approximately 2 acres. Adjacent land consists of agricultural tracts, heavily forested areas, and grassy coverage with isolated tree clusters. There are no permanent water features or wet sediment within the site boundary.

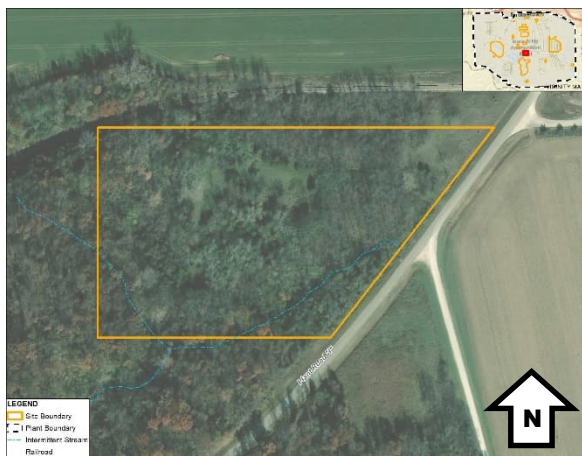
**Figure 5 – Layout of Construction Debris Disposal Area (IAAP-028 and IAAP-028G)**

The Construction Debris Disposal Area (CDDA) is located in the central portion of the IAAAP (Figure 5). This Proposed Plan includes both soil and groundwater at the CDDA, which fall under IRP sites IAAP-028 and IAAP-028G, respectively.

The CDDA is in a recreational area and consists of a 5.7-acre inactive disposal site located in the central portion of the IAAAP, within the Long Creek *watershed*. It has been historically referred to as the CDL in historical documents. The site previously was used for debris disposal and storage, but it was never designated as a landfill nor operated as such under any regulatory framework.

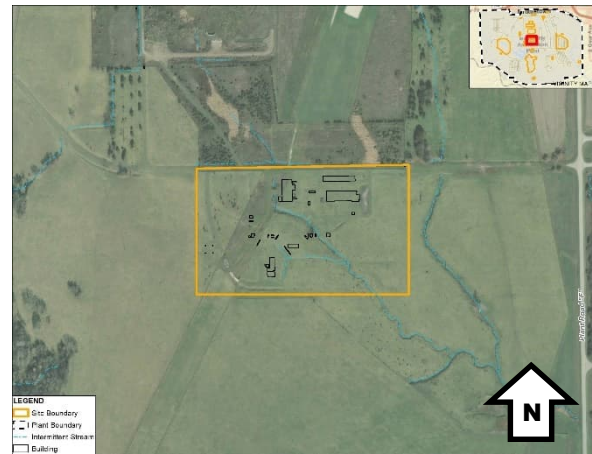
Figure 10 – Layout of Line 7 Ammo LAP (Fuze/Blank) (IAAP-008G)

Line 7, which comprises approximately 25 acres, is surrounded by agricultural fields, vegetation and trees, and is within the boundary of the active 40-millimeter (mm) test range (constructed in 2013). Line 7 is located within a restricted area; no hunting or recreation is

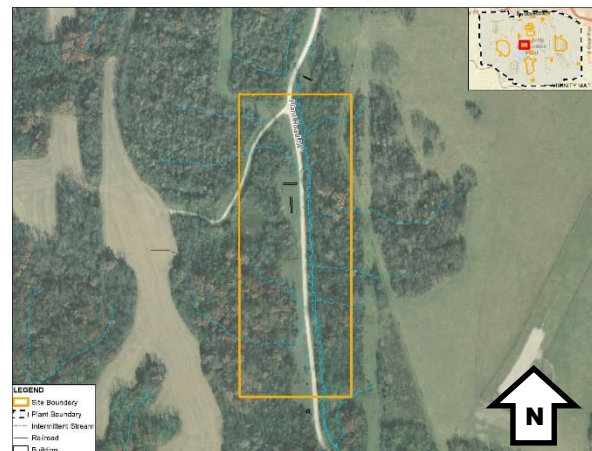
Figure 11 – Layout of Line 8 Ammo LAP Site (Fuze/Rocket) (IAAP-009G)

The Line 8 Ammo LAP site is located in the central portion of the IAAAP (Figure 11). This Proposed Plan addresses groundwater at Line 8, which is designated as IAAP-009G. Soil (IAAP-009) is addressed under the OU-1 remedial action and is not part of this Proposed Plan. Note, although the 1996 RI (JAYCOR) concluded that contamination was only present in shallow soil, the IRP site for groundwater (IAAP-009G) was created in 2012 to facilitate the management of environmental work at the IAAAP.

Line 8 comprises approximately 22 acres and encompasses a former production line located in the central portion of the IAAAP facility on the western edge of the 40-mm fragmentation zone, approximately 0.375-mile west of Lines 7 and 9. All buildings have been demolished and the site is currently inactive. An intermittent tributary to Long Creek also runs north-south, parallel to the road.

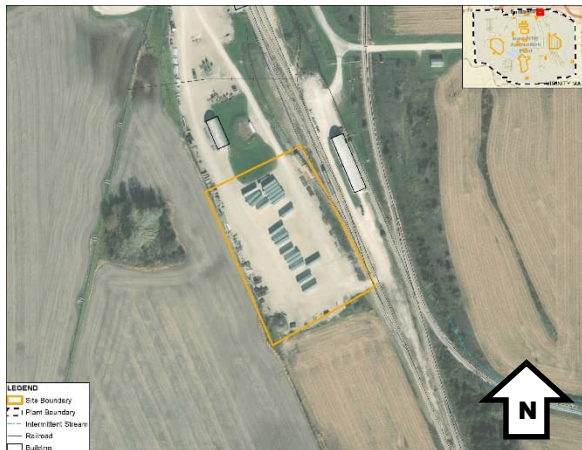
**Figure 16 – Layout of Roundhouse Transformer Storage Area (IAAP-040G)**

The Roundhouse is located in the northeast-central portion of the IAAAP facility, approximately 1,000 feet from the northern site boundary and within the Spring Creek watershed. The site is approximately 4.5 acres and encompasses a graded, flat storage area with a compacted clay foundation overlain by crushed stone; the area is designated for industrial land use.

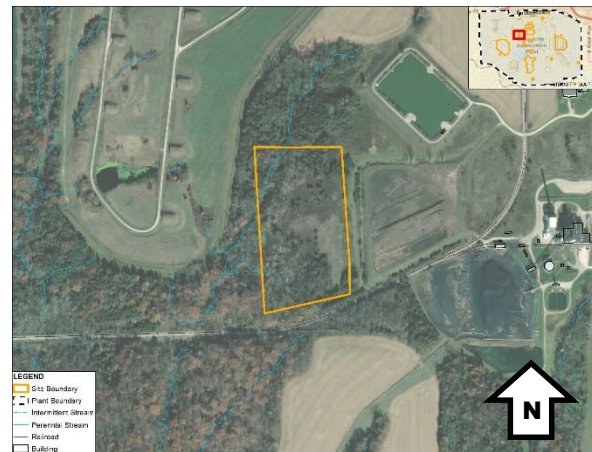
Figure 17 – Layout of Fly Ash Disposal Area (IAAP-043G)

The Fly Ash Disposal Area (FADA) is an inactive site located in the west-central area of the IAAAP site (Figure 17). This Proposed Plan includes groundwater at the FADA, which is designated as IAAP-043G. Soil (IAAP-043) is addressed under the OU-7 and is not part of this Proposed Plan.

The FADA comprises an approximately 6-acre area, located adjacent to and directly west of the existing Fly Ash Landfill. The FADA is located in a recreational zone.

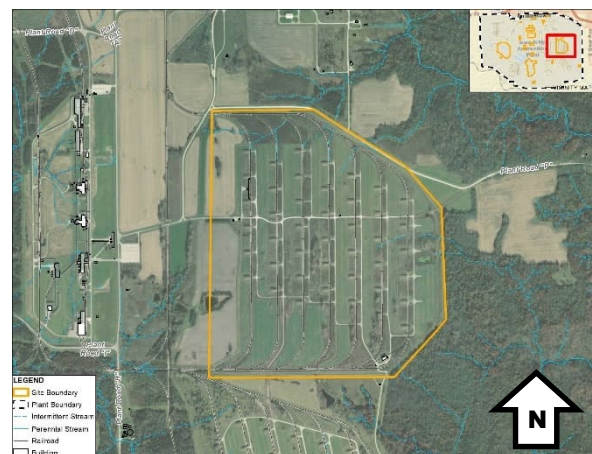
Figure 22 – Layout of Yard C

Yard C is located in the eastern portion of the IAAAP (Figure 22). This Proposed Plan includes both surface water and groundwater at Yard C; neither are assigned an identification number. Soil at Yard C is being addressed under FUSRAP (OU-8).

Yard C, which comprises approximately 301 acres, is primarily an open field containing over 40 storage igloos and several support buildings; the open field is used for agriculture and often harvested for hay. Yard C is fully enclosed by a security fence. The site is surrounded by wooded and agricultural lands and is closed to hunters and recreators.
