# Iowa Army Ammunition Plant

## Proposed Plan for 27 Iowa Army Ammunition Plant Sites Proposed for No Further Action

### Operable Unit 11

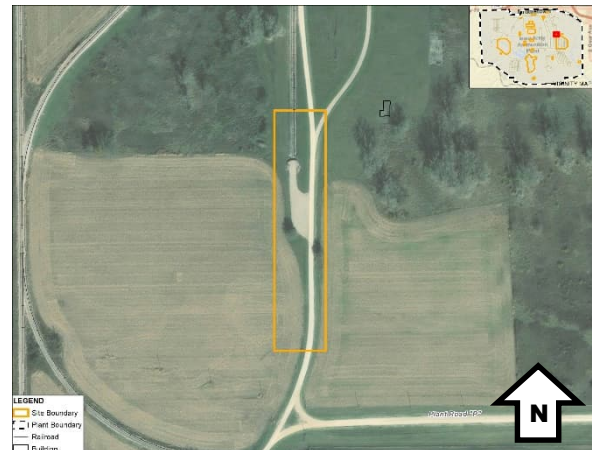
Figure 2 – Layout of Boxcar Unloading Area (IAAP-014 and IAAP-014G)

The BCU, which encompasses approximately 7 acres, is surrounded by agricultural fields, vegetation, and trees, and is adjacent to railroad tracks and Plant Road O. The BCU is located within a recreational hunting area. Surface water and sediment are not present at the BCU.

The Boxcar Unloading Area (BCU) is located in the northeast portion of the IAAAP site (Figure 2). This Proposed Plan includes both soil and **groundwater** at the BCU, which fall under IRP sites IAAP-014 and IAAP-014G, respectively. Note, although the 1992 Site Inspection (SI) (JAYCOR and CDM, 1992) concluded that the potential for a release at this area was negligible, the IRP site for groundwater (IAAP-014G) was created in 2012 to facilitate the management of environmental work at the IAAAP.

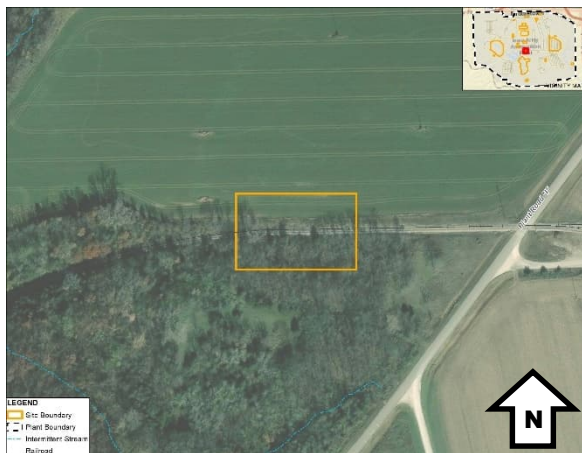
Figure 3 – Layout of Unidentified Substance Waste Site (IAAP-022 and IAAP-022G)

The USWS is an area of approximately 20 feet by 20 feet and located approximately 15 to 20 feet south of the railroad track bed. The Construction Debris Landfill (CDL) is located to the south. The site is located within a forested area that is designated for recreational use..

The Unidentified Substance Waste Site (USWS) is located in the central portion of the IAAAP (Figure 3). This Proposed Plan includes both soil and groundwater at the USWS, which fall under IRP sites IAAP-022 and IAAP-022G, respectively. Note, although the 1992 SI (JAYCOR and CDM, 1992) concluded that was not widespread or significant contamination present, the IRP site for groundwater (IAAP-022G) was created in 2012 to facilitate the management of environmental work at the IAAAP.

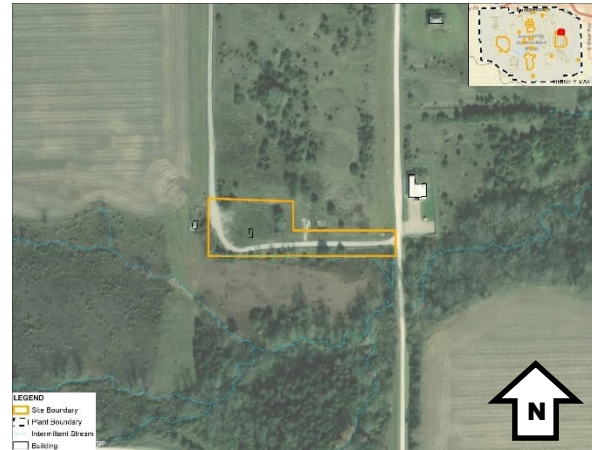
**Figure 4 – Layout of Explosive Waste Incinerator (IAAP-025 and IAAP-025G)**

The EWI is enclosed in Building BG-199-1. The EWI is in a recreational area and covers approximately 2 acres. Adjacent land consists of agricultural tracts, heavily forested areas, and grassy coverage with isolated tree clusters. There are no permanent water features or wet sediment within the site boundary.

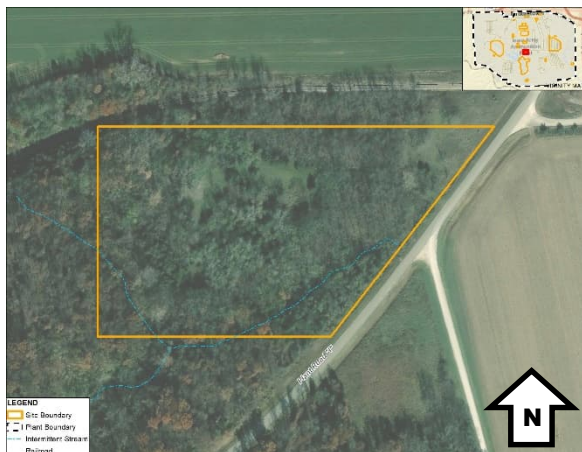
**Figure 5 – Layout of Construction Debris Disposal Area (IAAP-028 and IAAP-028G)**

The CDDA is in a recreational area and consists of a 5.7-acre inactive disposal site located in the central portion of the IAAAP, within the Long Creek *watershed*. It has been historically referred to as the CDL in historical documents. The site previously was used for debris disposal and storage, but it was never designated as a landfill nor operated as such under any regulatory framework.

The Construction Debris Disposal Area (CDDA) is located in the central portion of the IAAAP (Figure 5). This Proposed Plan includes both soil and groundwater at the CDDA, which fall under IRP sites IAAP-028 and IAAP-028G, respectively.

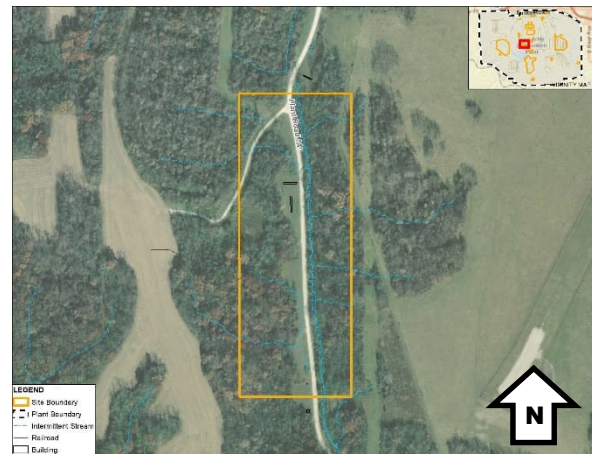
Figure 11 – Layout of Line 8 Ammo LAP Site (Fuze/Rocket) (IAAP-009G)

Line 8 comprises approximately 22 acres and encompasses a former production line located in the central portion of the IAAAP facility on the western edge of the 40-mm fragmentation zone, approximately 0.375-mile west of Lines 7 and 9. All buildings have been demolished and the site is currently inactive. An intermittent tributary to Long Creek also runs north-south, parallel to the road.

The Line 8 Ammo LAP site is located in the central portion of the IAAAP (Figure 11). This Proposed Plan addresses groundwater at Line 8, which is designated as IAAP-009G. Soil (IAAP-009) is addressed under the OU-1 remedial action and is not part of this Proposed Plan. Note, although the 1996 RI (JAYCOR) concluded that contamination was only present in shallow soil, the IRP site for groundwater (IAAP-009G) was created in 2012 to facilitate the management of environmental work at the IAAAP.

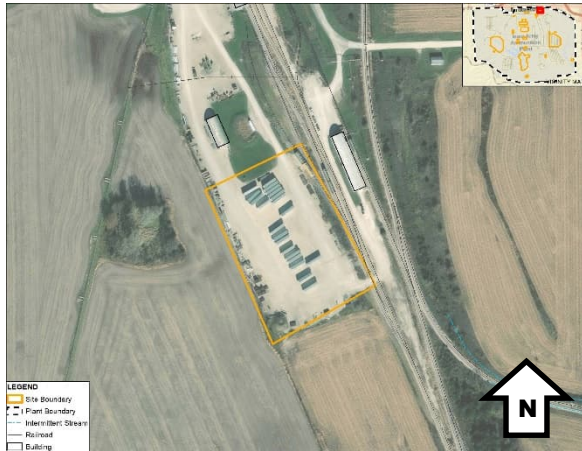
**Figure 16 – Layout of Roundhouse Transformer Storage Area (IAAP-040G)**

The Roundhouse is located in the northeast-central portion of the IAAAP facility, approximately 1,000 feet from the northern site boundary and within the Spring Creek watershed. The site is approximately 4.5 acres and encompasses a graded, flat storage area with a compacted clay foundation overlain by

crushed stone; the area is designated for industrial land use.

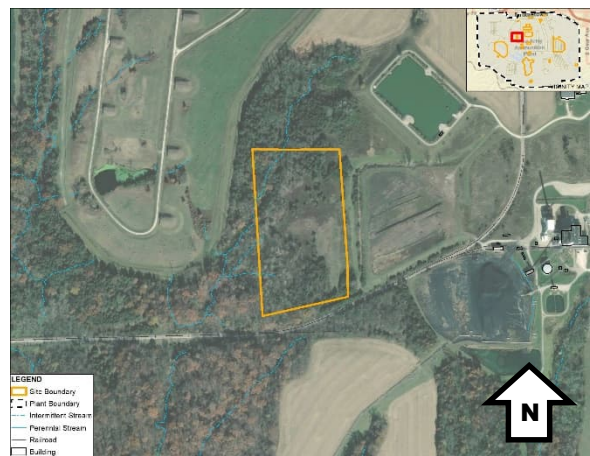
Figure 17 – Layout of Fly Ash Disposal Area (IAAP-043G)

The FADA comprises an approximately 6-acre area, located adjacent to and directly west of the existing Fly Ash Landfill. The FADA is located in a recreational zone.

The Fly Ash Disposal Area (FADA) is an inactive site located in the west-central area of the IAAAP site (Figure 17). This Proposed Plan includes groundwater at the FADA, which is designated as IAAP-043G. Soil (IAAP-043) is addressed under the OU-7 and is not part of this Proposed Plan.
